Nuneaton and Bedworth Borough Council
**Bulkington Conservation
Area Appraisal and
Management Plan**
Supplementary Planning Document 2022

1. Statement of Special Interest

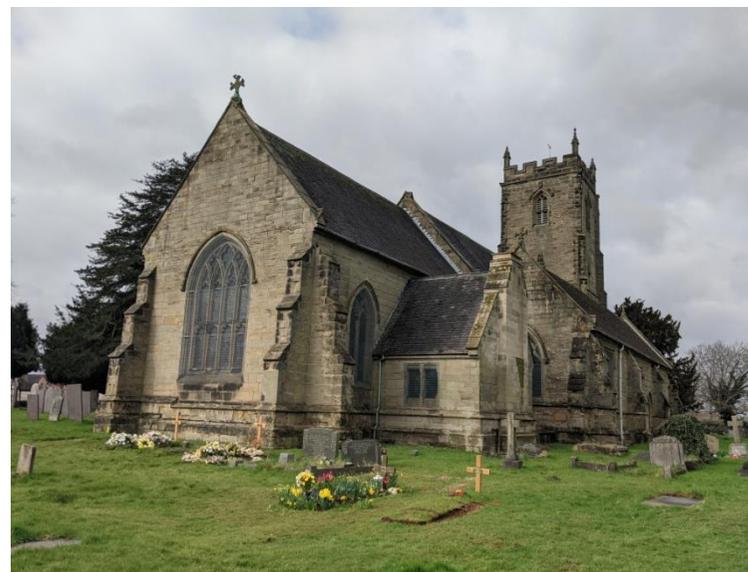
Figure 3: St. James Parish Church

roughly rectangular shaped area of land immediately to the south of the Church, defined on three-and-a-half sides by Church Street, Chequer Street, Leicester Street and School Lane (Figure 1 above). The backs of house plots lining the east side of Church Street and the west side of Leicester Street - the village's two principal streets - do not directly abut each other but instead have a strip of open ground between them terminating in a larger open space to the south (now occupied by Bulkington Working Men's Club). The alignment of Church Street is focused upon the parish Church of St James; the village's oldest standing structure with fabric surviving from the 13th century.

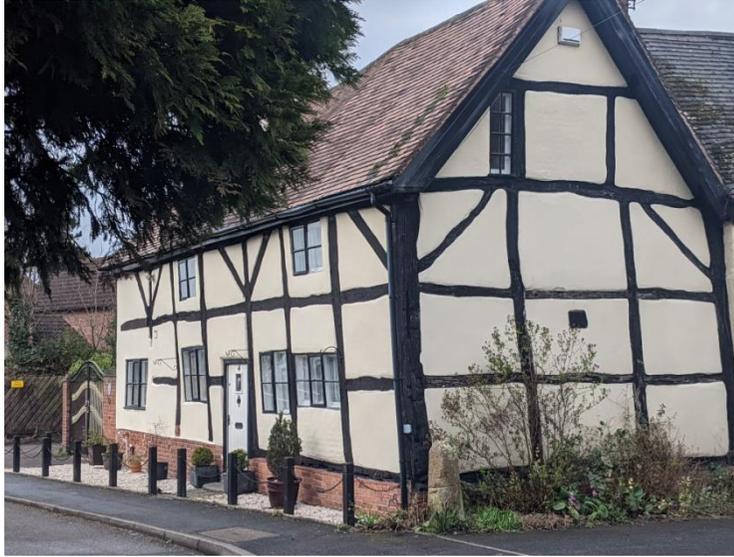
Figure 4: 3 and 4 Church Street

The earliest surviving standing secular building in the street, on the west side, is 3-4 Church Street of early 17th century date.

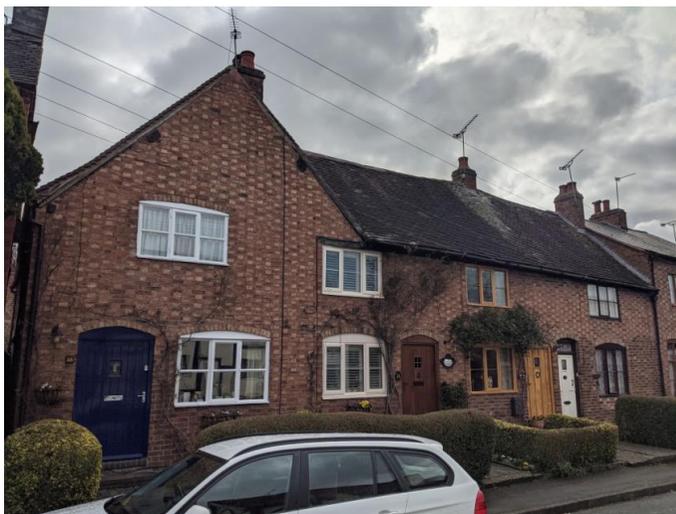
Figure 5: 25 to 28 Church Street

large 'weavers windows'. These however were the exceptions in the village, most weaving being carried out on handlooms in ground-floor rooms of cottages and houses such as those at 25-29 Church Street, no three-storey buildings with loom-shops survive today.

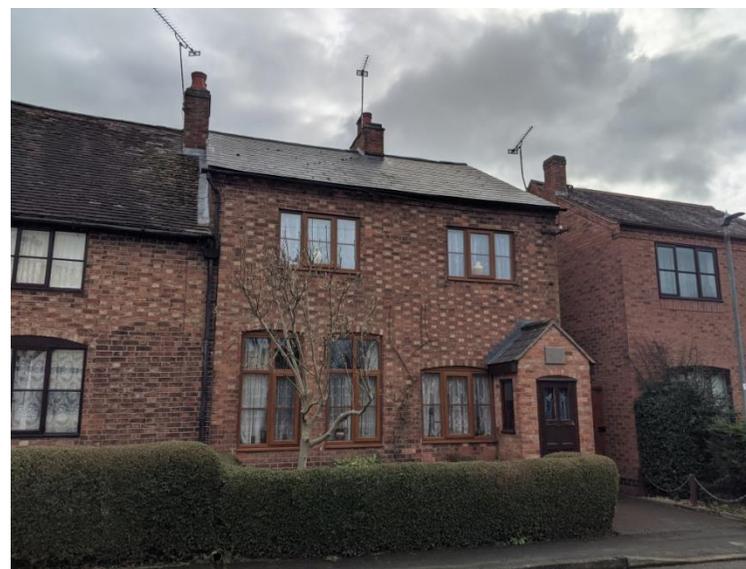
Figure 6: 29 Church Street

5.3.4 29 Church Street. Probably late 18th or early 19th century in origin and, on the evidence of the large ground floor windows, built as a silk weaver's cottage. It has a modern porch, stained timber windows, and an artificial slate roof. The front elevation is important for its evidence of ribbon weaving, its locally distinctive chequer-board pattern brickwork, and its group value with nos. 25-28.

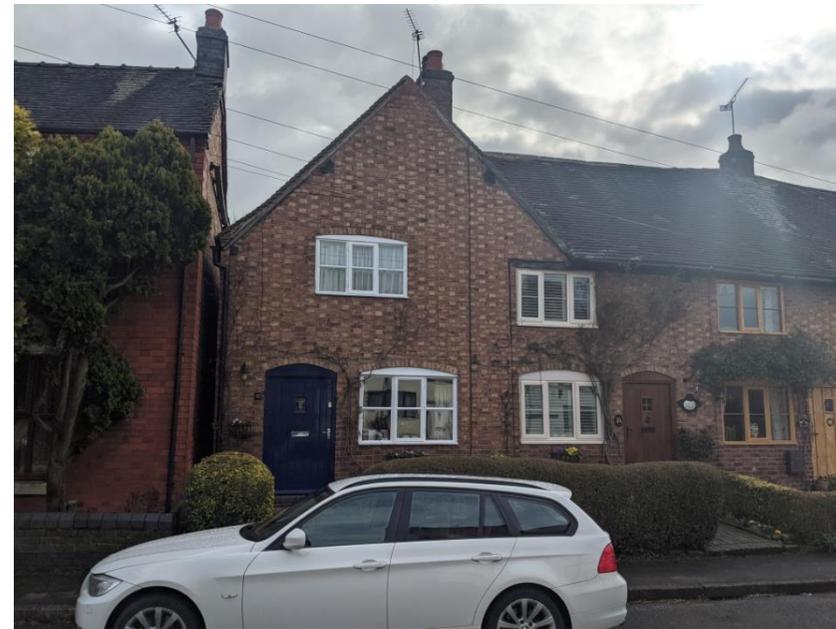
Figure 7: Chequer patterned brickwork 25 Church Street

village particularly hard. The 1830s were a difficult time for cottage ribbon weavers, partly because of the introduction of factory production at Coventry, and because of competition from cheap imports. The 1840s however were again a boom time and, judging from earlier 20th century photographs, many houses were either re-fronted or rebuilt then. Their chequer-pattern brick facades (a feature of North Warwickshire buildings of the period) were highly characteristic of the village buildings up until the middle of the last century. Continuous rows of them lining the back edges of pavements imparted a harmonious, locally distinctive, and cohesive appearance to the village.

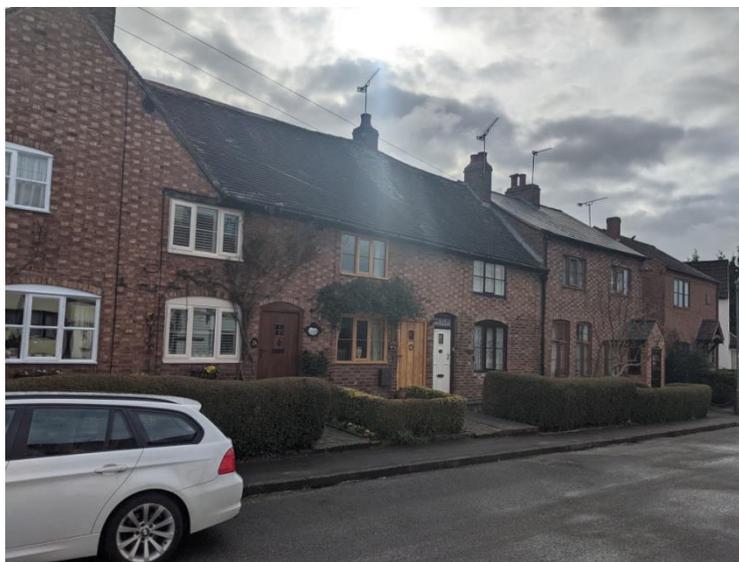
Figure 8: 25 to 29 Church Street

- 4.2.1 Historically the most important uses are those that are still represented – the church use of lands to the north of School Road, and the small houses and cottages of villagers along the street itself.
- 4.2.2 The most significant and locally distinctive influence for the Conservation Area is that of the 18th and early 19th century

local silk weaving industry on the appearance of front elevations of some surviving cottages of the period (25-29 Church Street – see below)

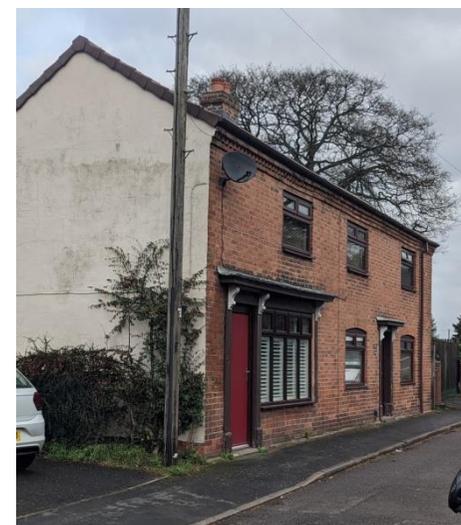
Figure 9: 10 and 10A Church Street

- 4.2.3 Evidence of a departed 19th century village shop is provided by the surviving Victorian shop front to 10&10a Church Street.

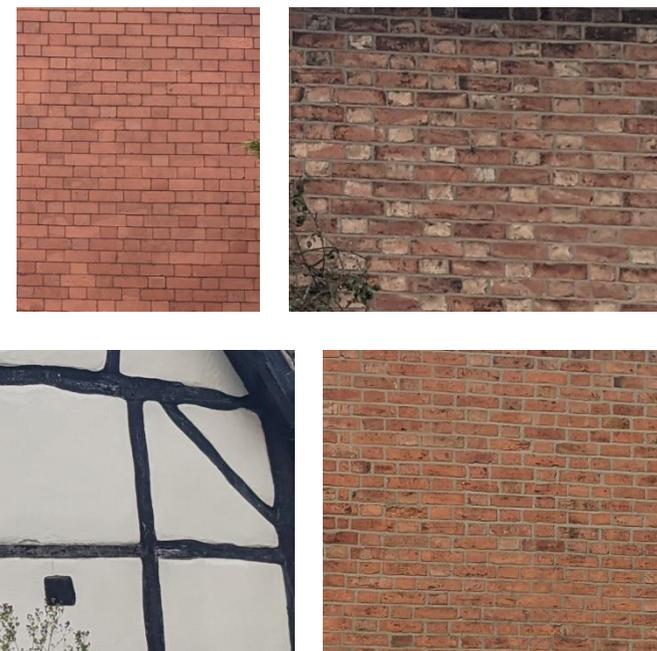
Figure 11: Materials Palette

area has a special local vernacular character given by the consistent use of lighter header bricks and darker stretchers. This means that the wall has a dark tone with lighter ends of bricks making a diaper pattern. The local bricks are a light brown. Some buildings have been rendered.

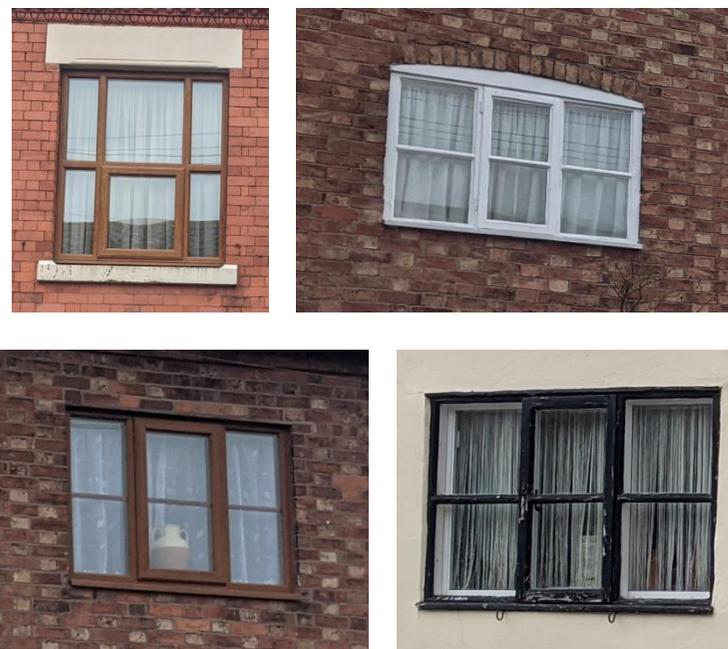
Figure 12: Types of Windows

4.7.2 Modern buildings have uPVC windows, also several historic buildings have had their windows inappropriately replaced with modern timber stained or uPVC units. Where opportunities arise, this replacement should be reversed.

7.3.7 UPVC or plastic windows and doors are not a traditional or vernacular material and are unsuitable for use in historic buildings. The replacement of uPVC windows and doors with timber products is encouraged in historic buildings.

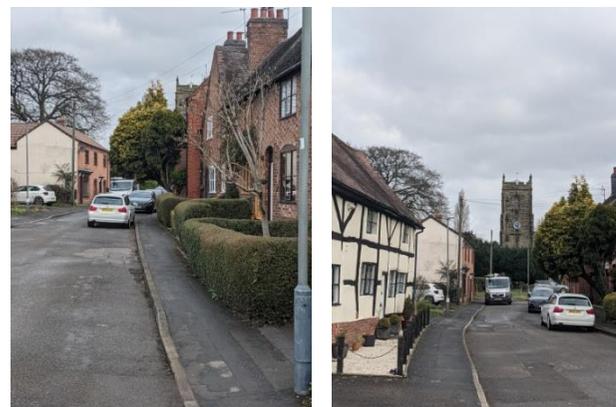
Figure 13: Church Street Boundary Treatments

4.8.1 Boundary treatments refer to where private buildings meet the public realm. Most of the important heritage buildings in the Conservation Area are in Church Street. Some of these dwellings are situated with direct access to the street and do not have a boundary. Other buildings are variously bounded by low brick walls, privet hedges or railings. The boundary treatments of properties on Church Street are low in height and not above the lower floor windowsill.

7.3.6 Boundary treatments often have historic and architectural value and make a positive contribution towards the character of the Conservation Area. Repair to boundary treatments is better than replacement. The erection of new boundary walls and fencing should not be greater than the height of the lower floor windowsill.

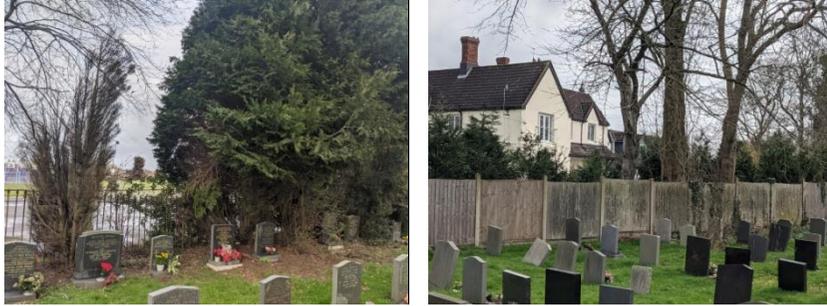
Figure 14: Churchyard railings and fencing

4.8.2 St James Churchyard southern boundary on School Road is marked by a low-lying hedge; a low retaining wall can be found on the eastern boundary; iron railings can be found amongst the hedge on the western boundary - the railings are nationally listed; uncharacteristic modern concrete fence posts with wooden fencing panels are in use on the north west boundary.

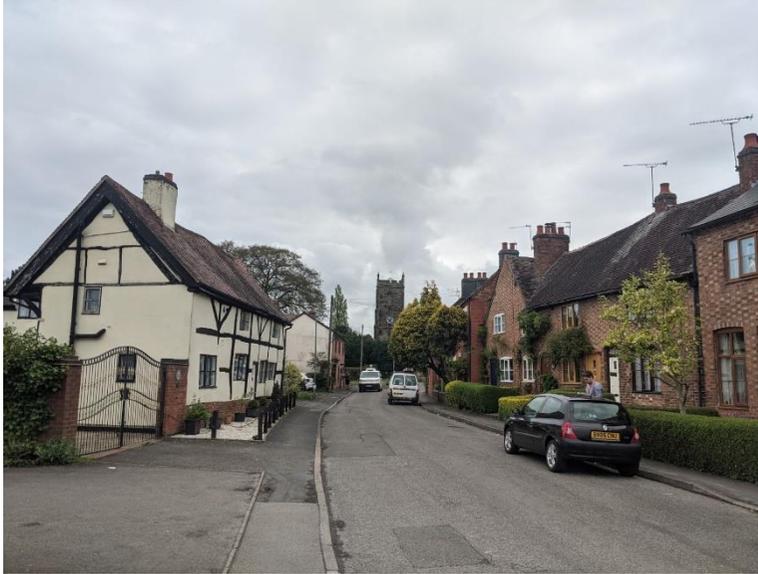
Figure 16: Church Street - A narrow curving street aligned on the church tower

4.9.2 The most important views are those looking northward along Church Street from its southern end towards the tower of St James. It is from here, with 3 and 4 Church Street and 25-28 Church Street flanking the foreground on the left and right, there is the impression of an historic village street. The townscape of curving street bounded by houses and cottages leading the eye towards the church tower and offering gradually unfolding sequential views of buildings that terminate with the Church as a focal point.

- 4.10.2 There are two principal types of space within the Conservation Area. The first is the gently curving corridor space of Church Street, still relatively well defined by buildings in parts along its edges and whose axis is centred on the church (Figure 16).
- 4.10.3 The second is the green space associated with the church and former vicarage into which a modern suburban-style vicarage has intruded.

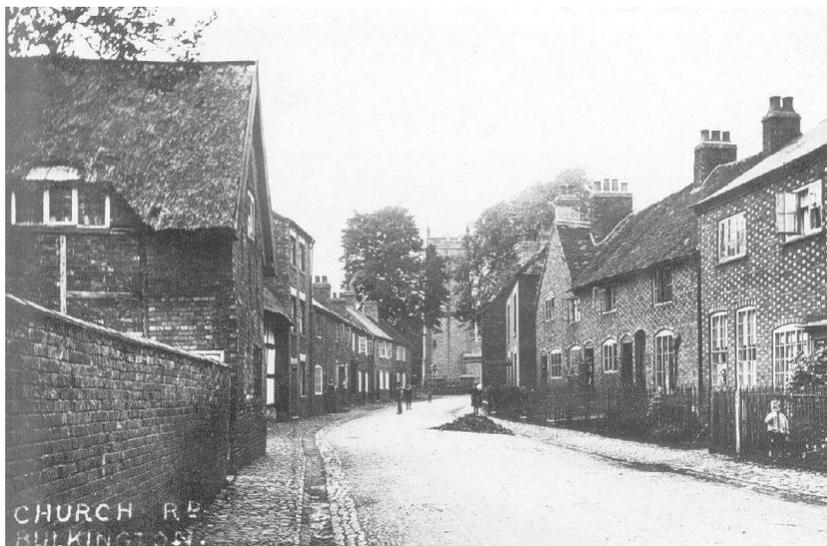
Figure 19: Houses in Church Street, Bulkington with church at the end of the road. 1930s¹⁸

4.10.4 Cutting across and separating the two is a third type of ill-defined space created by the construction of the recent east-west distributor-road that has no intrinsic interest, and which detracts from the integrity of the Conservation Area. It has severed the previously intimate historical and physical connection between the street and church precinct and removed houses that once provided greater enclosure and definition of the street edges. Before the 1960s the spatial enclosure of Church Street was much more strongly defined by almost continuous rows of houses to both sides and with

houses built either directly on, or very close, to the back edges of the footpaths.

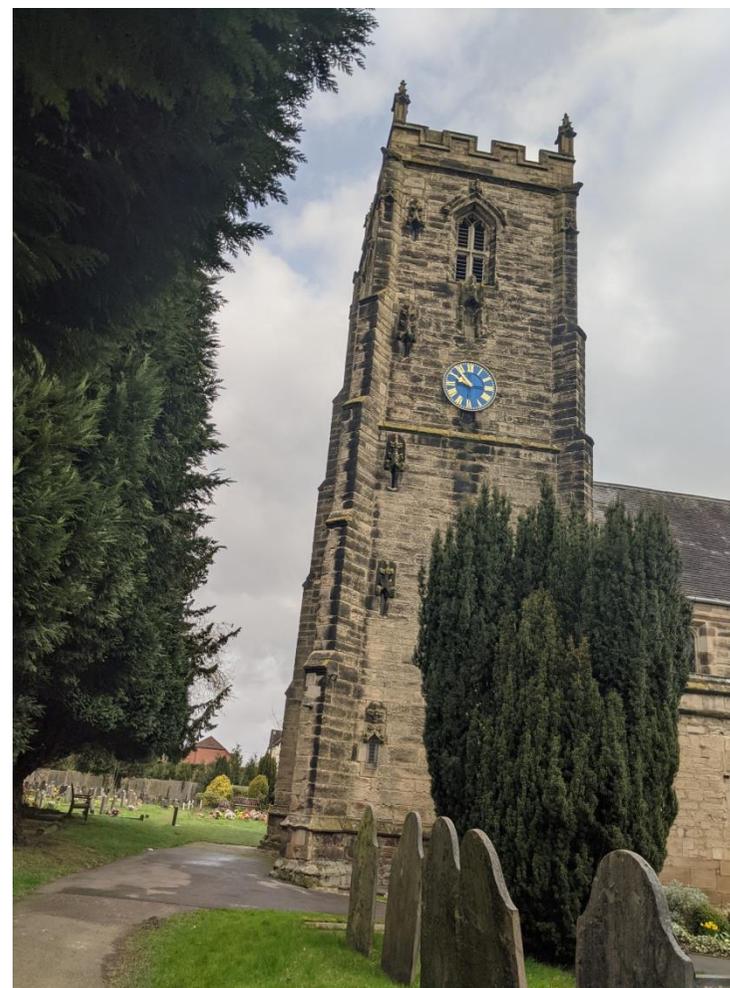
Figure 20: St. James Church from the east

5.2.5 The Church of St James, School Road is listed Grade II*. The high west stone tower dating from the mid to late 14th century forms the focal point and landmark feature of the Conservation Area on which Church Street is aligned. Its earliest surviving fabric comprises parts of the nave and aisles that date from the 13th century, while its chancel dates from the 14th century. The architect GT Robinson heavily restored these elements in the Victorian era, and the tower was restored in the early 20th century.

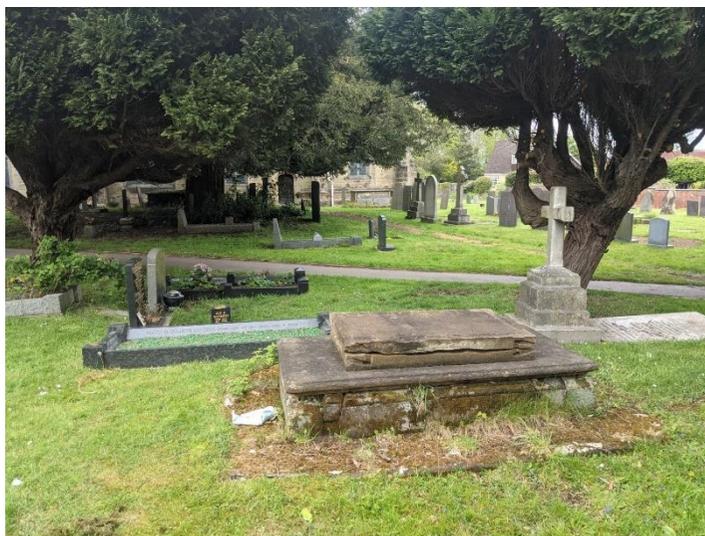
Figure 21: Chest Tomb

5.2.6 The chest tombs in the churchyard to St James's Church are listed Grade II. A pair of rare 17th century sandstone chest tombs which featured corner balusters standing in front of the church they are a very important part of the Conservation Area value. The tombs have been substantially altered since the last review of the Conservation Area in 2008.¹⁹

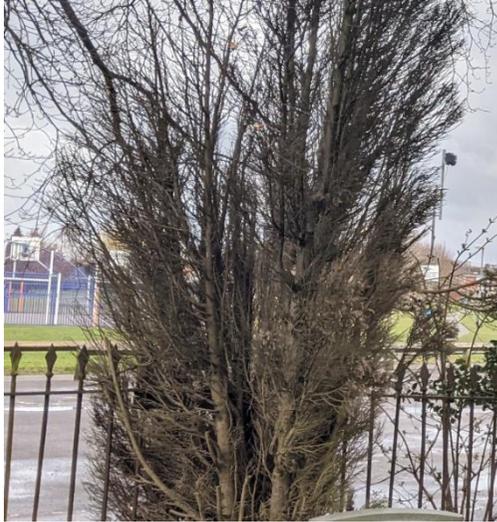
Figure 23: Church Railings

5.2.7 The wrought iron railings to the churchyard, are Grade II listed²⁰. In addition to their intrinsic architectural and historic interest, the railings define important historic boundaries to the church precinct. They are in poor condition and largely obscured from view by hedging.

6.1.5 The repair and maintenance of the listed railings around the churchyard should be a high priority.

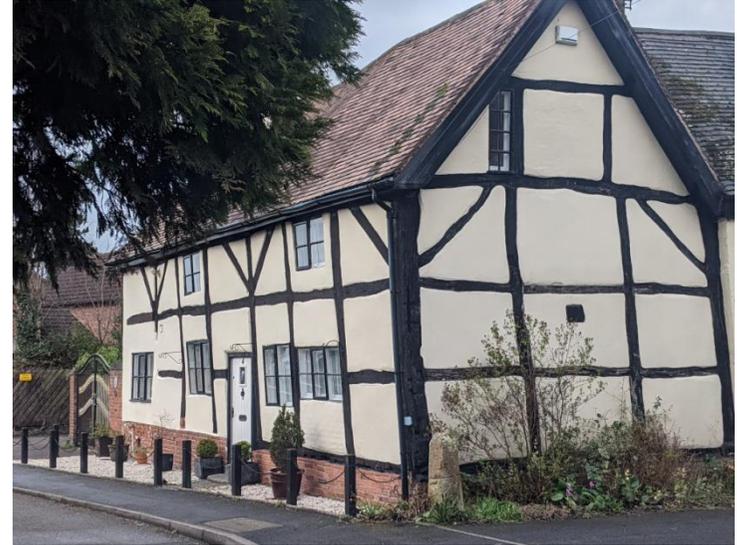
Figure 24: 3 and 4 Church Street

5.2.8 Number 3 and 4 Church Street is Grade II listed²¹. A late 16th or early 17th century timber-framed house built in the West Midlands vernacular tradition. Its exterior makes a very important historical and architectural contribution to the streetscape despite some adverse changes such as the painting of timbers in brown gloss paint and infill panels that project forward of the framing.

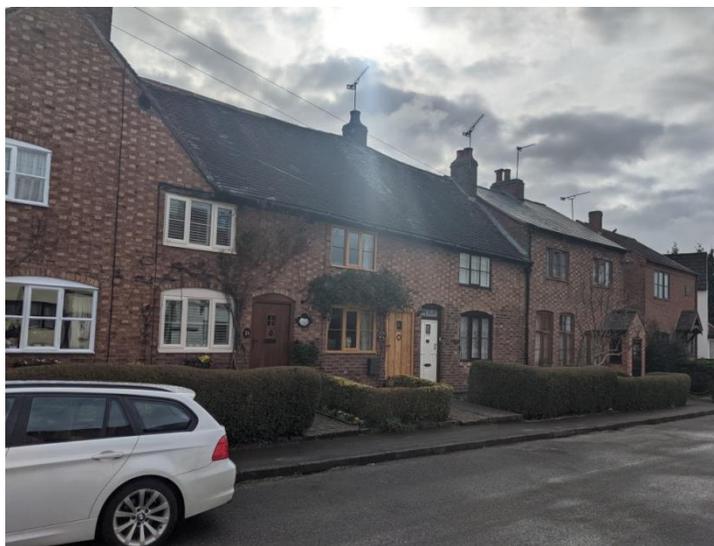
Figure 25: 25 to 28 Church Street

5.3.3 This substantial and quite imposing traditional 18th/19th century group with their prominent tall steeply pitched tiled roofs and mellow patterned brick elevations, make a very important contribution to the character of the Conservation Area and the threat of their demolition was the primary reason for its establishment in 1985. The chimneystacks also make an important skyline contribution, whilst the traditional hedge boundaries, though of recent date, provide attractive low-level enclosure to the back edge of the footpath.

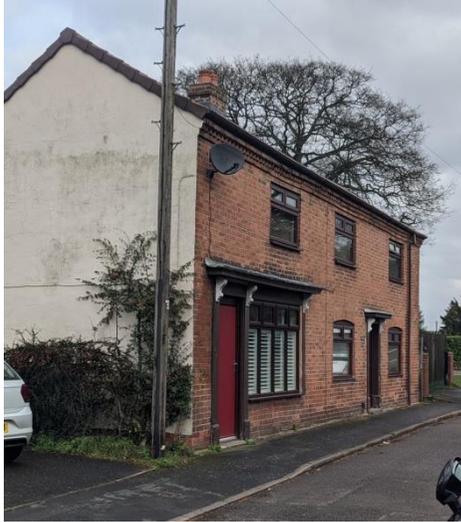
Figure 27: 10 and 10A Church Street

- 5.4.3 10 and 10a Church Street. Probably originally a pair of late 18th early 19th century cottages. The southerly unit was converted to a shop and retains a mid to late 19th century shop front and door case. It has unsympathetic modern stained windows and concrete roof tiles.

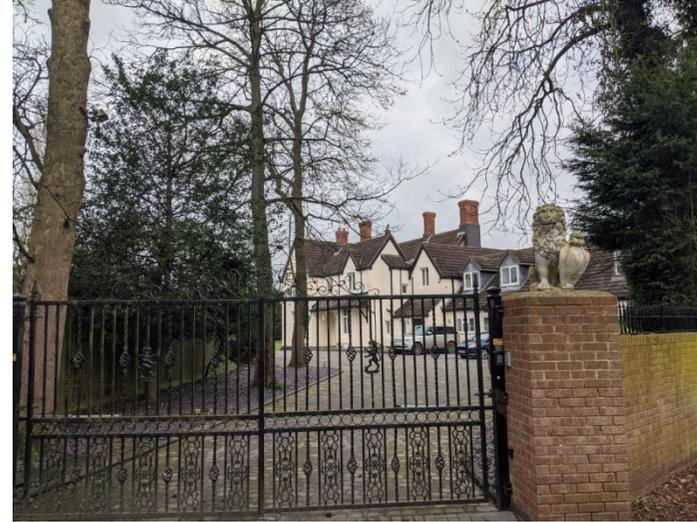
Figure 28: The Old Vicarage

5.4.4 The Old Vicarage. A heavily altered and extended Victorian Tudor-Gothic style former vicarage set in large mature gardens. The grounds make a significant contribution to the open green setting of the Church.

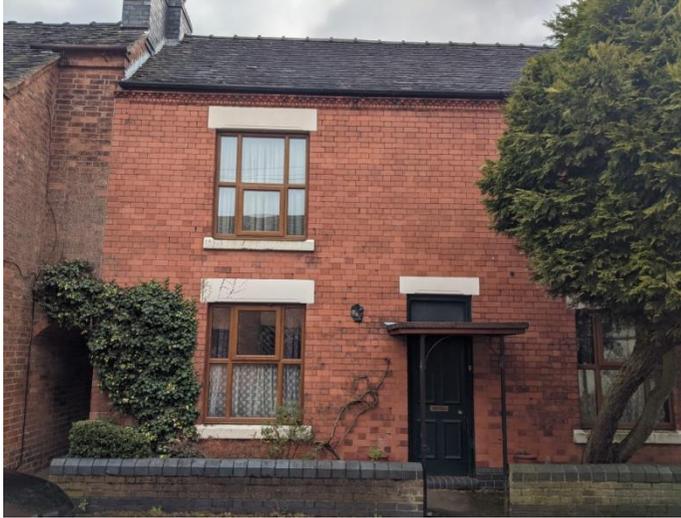
Figure 29: 24 Church Street

5.4.5 24 Church Street. Late 19th century house in red machine-made bricks with terracotta eaves detailing and stone lintels and sills to windows. Plain clay tile roof with end chimneystacks in blue-brick. Modern windows. Coniferous trees planted dangerously close to the front elevation and hiding some of it from view. Original dwarf brick walls to back of footpath. Group value with 25-29 Church Street.

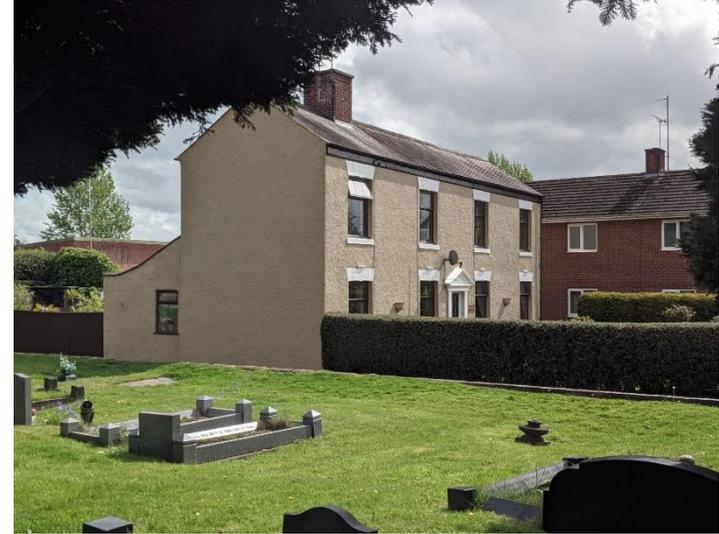
Figure 30: 1 School Road

5.4.6 1 School Road. Probably originally a pair of late 18th /early 19th century semi-detached houses now combined to form one. The front elevation has a later central pedimented door-case, and its windows have been replaced with stained timber mock-sashes. The brickwork has been rendered.

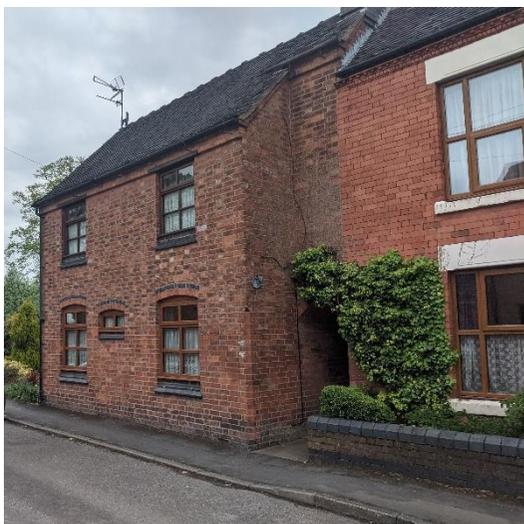
Figure 31: 23 Church Street

5.4.7 23 Church Street. Late 19th century house. Its original central front doorway has been bricked up to leave a small window opening. The other window openings have been partially bricked up to fit off-the-peg stained modern windows of unsympathetic design. Plain clay tile roof.

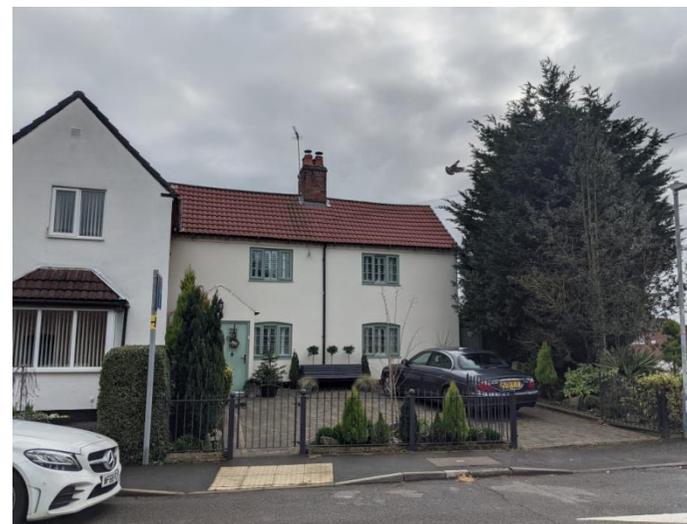
Figure 32: 30 and 31 Church Street

5.4.8 30 and 31 Church Street. Now two, originally three, very heavily altered houses. The white rendered house with roof parallel with the street again appears to be an amalgamation of two cottages that most likely date from the late 18th or early 19th century. The house with gable at right angles to the road appears once to have been part of the cottage range and may have started as such before being extended in front at right angles to the street. The major elevations of both have been rendered, and plastic windows have been inserted. The roof to the house with gable at right angles to

the street has been recovered in concrete tiles. The building is of marginal positive interest based on its still-recognisable historic form, traditional proportions and remaining traditional building materials. It also occupies a prominent corner location at the entrance to Church Street from Chequer Street.

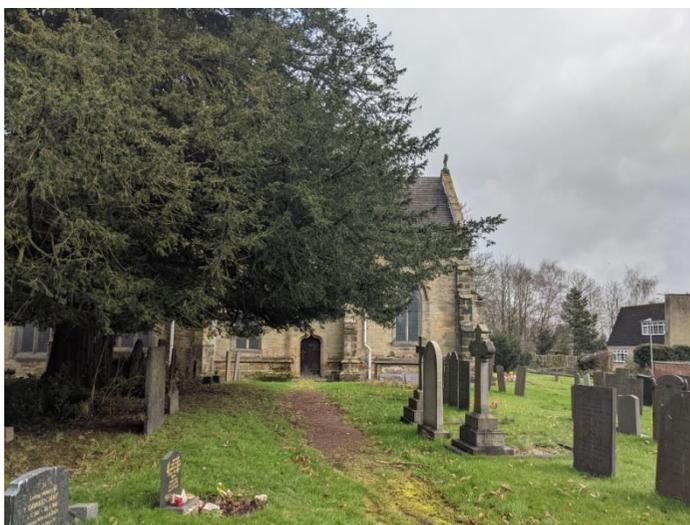
Figure 34: Trees within churchyard

5.5.4 They provide the necessary space for the establishment of large mature tree groups including yew, cedar, oak, ash, lime, chestnut, and sycamore that form a green backcloth to views northward along Church Street and along the footpath forming the eastern boundary of the Conservation Area.

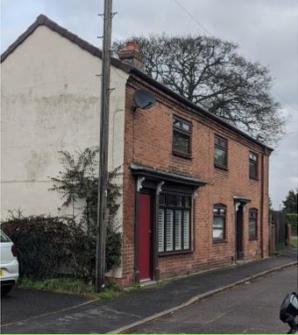
<p>10 and 10A Church Street 10 Positive contribution - Local List 10A Positive contribution despite adverse alterations</p>	<p>8 Church Street Does not contribute positively</p>	<p>3 and 4 Church Street Listed Building</p>	<p>4 The Cedars, Chequer Street Does not contribute positively</p>
