FIRE RISK ASSESSMENT – REFERENCE 41963

Fire Risk Assessment

Alderman Gee Hall
BEDWORTH
CV12 8EL.

Assessment Reference: 41963

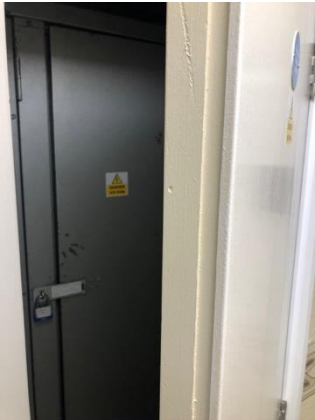
To prevent the unrestricted spread of fire and smoke, fire doors require smoke seals and / or intumescent strips fitted.	The following fire doors have missing smoke seals / intumescent strips that require replacing: Ground Floor: Electrics cupboard door adjacent to Flat 15.	3

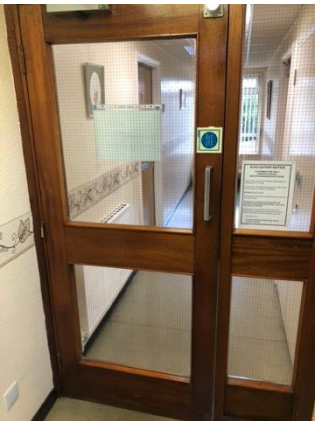
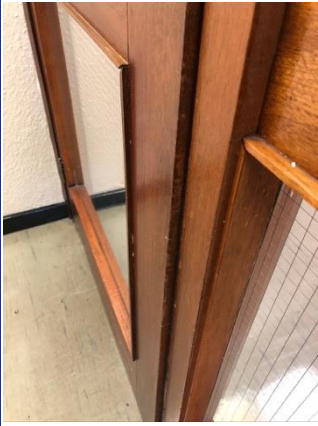
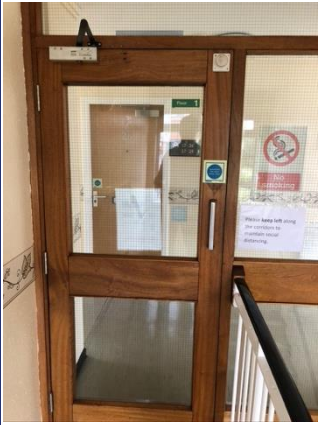
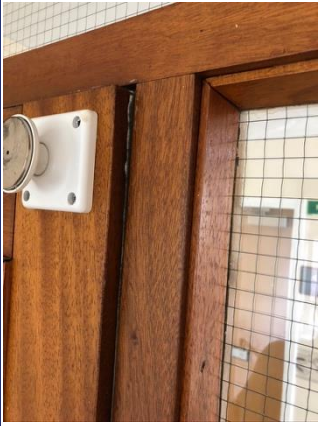
To prevent the unrestricted spread of fire and smoke, self-closing fire doors need to close fully into their frames and latch fully where appropriate. The door closer must be capable of closing the door fully onto the frame	The following fire doors do not close / latch fully, this was due to them being warped and require replacements: Ground Floor: Lobby fire door adjacent to Flats 10, 11. First Floor: Staircase fire door opposite Flat	3

<p>from all angles of swing including when released from 75mm and be of sufficient strength to overcome the resistance of any latch. (Rising butt self-closers are not acceptable).</p>	26	3

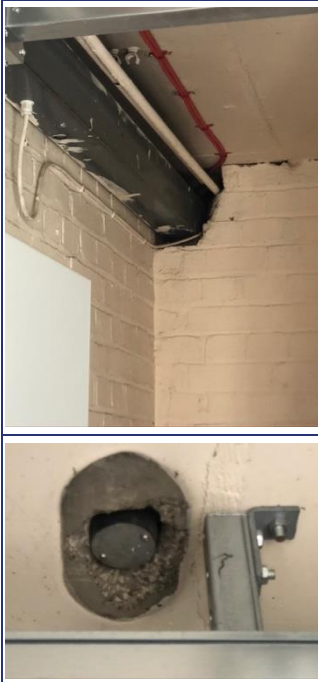
<p>There were gaps in the building structure caused by penetrating services (cables and pipes) through which smoke or fire could readily pass, namely:</p> <p>Boiler room</p>	<p>Arrange for the gaps to be fire stopped. Example remedies include:</p> <ul style="list-style-type: none"> - intumescent collars/wraps and intumescent pillows suitable (not appropriate for enclosing MOE unless smoke travel contained), fire resisting mortars, coated mineral fibre batts. - intumescent sealants (expanding foams) for narrow gaps only. 	2

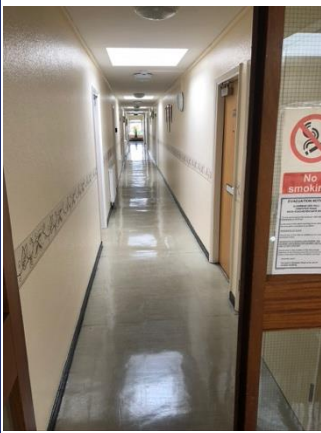
Due to excessive travel distances being identified (corridor of approximately 39 metres), additional cross corridor fire doors were identified as being necessary.	Install an additional cross-corridor fire door in the corridor containing Flat 32. The number and location of existing exits was inadequate.	2

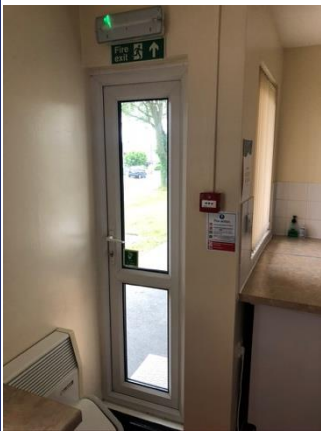
The fire exit door within the ground floor kitchen is too narrow to be utilised for escape purposes (450mm); the width should ideally be 1050mm.	Either install a 1050mm fire exit door within the room or remove all fire exit signs and utilise the alternative exits, of which there are sufficient numbers and within easy reach.	2
