Heritage Supplementary Planning Document (2026)

Heritage Supplementary Planning Document

2026

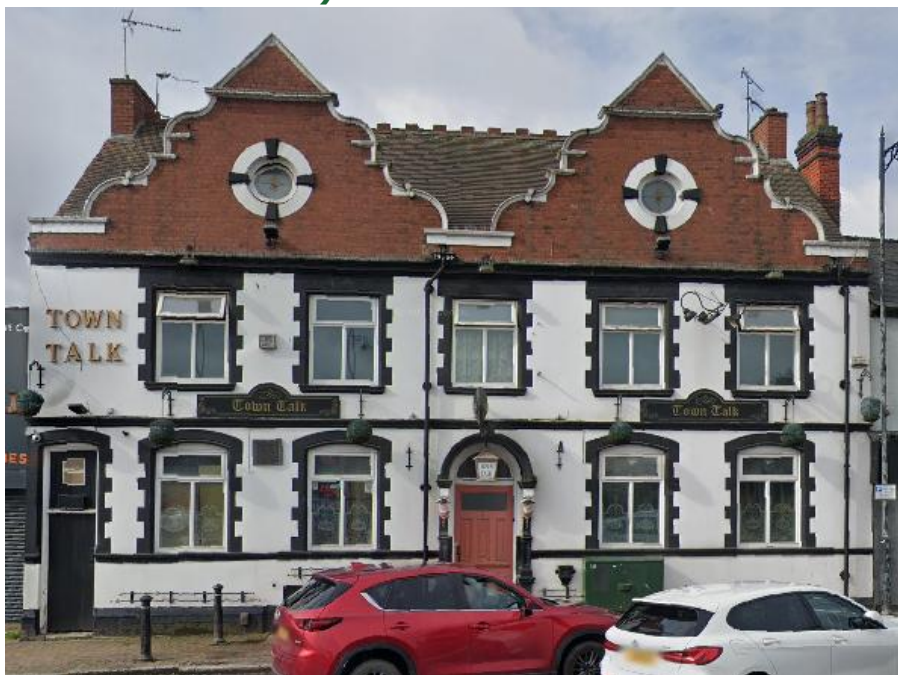
11 Abbey Green, Nuneaton (Former Plough and Ball Public House)

Criteria	Description
Asset type	Building (public house)
Age	Built between 1906 and 1913.
Rarity	Rare in comparison to local characteristics.
Architectural and artistic interest	<ul style="list-style-type: none"> • Decorative roof tiles on the ridges • Decorative shaped Dutch gables • String courses on multiple levels • Black painted quins and lintels around first and ground floor windows • Round arched windows on ground floor • Round arch porch in front of the main entrance • Pilasters either side of the main entrance, including column with wooden carved figures (Atlas), supporting the small porch • CAMRA description: "A typical old town pub, dating back to the Edwardian period, with an ornate Dutch gabled parapet front, comprising of a main bar and games room with terraced beer patio and car park to the rear. (CAMRA, n.d.)"

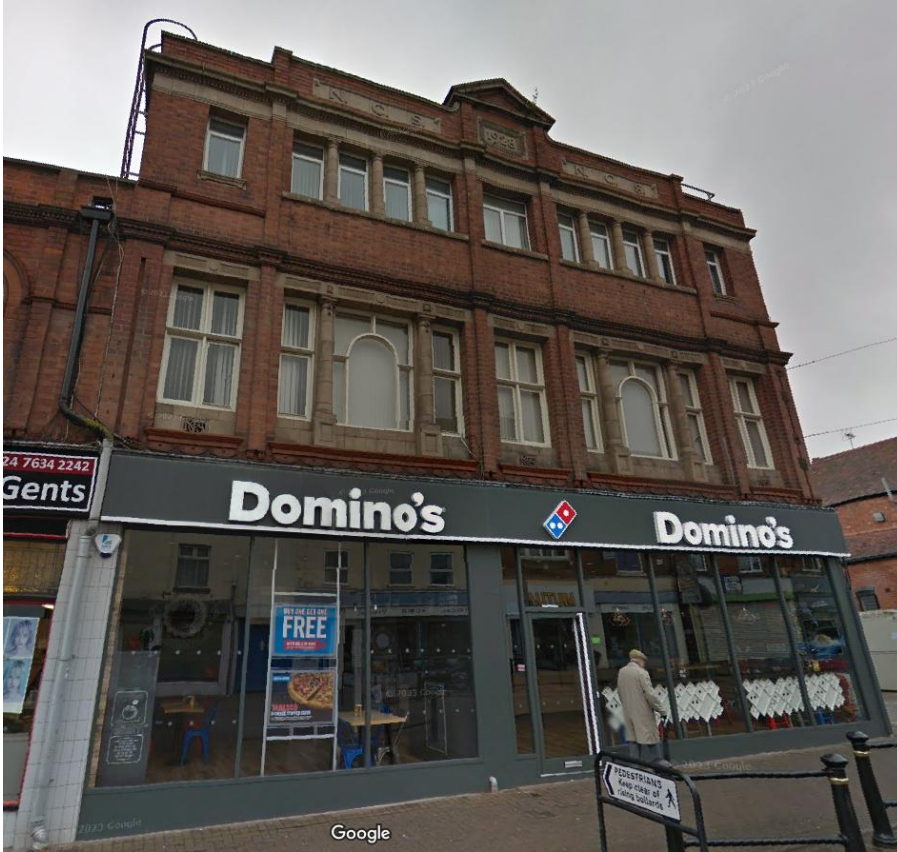
23a Abbey Street, Nuneaton

Criteria	Description
Asset type	Building
Age	1928
Rarity	Creates a group value and shares similar architectural characteristics (pilasters, window surrounds, dating plate, pediments) with other town centre buildings.
Architectural and artistic interest	<ul style="list-style-type: none"> • Brown brick in Flemish bond • Ashlar stone used for architectural details (pilasters, window surrounds, dating plate, pediment) • Pediment above second floor windows • Concealed roof • Pilasters on the second and first floors, supported by consoles

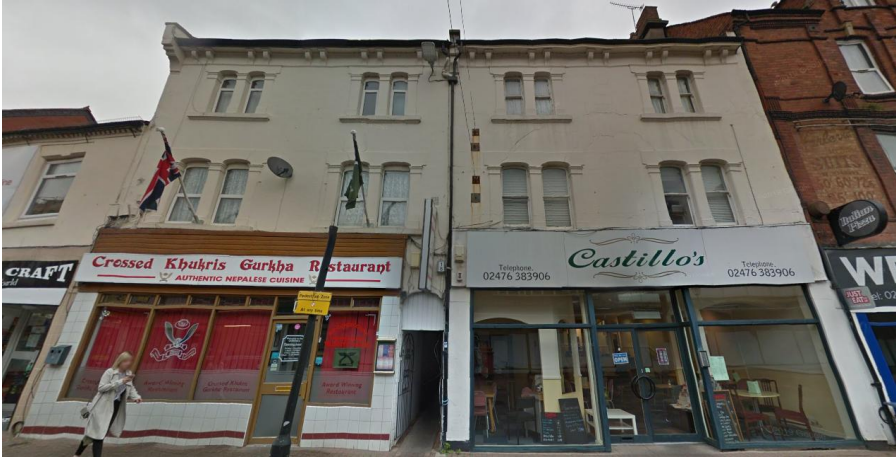
115-116 Abbey Street, Nuneaton

Criteria	Description
Asset type	Building
Age	Built before 1904
Rarity	Rare in comparison to local characteristics.
Architectural and artistic interest	<ul style="list-style-type: none"> • Corbel table (modillions) • Pilasters topped by capitals surrounding second and first floor round arched windows • Off-white render • Passageway to the courtyard in the middle
Group value	n/a
Archaeological interest	Subject to future assessment
Historic interest	In the early 20 th century, No. 116 was a dispensing chemist shop named "Slinn", which was replaced by "Lesters Chemist" by the 1920s.

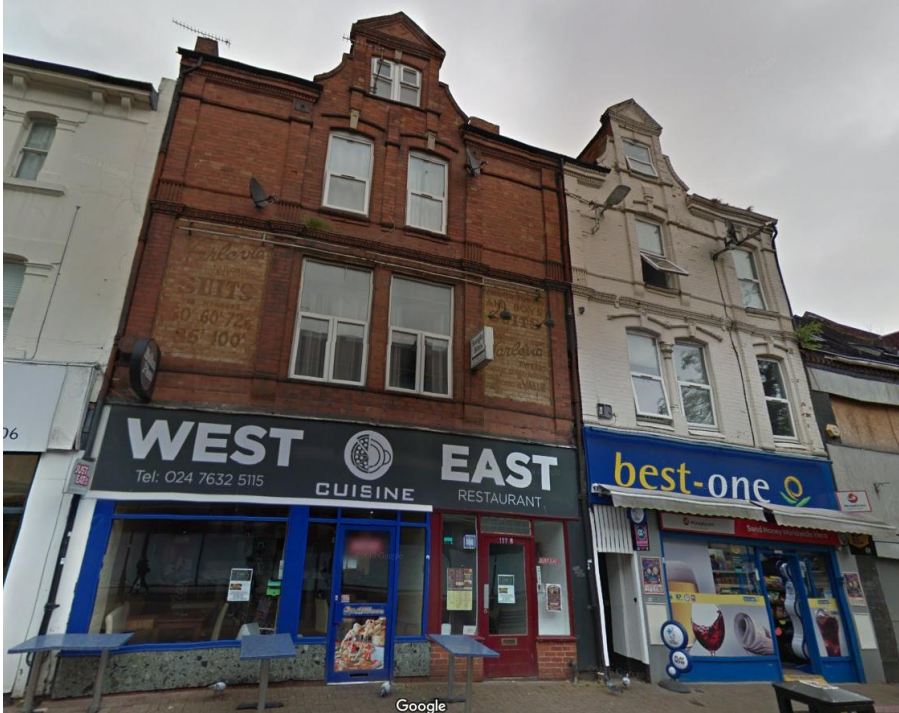
117 and 118 Abbey Street, Nuneaton

Criteria	Description
Asset type	Buildings
Age	Built before 1904
Rarity	Rare in comparison to local characteristics.
Architectural and artistic interest	<p>117</p> <ul style="list-style-type: none"> • Decorative red and yellow brick façade • Dutch gable with decorative pedimented dormer • Decorative dentilled cornices • Keystones above third and second floor round arched windows • Hood mouldings above second floor windows • Egg and dart string course above first floor window;

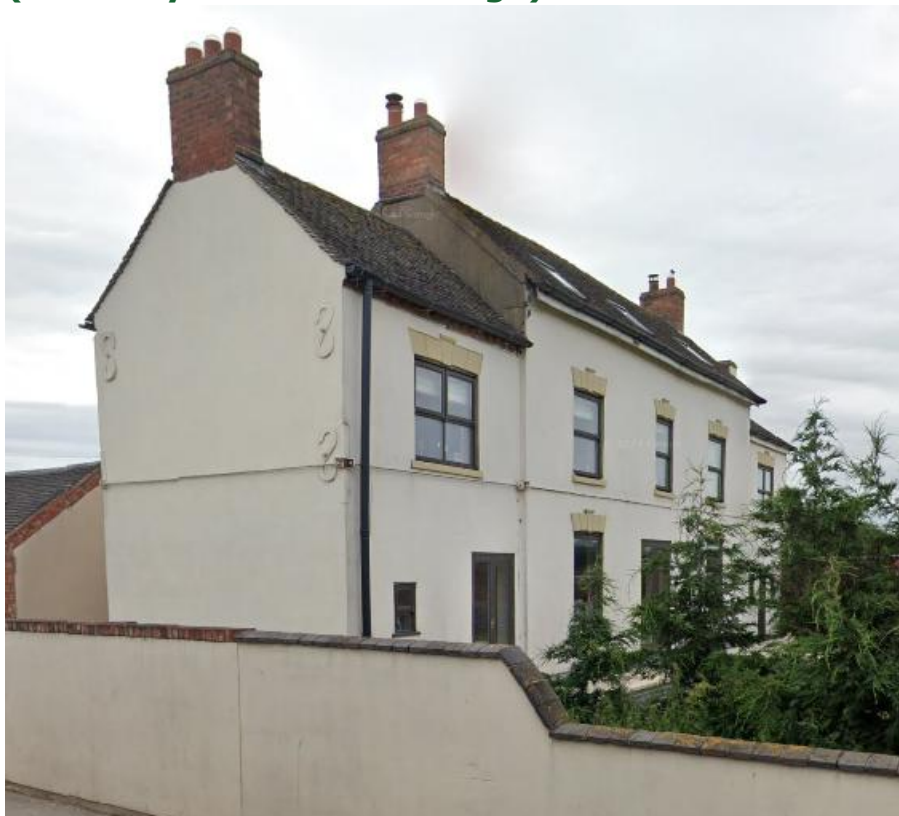
Woodlands Farm, Ansley Road, Nuneaton (Formerly Woodland Cottage)

Criteria	Description
Asset type	Buildings
Age	Built before 1842
Rarity	Rare in comparison to local characteristics. This is a regular U-shaped farmstead.
Architectural and artistic interest	<ul style="list-style-type: none"> • Historic maps show three sides since at least 1842 in U-shape. Southern side has been replaced with unsympathetic modern wing. Northern and western buildings have been rebuilt circa 2009-2012. Only the farmhouse is original. • The historic farmstead has interest as it evidences the local farming region, as well as advanced agricultural regimes. Additionally, the farmstead

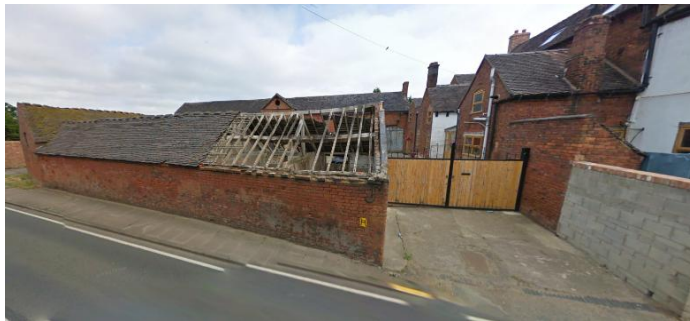
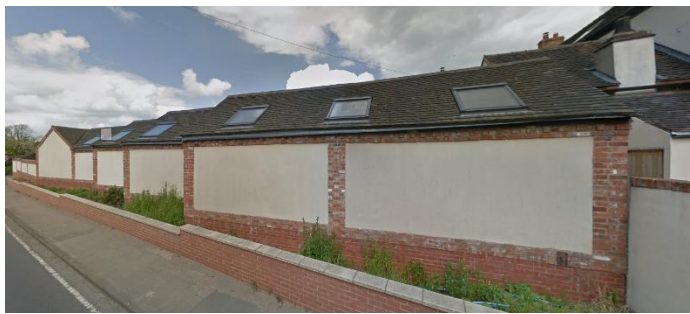
Images: Google (2009) and Google (2012)

- Keystones above ground and first floor windows of cottage; modern windows and doors; skylights inserted in the roof.
- The farmstead courtyard buildings completely rebuilt as per Google images below (2009 vs 2012)

Only the farmhouse is locally listed, however the U-shape courtyard layout is of significance.

Group value	Planned U-shape of farmstead of significance, although only the farmhouse is original.
Archaeological interest	Subject to future assessment
Historic interest	According to the Tithe Map 1842 and Nuneaton Millenium Project "The History of the Nuneaton area", the farmhouse and the surrounding land belonged to Thomas Hood, who owned 72 acres of land in 1873. Most likely, he built the farmhouse.

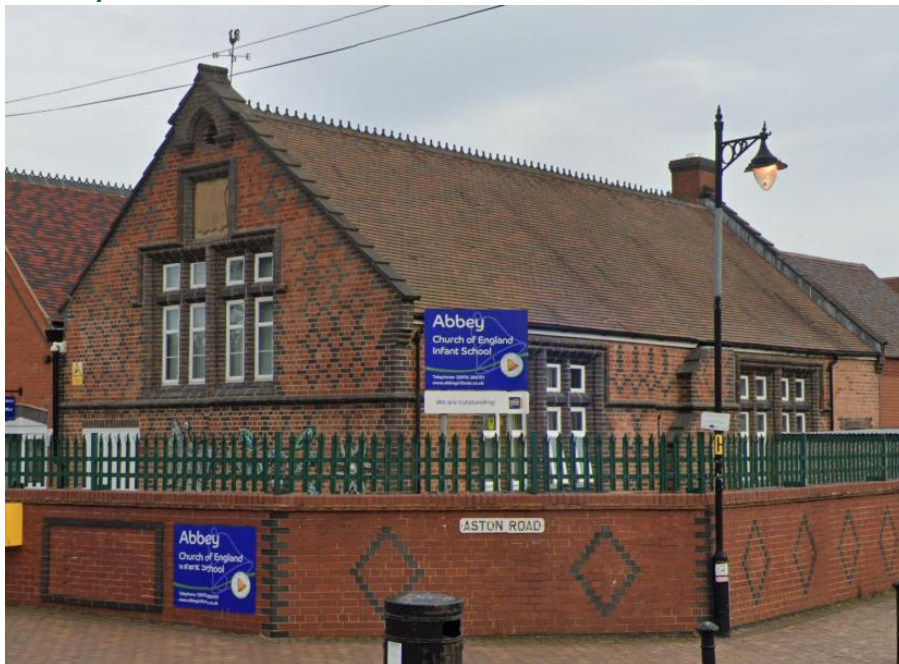
Abbey C of E Junior and Infant School, Aston Road, Nuneaton

Criteria	Description
Asset type	Building
Age	Main building built before 1886. Extended in 1896 to northwest. Further extended to north and west in 2009.
Rarity	Typical of late Victorian suburban schools, this building is rare in comparison to local characteristics, especially with many schools of this period demolished or heavily altered.
Architectural and artistic interest	<ul style="list-style-type: none"> Decorative roof tiles on the ridges Red brick with brown brick patterned brickwork in English bond Transom and mullion brown brick windows Brown brick string course Chimney trunk to the southeast side removed Extended to the rear Windows replaced with UPVC
Group value	n/a
Archaeological interest	Subject to future assessment

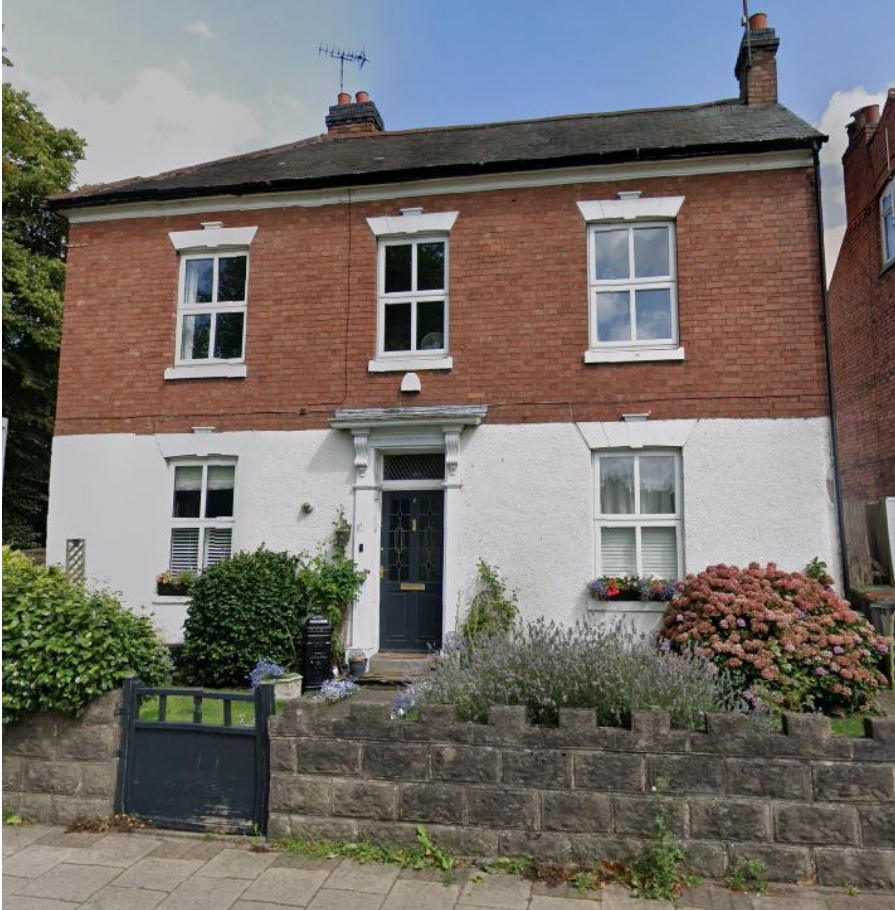
2 Attleborough Road, Nuneaton

Criteria	Description
Asset type	Building
Age	Built before 1887
Rarity	Rare in comparison to local characteristics.
Architectural and artistic interest	<ul style="list-style-type: none">• Flemish bond; brickwork to the south elevation looks older• Keystones above windows• Shallow porch above the main entrance, supported by consoles, on top of fluted pilasters• Rectangular fanlight above main entrance
Group value	n/a

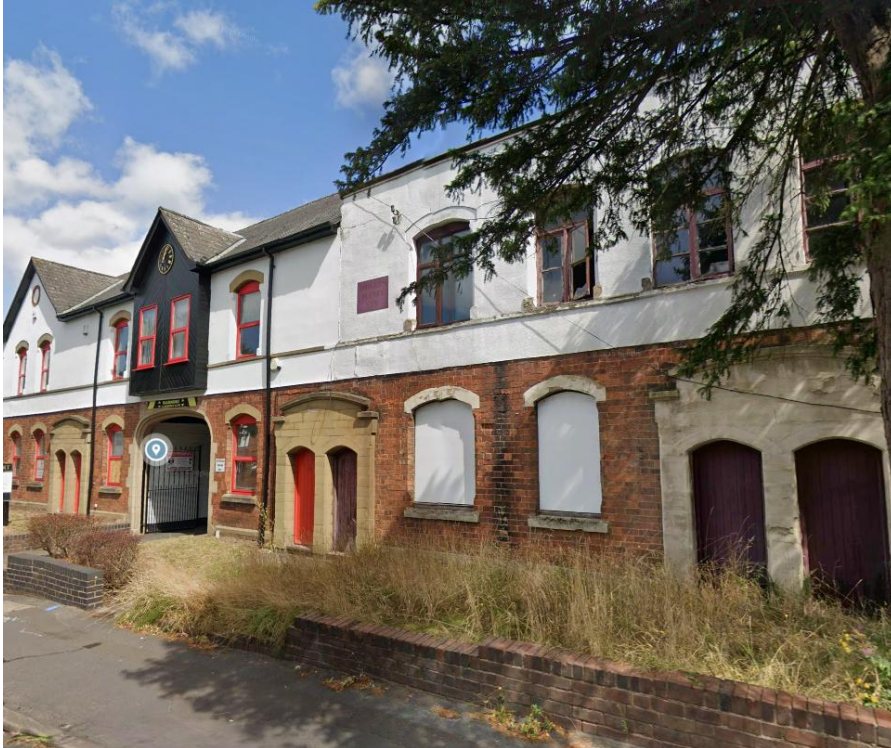
64-122 Attleborough Road, Nuneaton (Former Albion Works)

Criteria	Description
Asset type	Buildings
Age	Built before 1858 (Cook, A.F., 2021)
Rarity	Rare in comparison to local characteristics.
Architectural and artistic interest	<ul style="list-style-type: none"> • Round arched windows on ground and first floors • String course below first floor windows • Double round arched doorways surrounded by dressed stone surrounds • First floor rebuilt extensively; second floor demolished in the 1960s
Group value	These buildings have a clear visual design and historic relationship at ground floor.
Archaeological interest	Subject to future assessment

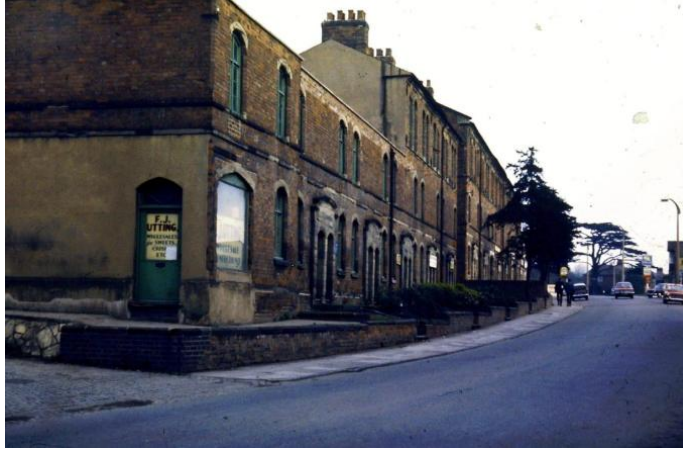
The rear of the Albion Buildings before demolition

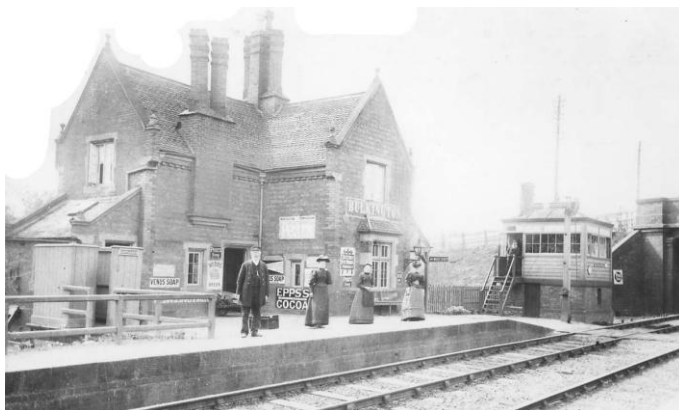
Image of the station from before 1909

Bulkington station's main building provided accommodation for the stationmaster as well as providing the passenger facilities. (Warwickshire Railways, n.d.)

The station's plan form and façade remain almost the same as they did originally; however, the station building now lacks chimney breasts, access from the tracks side, a bay window and roof finials. Additionally,

the roof with ornamental cornices and the extension to the south side have evidently been replaced.
Landmark status	None
References	<ul style="list-style-type: none"> • The Nuneaton and North Warwickshire Local and Family History Web Site (2021). <i>London & North Western Railway</i>. • Warwickshire Railways (n.d.). <i>Bulkington Station</i>. Available from https://www.warwickshirerailways.com/lms/bulkington.htm • Warwickshire County Record Office

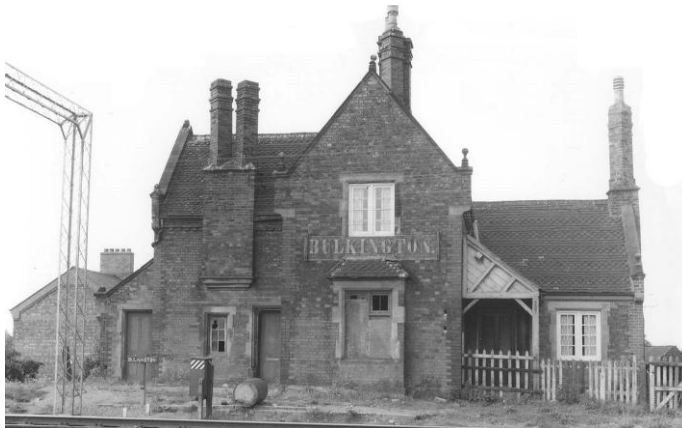
The remains of the station in 1961

Bulkington Station was closed in May 1931. After its closure, the station building was converted into a house and was still present in 1935, with the nameboard preserved. There are traces of the train station sign on the façade.

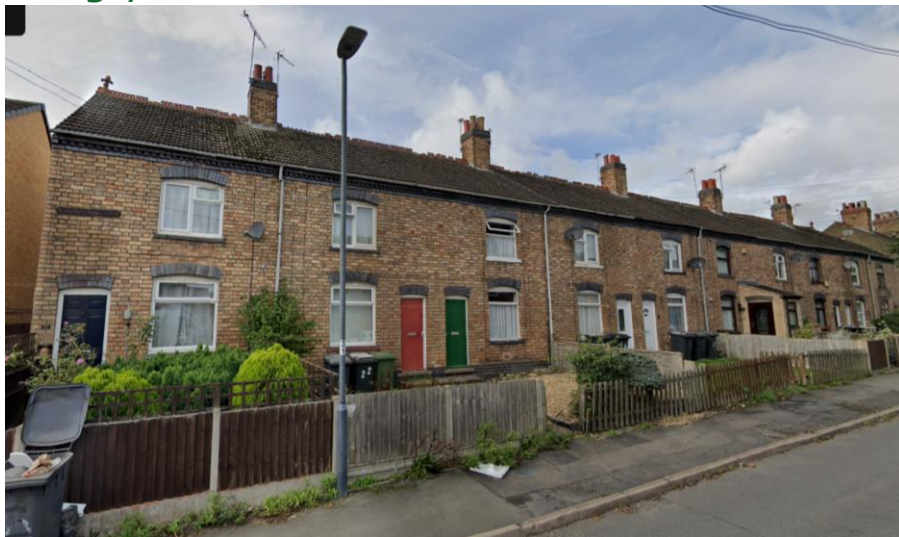
20-118 (evens) and 39-117 (odds) Bermuda Village, Nuneaton

Criteria	Description
Asset type	Buildings (row of terraced houses)
Age	1893 (The Nuneaton Society, 2007)
Rarity	Rare in comparison to local characteristics.
Architectural and artistic interest	<ul style="list-style-type: none"> • Flemish bond • Decorative roof tiles on the ridges • Decorative cornices • Round arched windows on the first and ground floors, topped with brick lintels • Round arched doors, topped with brick lintels. • Industrial Monuments Survey description: "Isolated and little altered late 19th century "model" colliery village of some 130 terraced brick built cottages." (Our Warwickshire, n.d.)
Group value	These buildings have a clear visual design and historic relationship.

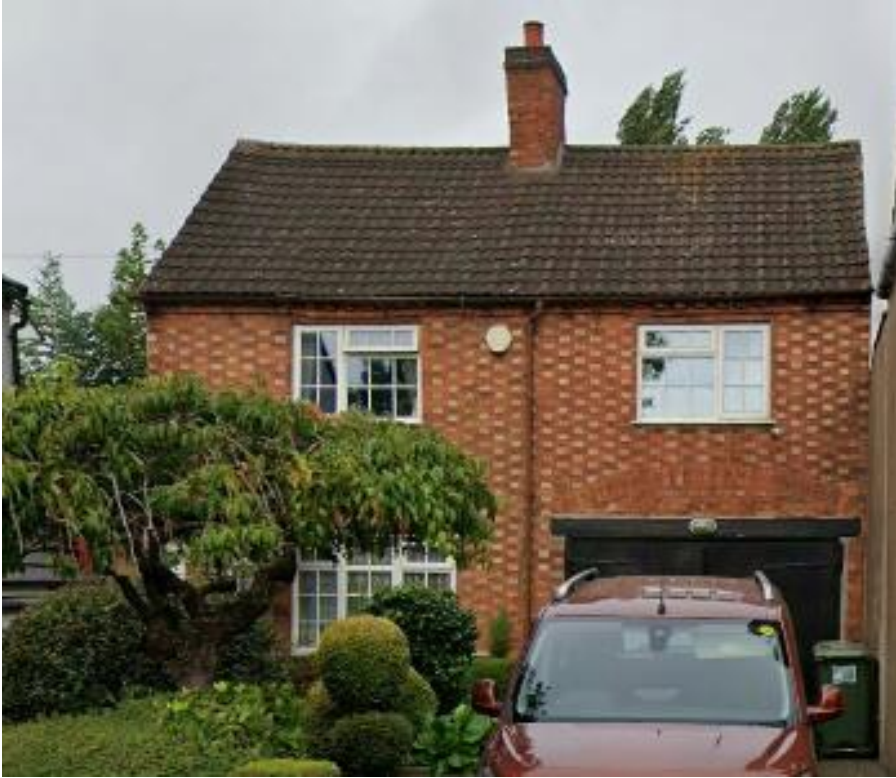
15 Black Bank, Bedworth

Criteria	Description
Asset type	Building
Age	Built before 1886
Rarity	Rare in comparison to local characteristics.
Architectural and artistic interest	<ul style="list-style-type: none">• Dentilled cornice• Chequer-board pattern brickwork• Round arched gateway
Group value	n/a
Archaeological interest	Subject to future assessment
Historic interest	Most likely associated with historical Exhall Colliery at Black Bank, Bedworth, which was a site of coal mining during the industrial revolution.

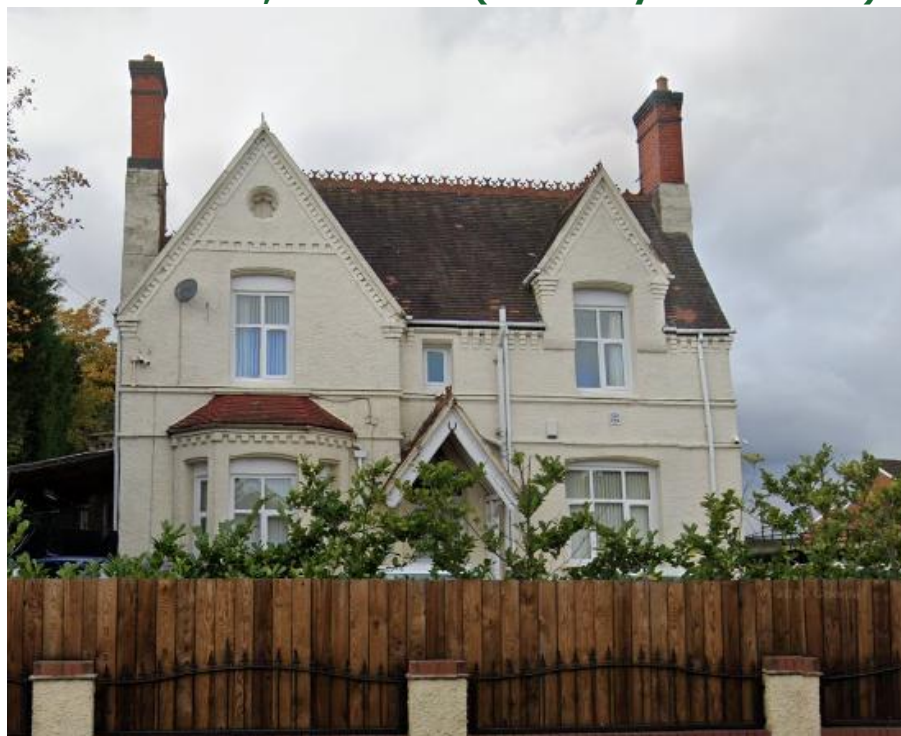
47 Black Bank, Bedworth (Formerly The Gables)

Criteria	Description
Asset type	Building
Age	Built before 1886
Rarity	Rare in comparison to local characteristics.
Architectural and artistic interest	<ul style="list-style-type: none"> • Off-white stucco • Decorative roof tiles on the ridges • Decorative gables • Dentilled cornice • String courses between first and ground floors • Dentilled cornice above ground floor bay window • Gable porch to entrance
Group value	n/a
Archaeological interest	Subject to future assessment

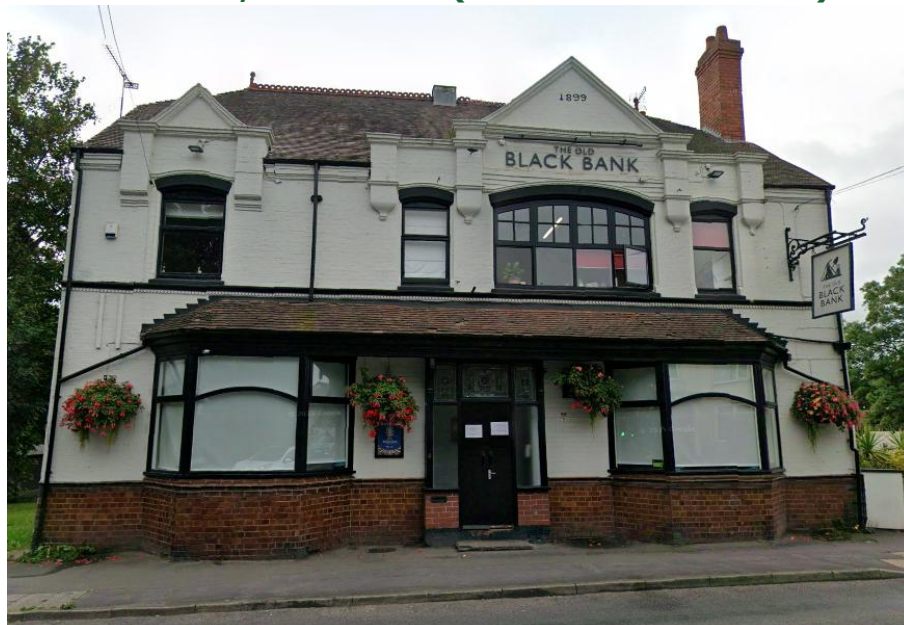
4 Black Bank, Bedworth (The Old Black Bank)

Criteria	Description
Asset type	Building (public house)
Age	1899
Rarity	Rare in comparison to local characteristics.
Architectural and artistic interest	<ul style="list-style-type: none"> Decorative roof tiles on the ridges Decorative gables Pilasters on the first floor, supported by consoles Round arched windows on the first floor Stained glass fanlight above main entrance
Group value	n/a
Archaeological interest	Subject to future assessment
Historic interest	Most likely associated with the historical Exhall Colliery at Black Bank, Bedworth, which was a site of coal mining during the industrial revolution.

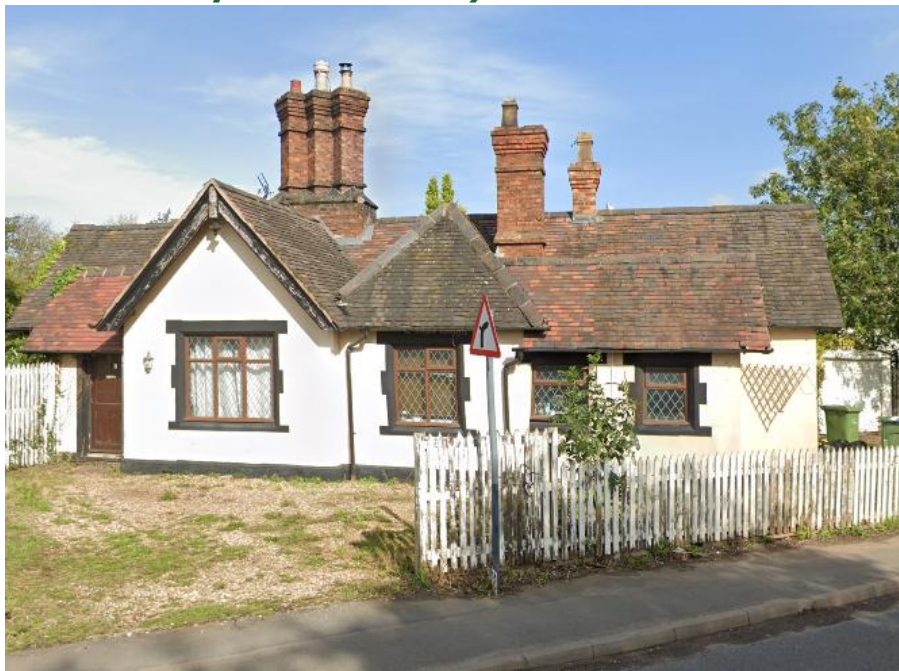
37 Blackhorse Road, Longford (Former Hawkesbury Lane Station)

Criteria	Description
Asset type	Building
Age	Opened along with the line on 2 September 1850 (Warwickshire Railways, 2021)
Rarity	Rare in comparison to local characteristics.
Architectural and artistic interest	<ul style="list-style-type: none"> • Decorative chimneys • Closers around windows • White stucco walls • Tiled roof
Group value	n/a
Archaeological interest	Subject to future assessment
Historic interest	The building has a significant historical association of local note, as it was constructed by London and North Western Railway (Warwickshire Railways, 2021), which until 1923 was the largest railway in Britain (London & North Western Railway Society, 2021). This association links the building to an important chapter in the nation's industrial and transport history.

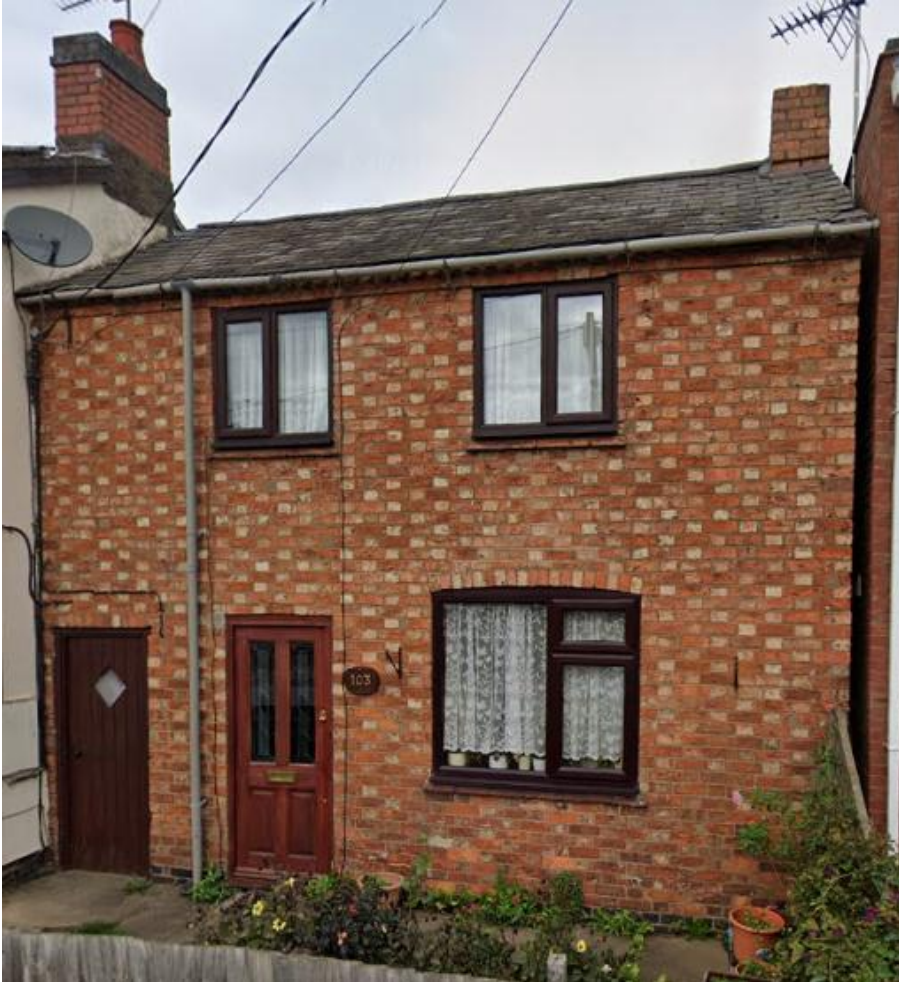
103 Blackhorse Road, Longford

Criteria	Description
Asset type	Building
Age	Built before 1890
Rarity	Rare in comparison to local characteristics.
Architectural and artistic interest	<ul style="list-style-type: none">• Chequer-board pattern brickwork• Round arched lintel to ground floor window
Group value	n/a
Archaeological interest	Subject to future assessment

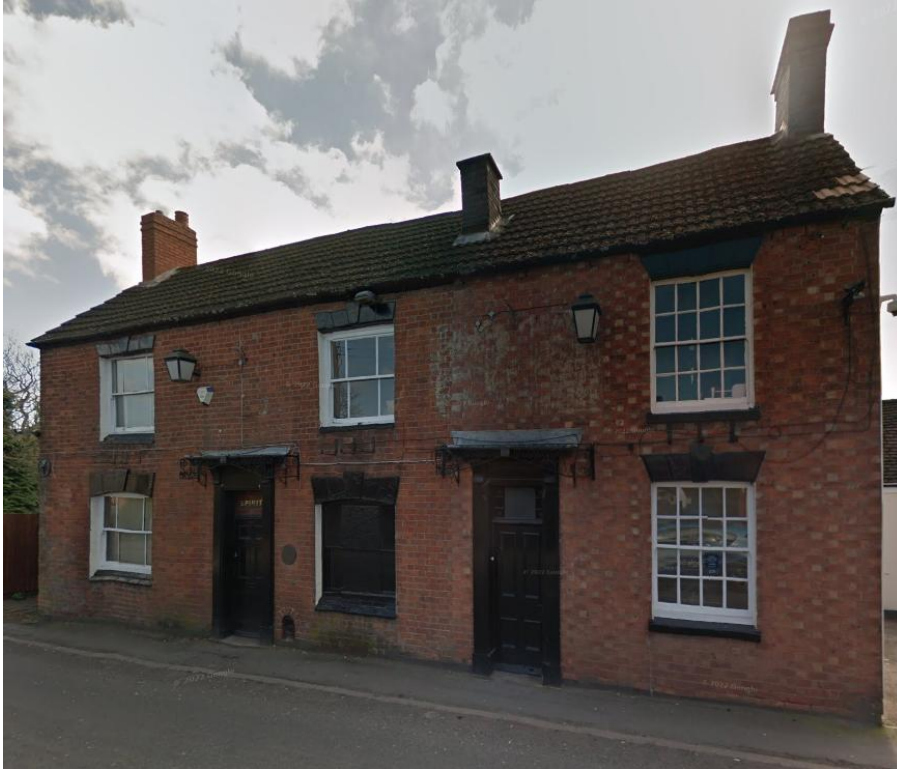
The Boat Inn, Blackhorse Road, Longford

Criteria	Description
Asset type	Building (public house)
Age	Built before 1886
Rarity	Rare in comparison to local characteristics.
Architectural and artistic interest	<ul style="list-style-type: none"> • Lintels with keystones above first and ground floor windows • Sash windows • Two entrances with wooden six-panelled doors topped by fanlights • Consoles supporting small porches with coving • Pilasters either side of front entrances • The façade has since been painted

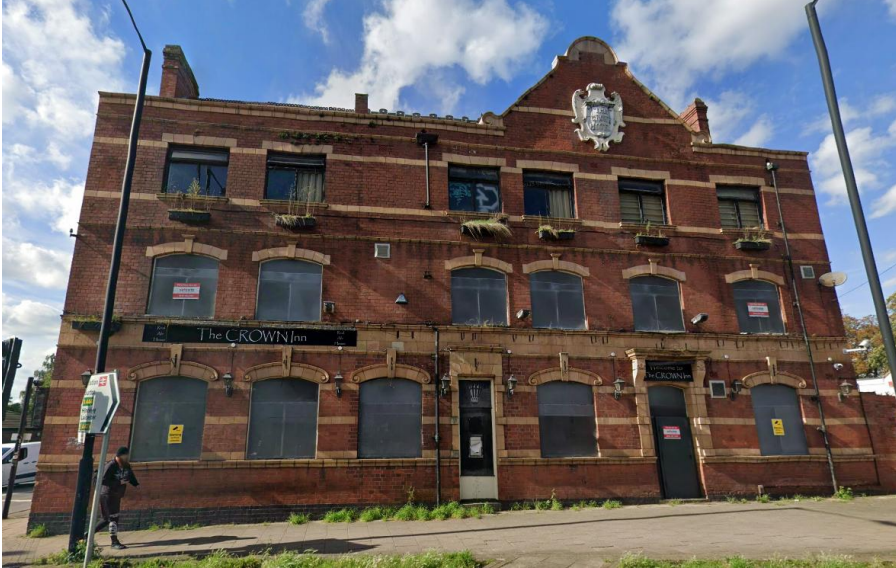
10 Bond Street, Nuneaton (Formerly The Crown Hotel)

Criteria	Description
Asset type	Building
Age	Rebuilt in 1905
Rarity	Rare in comparison to local characteristics.
Architectural and artistic interest	<ul style="list-style-type: none"> • Attractive red brick façade in English bond with decorative stonework • Decorative roof tiles on the ridges • Decorative gable • Stonework emblem displaying the name of the building "The Crown Hotel" • String courses on multiple levels • Stone lintels with keystones above first and ground floor windows; lintels adorned with volutes at the ground floor • Stone lintels above second floor windows

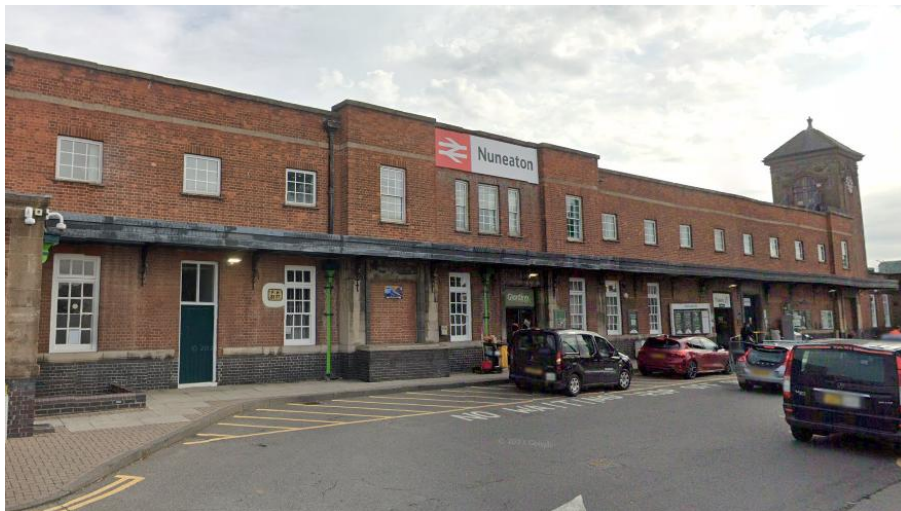
Nuneaton Trent Valley Station, Bond Street, Nuneaton

Criteria	Description
Asset type	Buildings (train station)
Age	1915 (Warwickshire Railways, 2025)
Rarity	Rare in comparison to local characteristics.
Architectural and artistic interest	<p>Station building frontage</p> <ul style="list-style-type: none"> • String courses above first floor windows and between first and ground floor • Fanlights above doorways • String course at ground floor level • Garland stonework around the top of the clock tower • Decorative clock face • Round arched doorway to enter clock mechanism • String course above ground floor level on southern building <p>Platforms 1 to 3</p> <ul style="list-style-type: none"> • Decorative chimneys

<p>WW1, the work was considerably slowed down, and new buildings were erected in the station concourse, whilst the old "Bay Lines", Platforms 1 & 2 and the north end bays, were cut through to form continuous through running. (The Nuneaton and North Warwickshire Local and Family History Web Site, n.d.)</p> <p>Network Rail constructed new platforms 6 & 7 on the far lines in the early 2000s.</p>
Landmark status	This large building has townscape value and therefore it serves as a landmark within the local scene.
References	<ul style="list-style-type: none"> • Warwickshire Railways (2025), <i>Nuneaton Trent Valley Station</i>. • The Nuneaton and North Warwickshire Local and Family History Web Site (n.d.). <i>On London North Western Railway Lines</i>. Available from http://www.nuneatonhistory.com/on-london--north-western-railway-lines.html

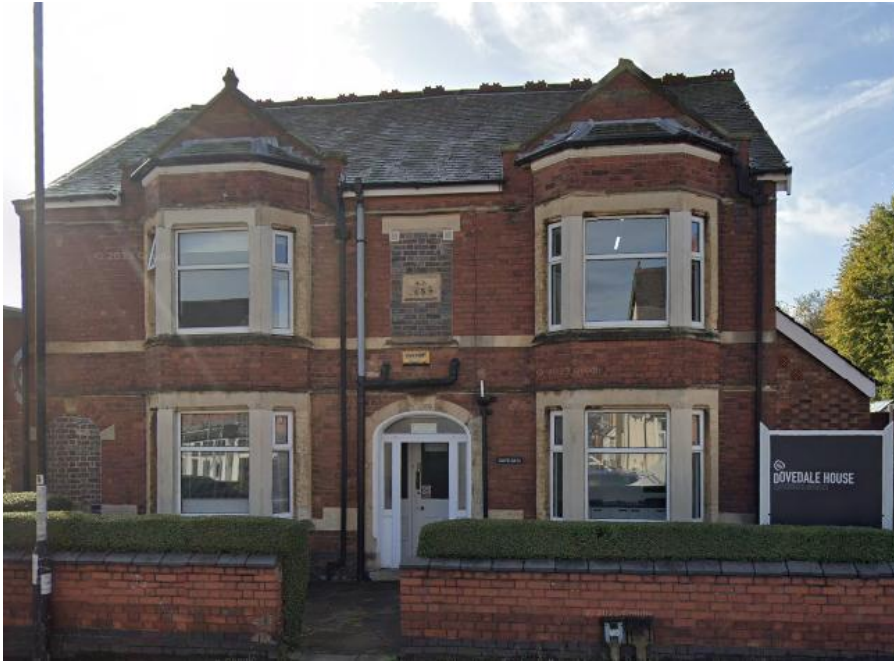
Dovedale House, 17 Bulkington Road, Bedworth

Criteria	Description
Asset type	Building
Age	Built between 1886 and 1902 (date stone suggests 1899)
Rarity	Rare in comparison to local characteristics.
Architectural and artistic interest	<ul style="list-style-type: none"> • Decorative roof tiles on the ridges • Decorative gables • String courses at multiple levels • Masonry surrounding first and ground floor bay windows • Keystones above both round arched doorways to the front of the building • Masonry surrounding main entrance • The central window on the first floor and the entrance to

the left have been bricked up.
Group value	n/a
Archaeological interest	Subject to future assessment
Historic interest	<p>The building has a significant historical association of local note, as it was the home and office of William Johnson MP (Lee, P., 2016), who was the General Secretary and Agent of the Warwickshire Miners' Association. He was also Treasurer of the Midland Miners Federation from 1886-1919, and became the Member of Parliament for Nuneaton in 1906.</p> <p>The Warwickshire Miners' Association was significant, as it was a founder constituent of the Miners' Federation of Great Britain, the predecessor of the National Union of Mineworkers (Our Warwickshire, 2021). William Johnson was known as the town's "miners' MP" for his work with Bedworth's poorly paid colliers at the turn of the last century (Coventry Telegraph, 2006)</p> <p>The second Warwickshire Miners' Association (WMA) was established on 26 September 1885, with offices in Church Street, Bedworth.</p> <p>In 1899 the union opened a purpose-built central office in Bulkington Lane, Bedworth. At a cost of £2,000, the building in an acre of land had an office for the General Secretary, a general office, a strong room and a thirty-five foot square assembly room. There was living accommodation for Johnson and out offices, toilets and a shed in the yard at the rear. The land at the rear was said to be</p>

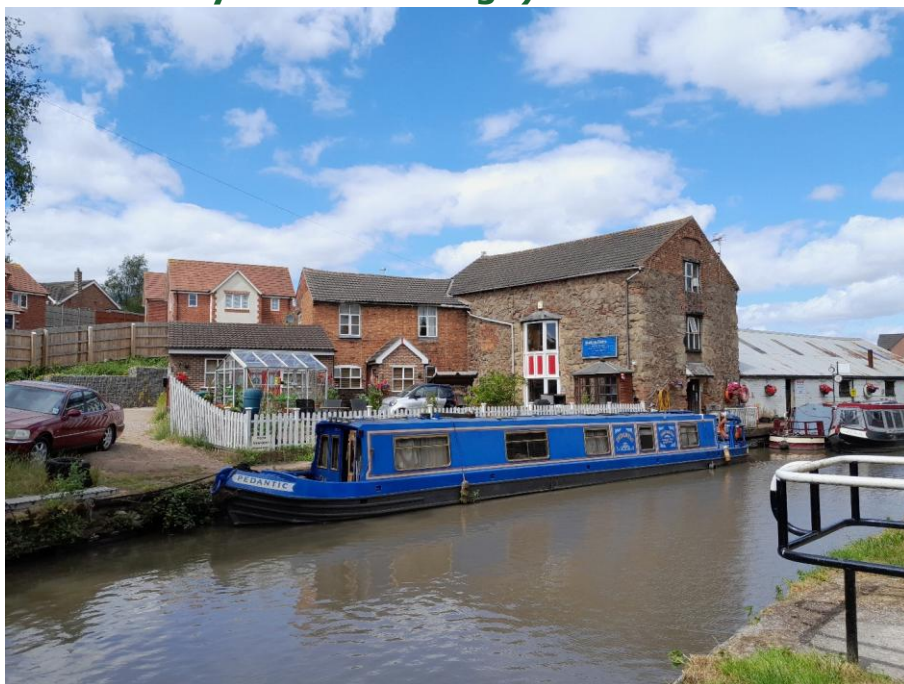
Star Line Boats and Boot Wharf Cottage, Bull Ring, Nuneaton (Former Chilvers Coton Canal Wharf Boatyard and Cottage)

Criteria	Description
Asset type	Buildings
Age	Built before 1886
Rarity	Rare in comparison to local characteristics.
Architectural and artistic interest	<ul style="list-style-type: none"> • Original stonework, topped a with brick gable. • Multiple changes to the façade over 100 years • Front façade second floor window partially bricked up. • Porches added to the side elevation and the extension • Bay window added • Chimneys removed

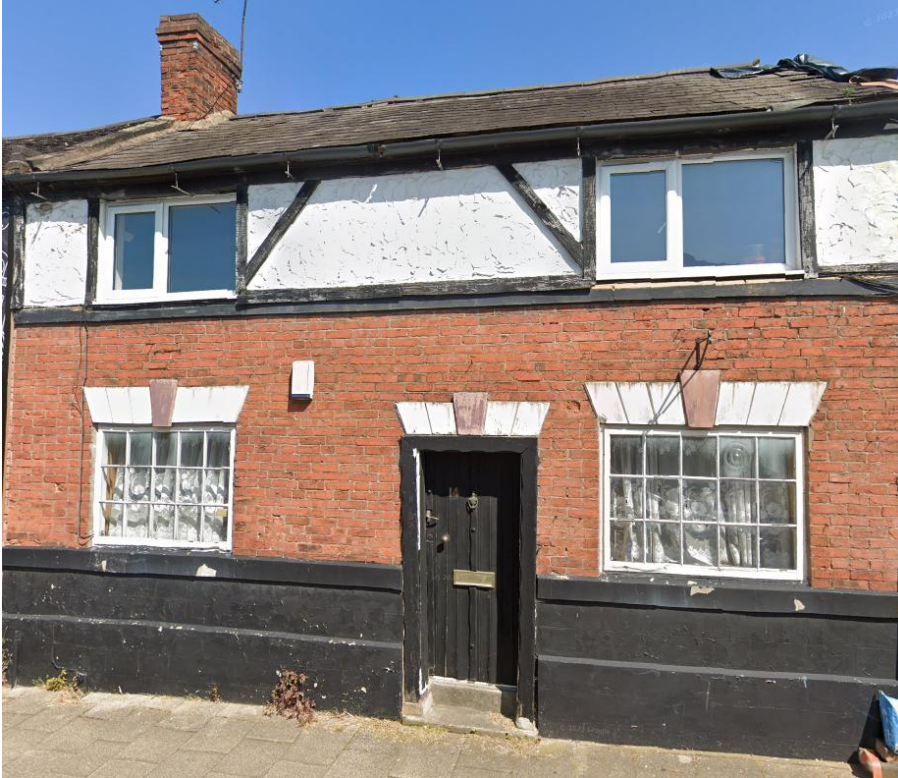
14 Bull Street, Nuneaton

Criteria	Description
Asset type	Building
Age	Built before 1886
Rarity	Rare in comparison to local characteristics.
Architectural and artistic interest	<ul style="list-style-type: none">• Decorative framing to first floor• Keystones above windows on ground floor• Sash windows on ground floor• Original door surround and front door• Best preserved example within the row
Group value	n/a
Archaeological interest	Subject to future assessment

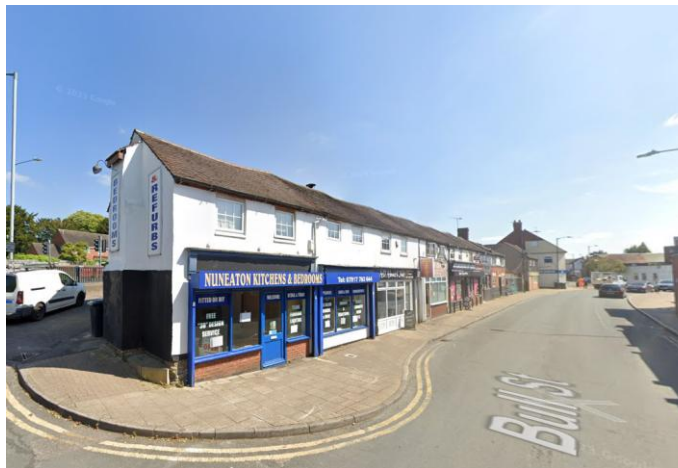
As of 2023, Google maps shows the row is still largely preserved, apart from No. 15 Bull Street which has been demolished.

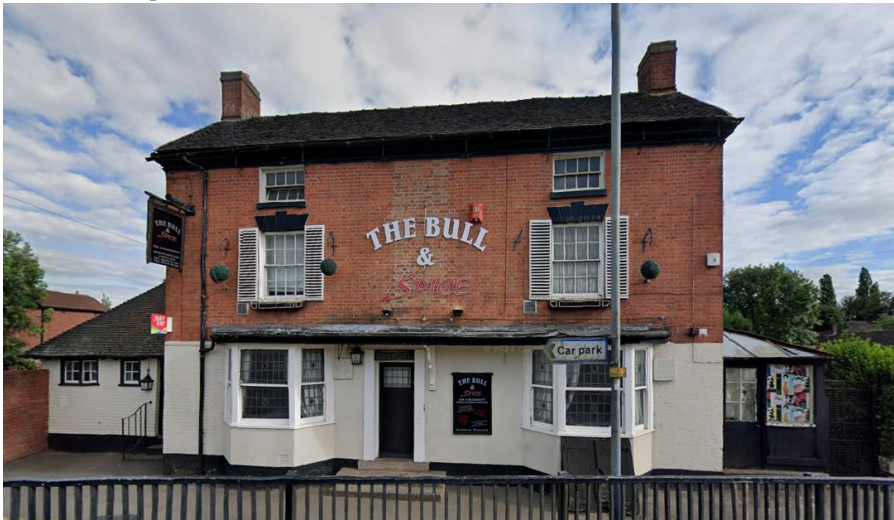
The Smoking Bull, Bull Street, Nuneaton (Former Bull Inn)

Criteria	Description
Asset type	Building (Public House)
Age	Built before 1886
Rarity	Rare in comparison to local characteristics.
Architectural and artistic interest	<ul style="list-style-type: none"> • Dentilled cornice • Original sash windows on first and second floors replaced with UPVC throughout • Lintels with keystones above first floor windows

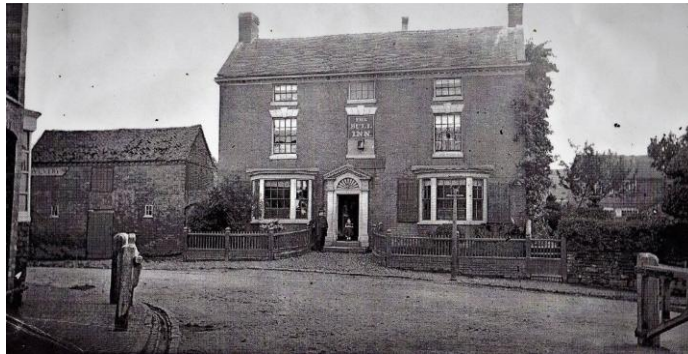
Historic interest **The Bull Inn at Attleborough, c. 1900**

This early 1900s photo depicts the Bull at Attleborough with the toll gates in front locked open after the old toll road system was abandoned in the 1870's (Nuneaton & Bedworth Local & Family History, n.d.).

<p>It is believed to date back to the 18th century and was mentioned in George Eliot's novel <i>Silas Marner</i> (Lee, P., n.d.).</p> <p>The front entrance featured an attractive ornate porch in a classical style. The first-floor middle window has already been blocked but not yet bricked up.</p>
Landmark status	<p>Attleborough's pub culture is deeply tied with its working-class quarrying history. The Smoking Bull serves as a physical and symbolic reminder of that heritage.</p>
References	<ul style="list-style-type: none"> • Warwickshire County Record Office • Nuneaton & Bedworth Local & Family History (n.d.) Available from https://www.facebook.com/groups/nuneatonhistory/posts/2122427031342466/ • Lee, P. (n.d.). <i>Attleborough Walking Tour: History & Landmarks</i>. <i>StudyLib</i>. Available from https://studylib.net/doc/7830269/attleborough-stone-quarries---nuneaton-and-bedworth-history

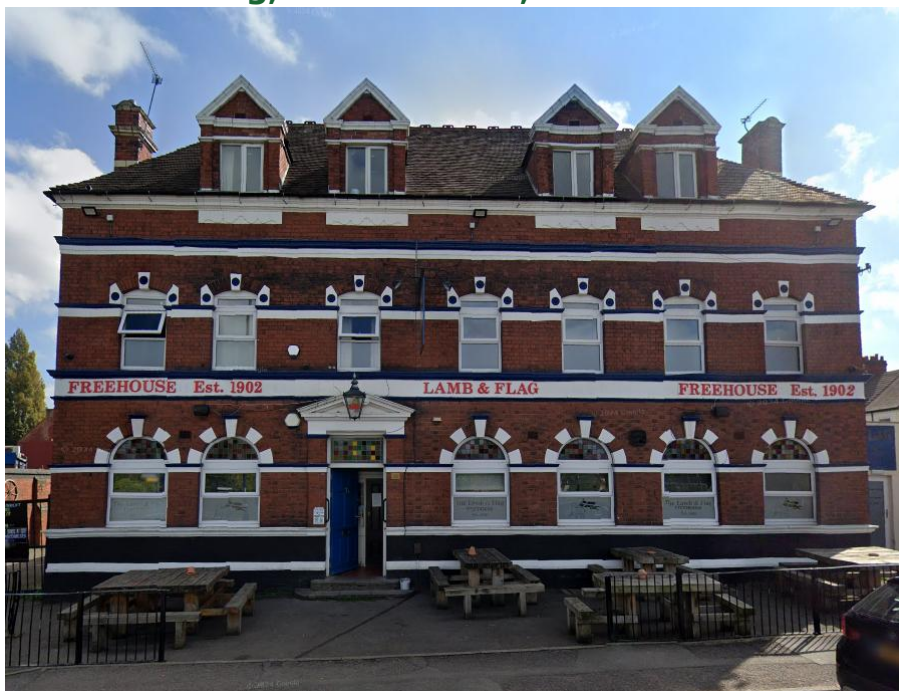
Lamb and Flag, Church Road, Nuneaton

Criteria	Description
Asset type	Building
Age	Built between 1886 and 1902
Rarity	Rare in comparison to local characteristics.
Architectural and artistic interest	<ul style="list-style-type: none"> • Decorative chimneys • Decorative roof tiles on the ridges • White and dark blue painted string courses at multiple levels • Pilasters either side of second floor dormer windows • Arched decorative lintels with keystones above first and ground floor windows • Round arched windows at first and ground floors • Pediment above main entrance • Stained glass fanlight above main entrance

<ul style="list-style-type: none"> • Stained glass windows on ground floor • White stucco fascia above the ground floor, framed with moulded strings painted dark blue
Group value	n/a
Archaeological interest	Subject to future assessment
Historic interest	CAMRA description: Former M&B pub which has been run under community ownership recently. Beautifully restored and imposing 3-storey building, which comprises of a main bar area, pool room (2 tables), function room and lounge/bar. The pub has a large garden area to the side of the pub with tables also at the front. (CAMRA, n.d.)
Landmark status	The building possesses aesthetic value and is taller than the surrounding buildings. It acts somewhat as a landmark of the Church Road.
References	CAMRA (n.d.). <i>Lamb and Flag, Nuneaton</i> . Available from https://camra.org.uk/pubs/lamb-flag-nuneaton-158286

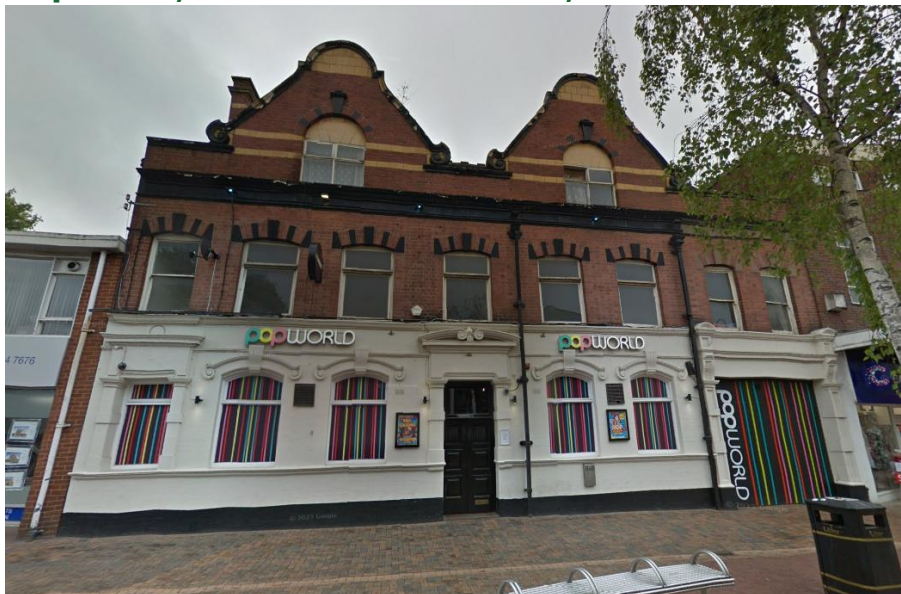
Popworld, 40-41 Church Street, Nuneaton

Criteria	Description
Asset type	Building
Age	Built between 1886 and 1913.
Rarity	Rare in comparison to local characteristics.
Architectural and artistic interest	<ul style="list-style-type: none"> • Decorative chimney • Shaped gables • Keystones above round arched windows on all floors • String courses at multiple levels • Pilasters topped by decorative capitals either side of former doorway • Hood mouldings above ground floor windows • Broken pediment above main entrance • Pilasters either side of main entrance, topped by decorative capitals • Fanlight above main entrance • Consoles above pilasters topped with decorative capitals at the former shopfront section
Group value	n/a
Archaeological interest	Subject to future assessment
Historic interest	According to the OS Maps, there has been a pub on the site since the 18th century. The current building is from

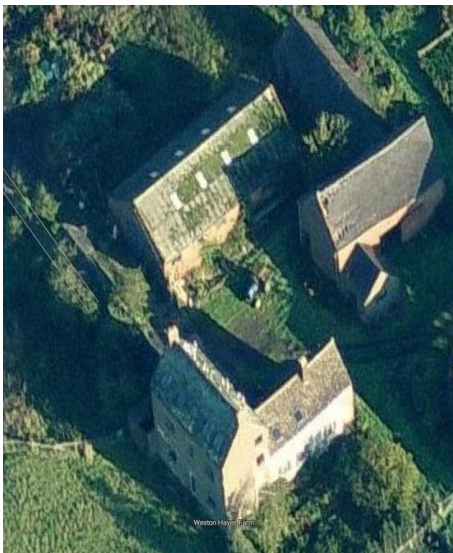
Weston Hayes Farm, Coalpit Fields Road, Bedworth

Criteria	Description
Asset type	Buildings
Age	Built before 1890
Rarity	Rare in comparison to local characteristics. This is the only farmstead located within a park in the borough.
Architectural and artistic interest	<ul style="list-style-type: none"> Historic farmstead arranged in a loose courtyard plan, with four sides. The historic farmstead has interest as it evidences the local farming region, as well as advanced agricultural regimes. Additionally, the farmstead was an essential component of the former more rural landscape (Historic England, 2017). Although the farmstead's limited architecture and condition reduces its value, its setting provides some historic interest as the house is in association with the farmland.

<ul style="list-style-type: none"> • The main farmhouse is in red brick, including its carved brick arched window headers, and has a corrugated iron roof. • The rear building is likely of less historic value, with what appear to be modern roof windows
Group value	These buildings have a clear visual design and historic relationship.
Archaeological interest	Subject to future assessment
Historic interest	Unknown
Landmark status	None
References	Historic England (2017). <i>Agricultural Buildings: Listing Selection Guide</i> .
