Heritage Supplementary Planning Document (2026)

Heritage Supplementary Planning Document

2026

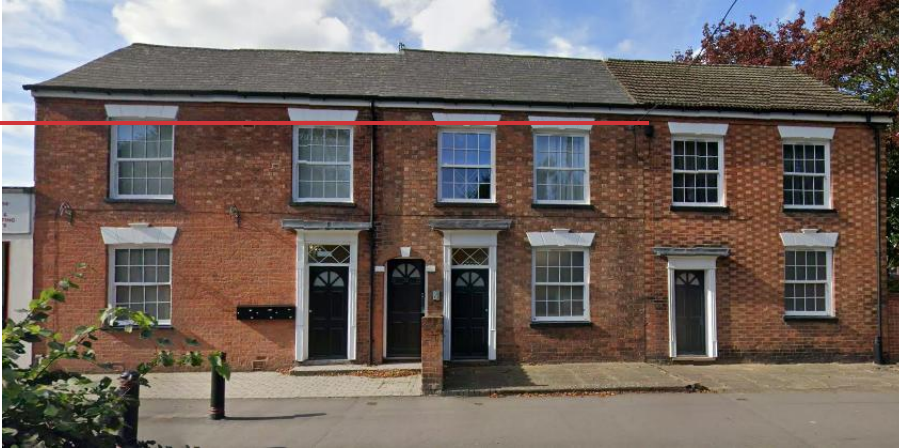
37-39 Coton Road, Nuneaton

Criteria	Description
Asset type	Buildings
Age	Built before 1886
Rarity	Somewhat rare in comparison to local characteristics.
Architectural and artistic interest	<ul style="list-style-type: none"> • Chequer board pattern brickwork • Dropped keystones over windows on ground and first floors • Sash windows • Pilasters to the sides of the front doors • Fanlights above the front doors to 38 and 39 Coton Road • Arched alleyway with dropped keystone between 38 and 39 Coton Road
Group value	These buildings have a clear visual design and historic relationship.
Archaeological interest	Subject to future assessment
Historic interest	These buildings have a historical association with local mines, as they were most likely purpose-built as accommodation for the miners.
Landmark status	None
References	None

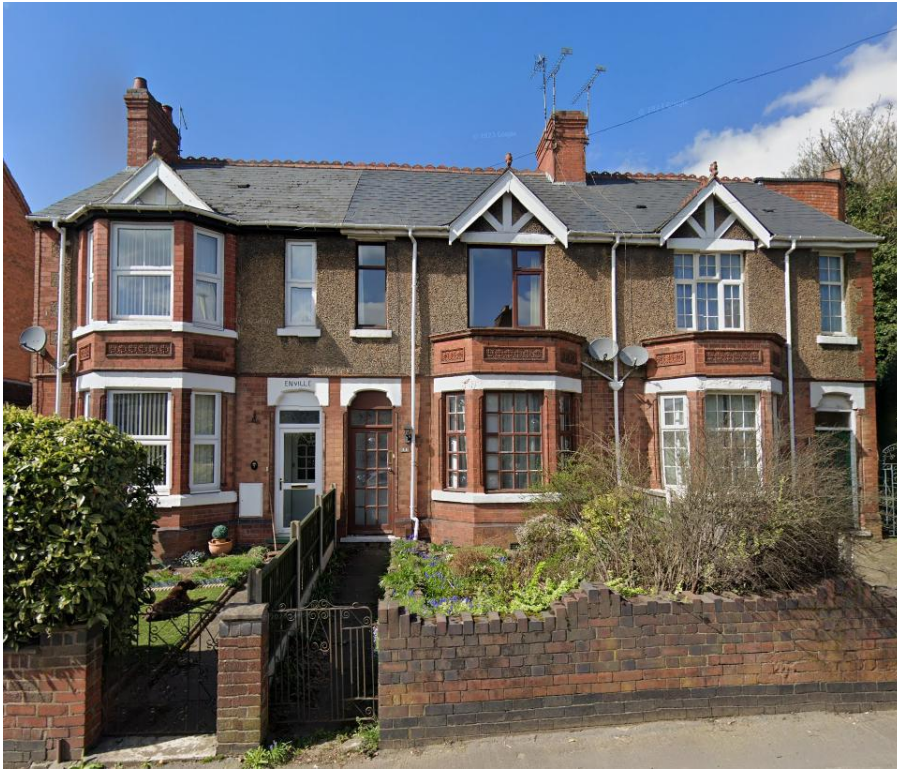
3-7 (odds) Coventry Road, Bedworth

Criteria	Description
Asset type	Buildings
Age	Built between 1886 and 1902
Rarity	Somewhat rare in comparison to local characteristics.
Architectural and artistic interest	<ul style="list-style-type: none"> • Arts and Crafts style • Decorative roof tiles on ridges • Patterned terracotta tiles between ground and first floor bay windows with a cornice above • String course between ground and first floor • Pitched gables with timber bargeboards, roof tiles including a finial detailing and mock timber framing • Painted arched doorways and white painted detailing to lintels, cills and bargeboarding to the pitched gables • Fanlights above front doors

<ul style="list-style-type: none"> • Brickwork to ground floor and detracting pebble-dash to first floor, with brick quoins at either end of the terrace. • Character of the single storey bays impacted by the two-storey bay at No. 7
Group value	These buildings have a clear visual design and historic relationship.
Archaeological interest	Subject to future assessment
Historic interest	<p>Related to the late 19th/early 20th century residential development along Coventry Road.</p> <p>c. 1900s Coventry Road</p>

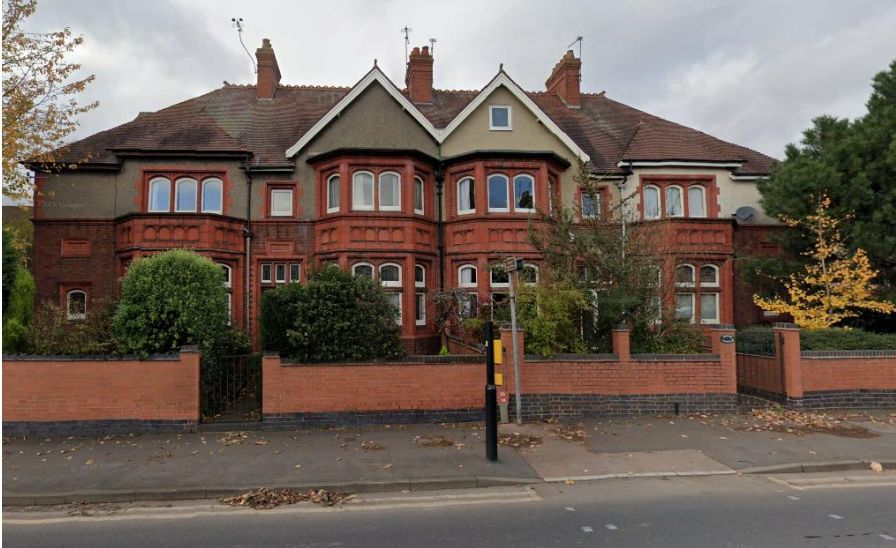
15-19 (odds) Coventry Road and 2 Park Road, Bedworth

Criteria	Description
Asset type	Buildings
Age	Built between 1886 and 1902
Rarity	Rare in comparison to local characteristics.
Architectural and artistic interest	<ul style="list-style-type: none"> • Arts and Crafts style • Decorative roof tiles on ridges with finials • Brick quoin detailing around windows • Round arched windows on the first and ground floors • Mullioned windows on first floor • Symmetrical character of two adjoining pitched gables, with roof tiles and bargeboards, and two storey bay windows beneath this. Additional hipped roof detailing on either side of the pitched gables and single storey bays. • String course below the first floor windows • Decorative terracotta tiling on bay windows between first and ground floor windows • Stained glass windows on the ground floor • Mullion and transom windows on ground floor • Fanlights above front entrances • Side pitched entrance porch to No. 2 Park Road • Original outbuildings • Rear dormer windows

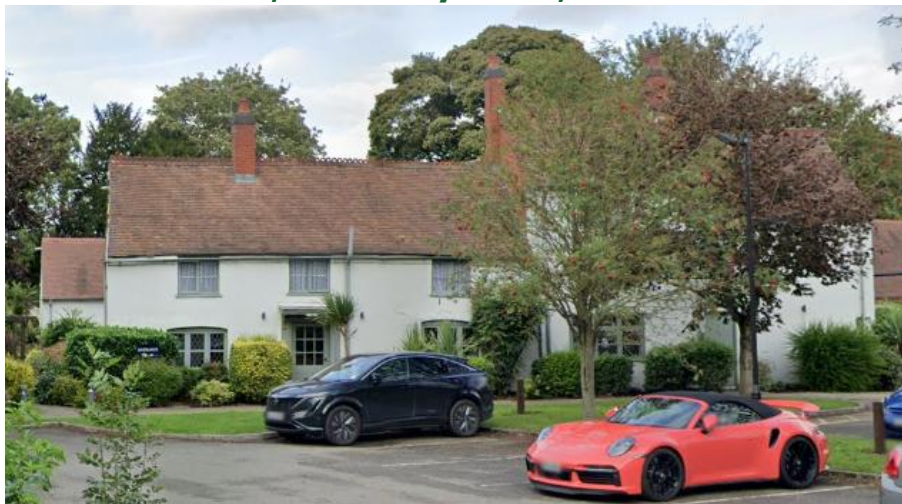
The Griffin Inn, Coventry Road, Nuneaton

Criteria	Description
Asset type	Building
Age	Built before 1886, various extensions and alterations to historic core throughout the 20 th century.
Rarity	Rare in comparison to local characteristics.
Architectural and artistic interest	<ul style="list-style-type: none"> • Decorative roof tiles on ridges • Original lead-work windows with gently arched lintels at ground floor • Canopy above main entrance, supported by consoles • Pilasters either side of main entrance with porch above • Plastered façade character
Group value	n/a
Archaeological interest	Subject to future assessment
Historic interest	Historic public house for the village of Griff.
Landmark status	None
References	None

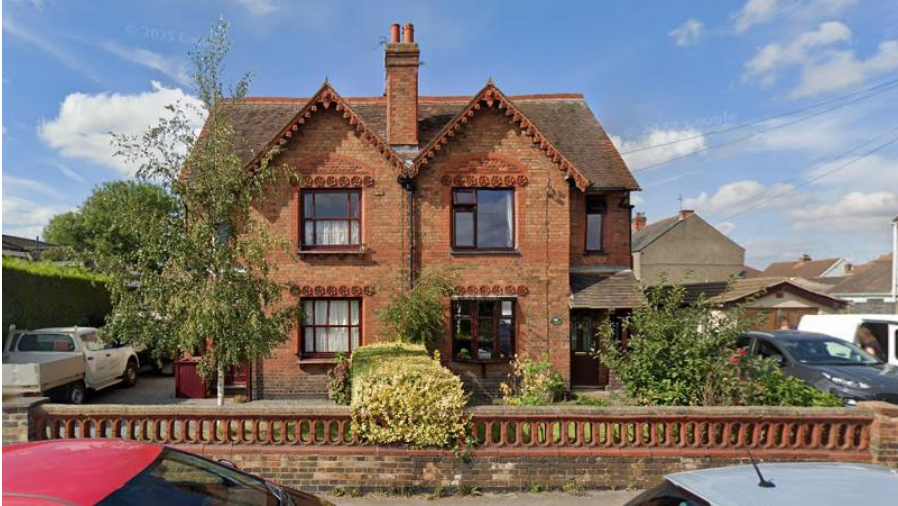
135 & 137 Croft Road, Nuneaton

Criteria	Description
Asset type	Buildings
Age	Built between 1842 and 1886
Rarity	Rare in comparison to local characteristics.
Architectural and artistic interest	<ul style="list-style-type: none"> • Arts and Crafts style • Decorative terracotta roof tiles on ridges including finials • Decorative terracotta bargeboard detailing to the pitched gable • Rosette terracotta lintels above windows on ground and first floors • Red brick detailing between ground and first floor, as well as around windows • Corbel table beneath windows of 137 Croft Road • Decorative terracotta front wall • Timber porch with half pitched tiled roof
Group value	These buildings have a clear visual design and historic relationship.
Archaeological interest	Subject to future assessment

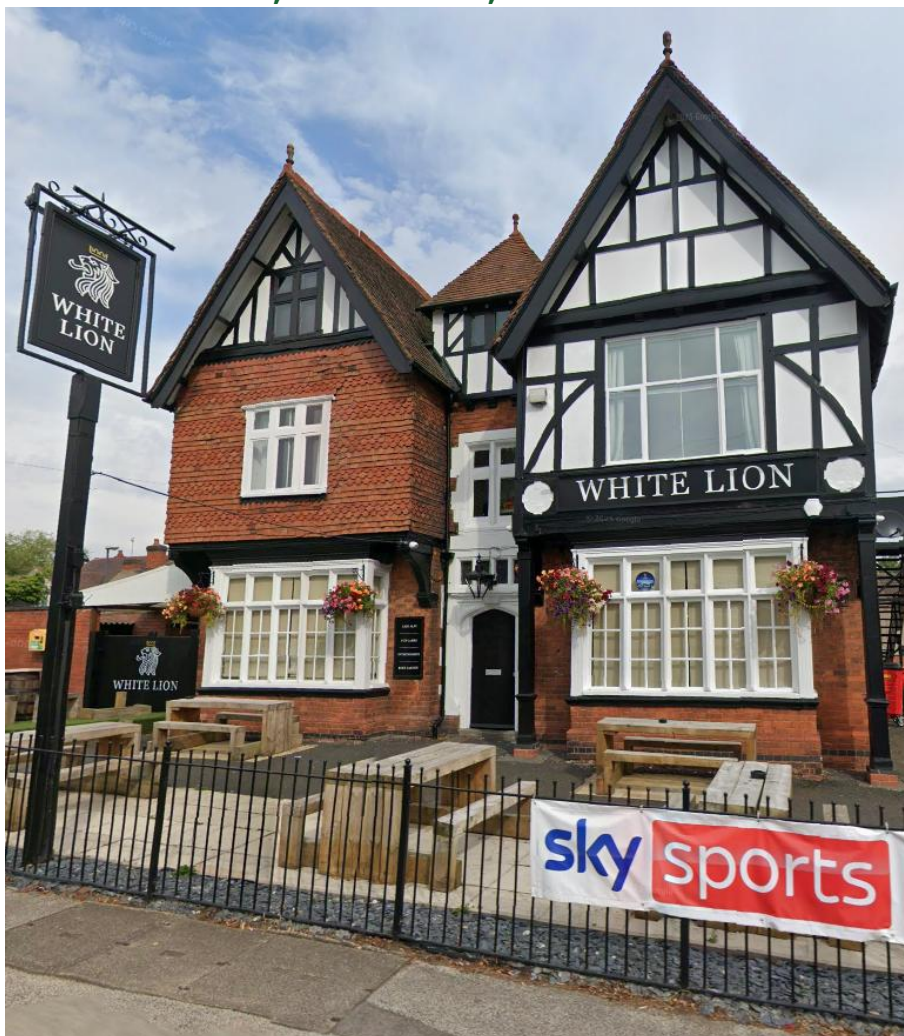
White Lion Inn, Croft Road, Nuneaton

Criteria	Description
Asset type	Building
Age	Built between 1886 and 1901
Rarity	Rare in comparison to local characteristics.
Architectural and artistic interest	<ul style="list-style-type: none"> Arts and Crafts style Decorative chimneys

<ul style="list-style-type: none"> • Decorative timber framing on front facing gables and first floor, including timber bargeboards • Painted quoin detailing around first floor central window with a timber framed addition above, topped by a pitched red tiled roof and finial detailing. • Fanlight above main entrance with mullions • Pointed arch main entrance • Sash windows on the ground floor • Red hanging tile detailing to left side of the facade • Red brick character to the side and rear of the building
Group value	None
Archaeological interest	Subject to future assessment
Historic interest	Rebuilt in the late 19 th century to replace the former White Lion Inn.
Landmark status	None
References	None

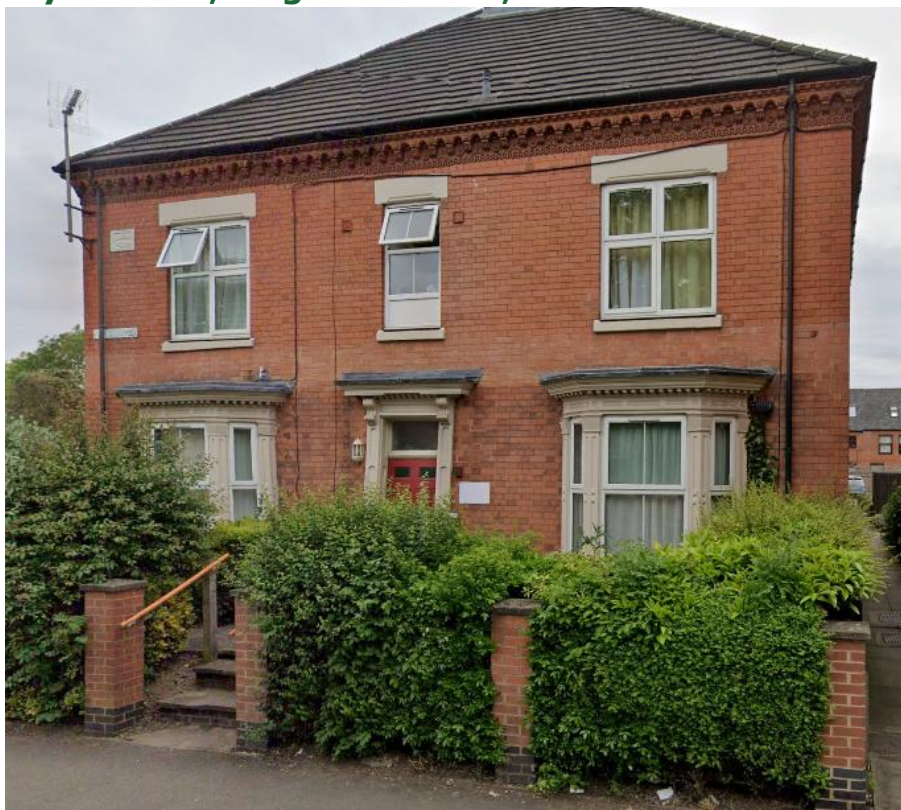
Blyth Court, Dugdale Street, Nuneaton

Criteria	Description
Asset type	Building
Age	Built between 1886 and 1902
Rarity	Rare in comparison to local characteristics.
Architectural and artistic interest	<ul style="list-style-type: none"> • Highly decorative terracotta cornice • Dentilled cornice above the ground floor bay windows • Decorative pilasters topped by capitals on the ground floor windows • Shallow porch with dentilled cornice, supported by consoles over decorative pilasters • Fanlight above main entrance

<ul style="list-style-type: none"> • Plain lintels to existing windows
Group value	None
Archaeological interest	Subject to future assessment
Historic interest	The building was constructed as part of the late 19 th / early 20 th century residential development of the area.
Landmark status	None
References	None

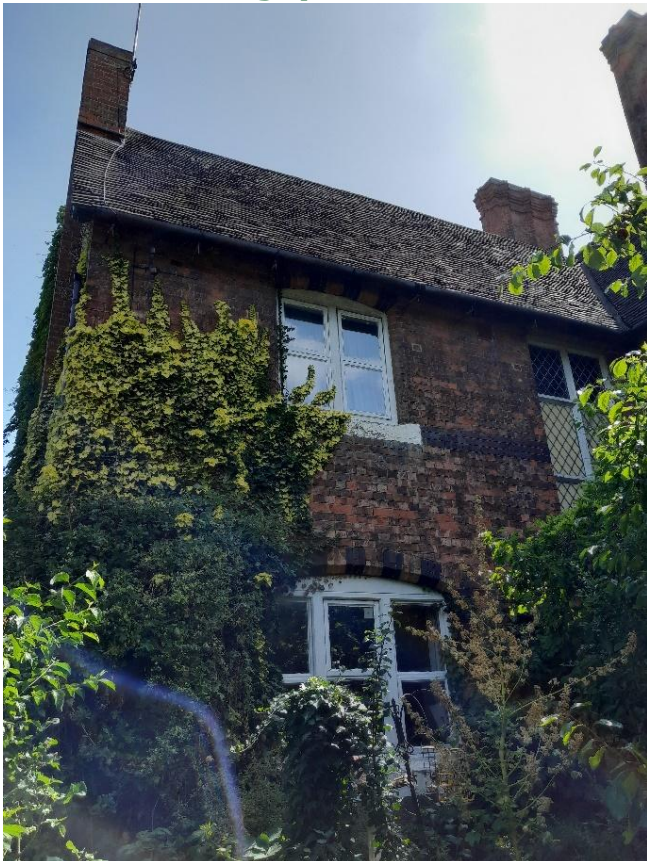
4 Fifield Close, Nuneaton (Former Holy Trinity Church Vicarage)

Criteria	Description
Asset type	Building
Age	Built between 1842 and 1886
Rarity	Rare in comparison to local characteristics.
Architectural and artistic interest	<ul style="list-style-type: none"> Decorative chimneys Red and blue brick detailing as string courses Arched windows built with two colour brick pattern Original window including mullions and transoms, complete with glazing bars

<ul style="list-style-type: none"> • Arched doorways • Original front door with decorative metalwork • Decorative tiled floor within porch • Overhanging eaves with black timber bargeboard
Group value	Group value with the nearby Grade II listed Church of the Holy Trinity and the Former Vicarage School (170 Attleborough Rd)
Archaeological interest	Subject to future assessment
Historic interest	<p>The building was constructed as the Vicarage for the Holy Trinity Church. This was constructed following the 1842 Tithe Map. The building would have involved the increased plot of the Church, as it is located on Plot 818, which was owned by the Garrett family and occupied by Thomas Green in 1842. The neighbouring plot (Plot 817) was already owned by the church in 1842, and by 1886, the Vicarage School was constructed on this plot.</p> <p>This building has social and communal interest, as it symbolises faith in the local area due to the vicarage’s relationship with the church.</p> <p>1842 Tithe Map</p>

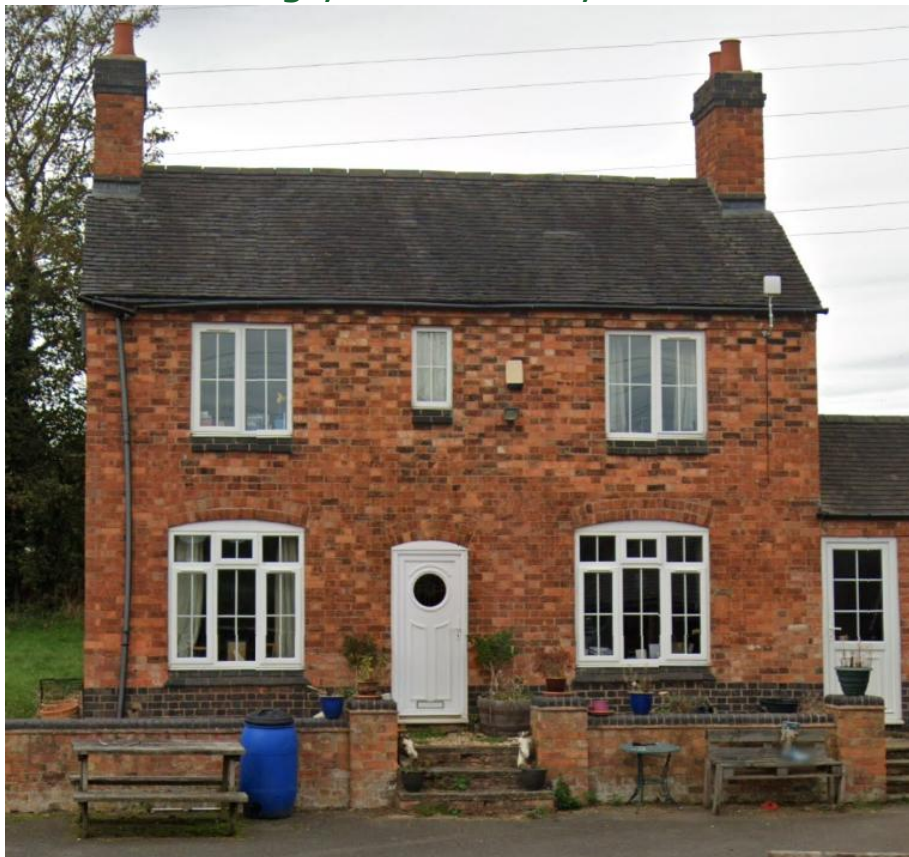
Yew Tree Cottage, Forders Lane, Bedworth

Criteria	Description
Asset type	Buildings
Age	Built before 1890
Rarity	Rare in comparison to local characteristics. This is one of only two village farmsteads within the borough.
Architectural and artistic interest	All buildings <ul style="list-style-type: none"> Historic farmstead arranged in a full regular courtyard plan, which has interest as it evidences the local farming region, as well as advanced

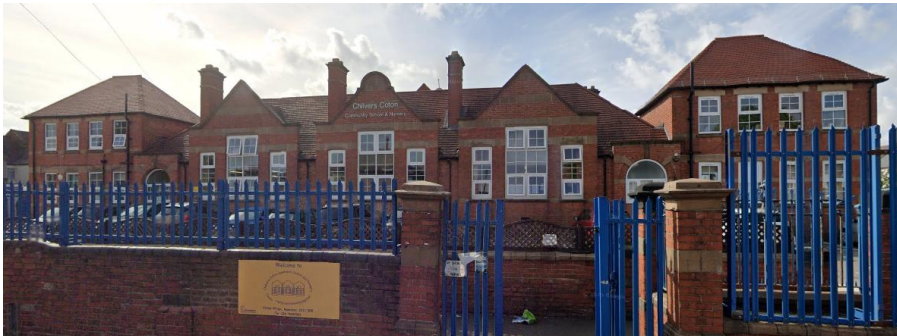
Chilvers Coton First School, Frank Street, Nuneaton

Criteria	Description
Asset type	Building
Age	Built between 1886 and 1913.
Rarity	Rare in comparison to local characteristics.
Architectural and artistic interest	<ul style="list-style-type: none"> • Sash windows on first and ground floors • Roofscape provides significant interest with decorative chimneys set between the symmetrical gables throughout the existing elevations • Contrasting use of pitched and hipped roofs • String courses on multiple levels • Round arched windows topped with keystones • The historic plot form has been conserved • Use of red brick and rows of stone provide architectural interest
Group value	n/a
Archaeological interest	Tile kilns found just south of the site in a 1967 archaeological excavation (Warwickshire County Record Office).
Historic interest	The school was constructed as part of the wider residential

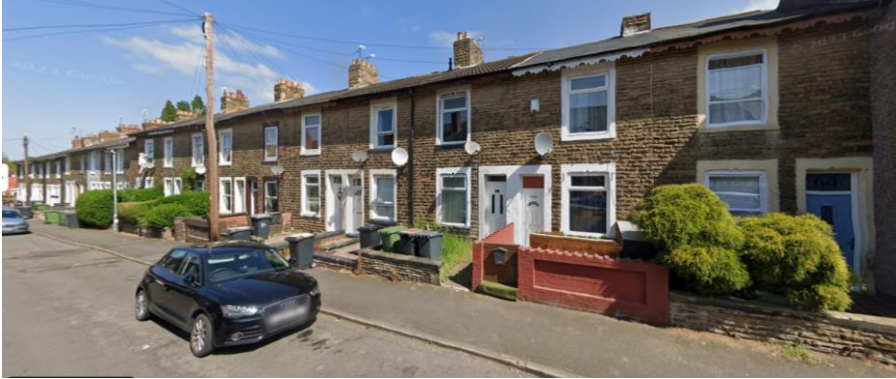
24-64 (evens) Gadsby Street, Nuneaton

Criteria	Description
Asset type	Buildings
Age	Built between 1886 and 1902
Rarity	Rare in comparison to local characteristics.
Architectural and artistic interest	<ul style="list-style-type: none"> • Some decorative timber bargeboarding conserved • Painted stonework window and door surrounds • Grey/yellow coarse stonework front elevation • Grey/yellow coarse stonework front boundary walls • Historic roof tiles conserved <p>The materiality and remaining conserved features provide architectural interest in this terrace, making this terrace unique in comparison with the similar historic context of the surrounding residential terraces.</p>
Group value	These buildings have a clear visual design and historic relationship.
Archaeological interest	Subject to future assessment
Historic interest	Some historic interest as the site is related to the residential development of this part of south Nuneaton between the late 19 th and early 20 th century.

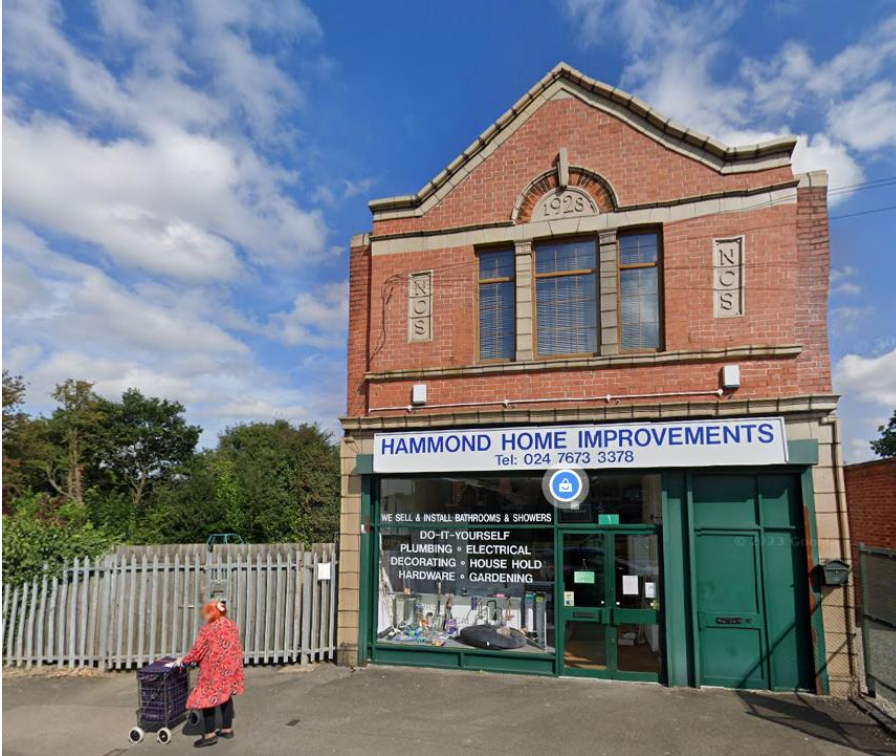
10 Haunchwood Road, Nuneaton

Criteria	Description
Asset type	Building
Age	1928
Rarity	Creates a group value and shares similar architectural characteristics (pilasters, window surrounds, dating plate, pediments) with town centre buildings
Architectural and artistic interest	<ul style="list-style-type: none"> • Pedimented frontage with keystone and 1928 date • Two identical stonework inscriptions are mirrored each side of the first floor window, with the inscribed "NCS" denoting the Nuneaton Co-operative Society • String courses at multiple levels • Pilasters between first floor windows, topped with fluted capitals • Faience shopfront and cornice detail to ground floor • First floor in red brick in Flemish bond on the front elevation • Fenestration to western elevation with brick flank wall to east

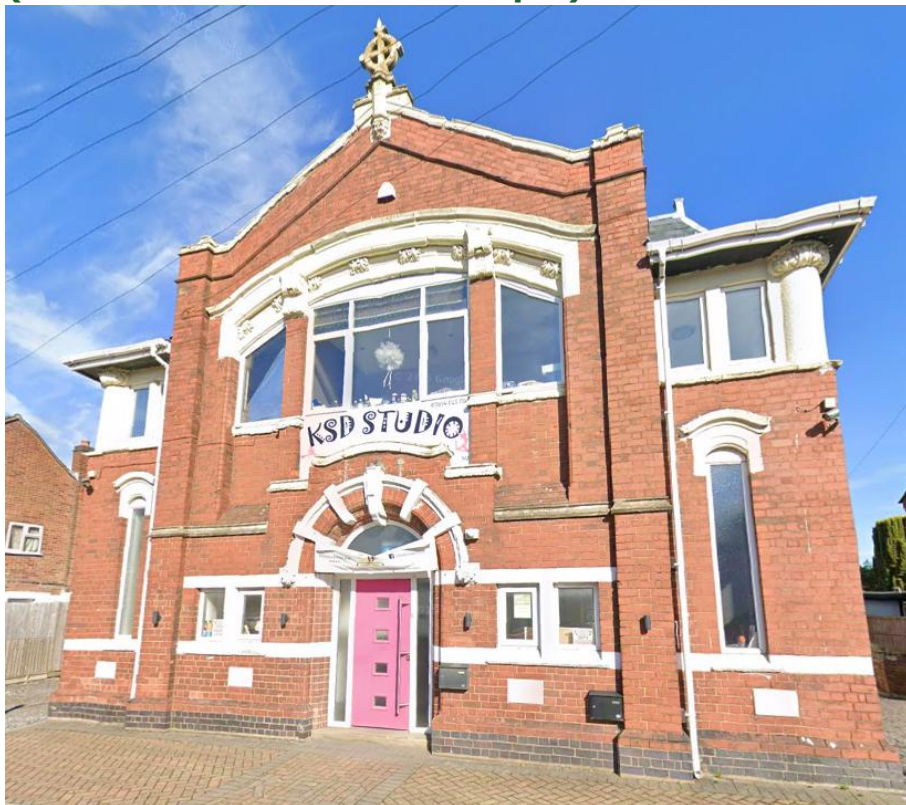
KSD Studio, 161 Heath End Road, Nuneaton (Former Free Methodist Chapel)

Criteria	Description
Asset type	Building
Age	1903
Rarity	Rare in comparison to local characteristics.
Architectural and artistic interest	<ul style="list-style-type: none"> • Decorative roof tiles on ridges • Predominantly red brick in English bond with cream stucco dressings • Arched stonework above first floor central windows, with cornice, naturalistic foliage stonework and consoles • Columns and capitals with volutes on the first floor corners • Arched hood mouldings over ground floor windows • Arched windows along the sides of the building • Blocked keystone above front entrance

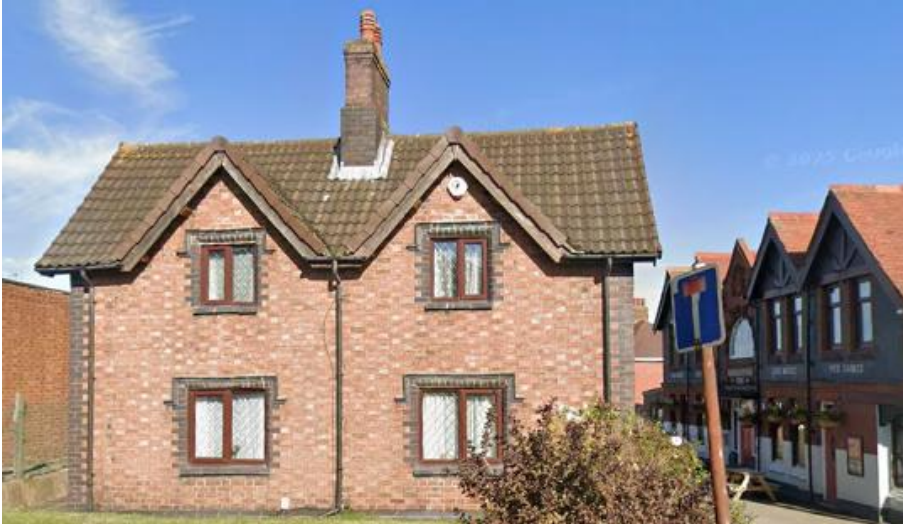
201 Heath End Road, Nuneaton

Criteria	Description
Asset type	Building
Age	Built before 1886. Map details indicate the building was either rebuilt between 1901 and 1913, or the northern elevation was demolished.
Rarity	Somewhat rare in comparison to local characteristics.
Architectural and artistic interest	<ul style="list-style-type: none"> • Predominantly red brick in Flemish bond, with a chequer-board brick pattern • External corners also feature blue brick quoins, extending both storeys. • Hood mouldings above ground and first storey windows • Closers around ground and first storey windows
Group value	n/a
Archaeological interest	Subject to future assessment
Historic interest	Unknown
Landmark status	None
References	None

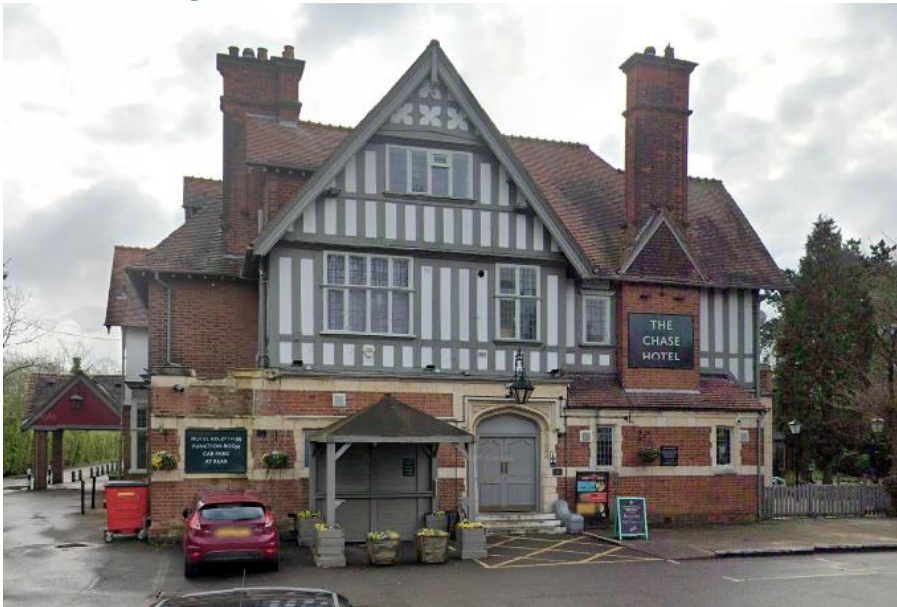
Chase Hotel, Higham Lane, Nuneaton (Formerly The Chase)

Criteria	Description
Asset type	Building
Age	1899 (Lee, P., 2021)
Rarity	Rare in comparison to local characteristics.
Architectural and artistic interest	<ul style="list-style-type: none"> • Decorative chimneys • Combination of red brick in Flemish bond and decorative timber framed cladding, exemplifying the Tudor revival seen at the turn of the 20th century • Studded framing to the first and second floors, and decorative framing to the gables • Original windows on the second, first and ground floors • String courses on multiple levels • Four-centred arch doorway • Mullion and transom windows on the ground floor in stone
Group value	n/a
Archaeological interest	Subject to future assessment

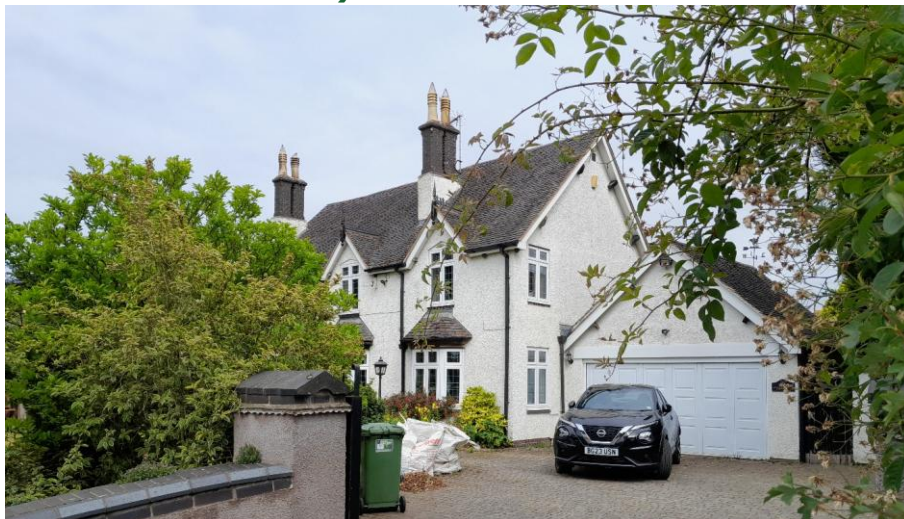
244 Hinckley Road, Nuneaton (Formerly Summerhill House)

Criteria	Description
Asset type	Building
Age	Built before 1890, although remodelled in mid-20 th century
Rarity	Rare in comparison to local characteristics.
Architectural and artistic interest	<ul style="list-style-type: none"> • Decorative chimneys • Decorative ridge tiles to dormer windows • Decorative barge boards to front porch topped with finial, supported by decorative consoles
Group value	n/a
Archaeological interest	Subject to future assessment
Historic interest	<p>The original Summerhill House site was owned by Henry Slingsby, a silk manufacturer.</p> <p>At one time, most of the houses on the left side of Hinckley Road continuing out of Nuneaton were large mansions (with Summerhill House being one of them).</p>

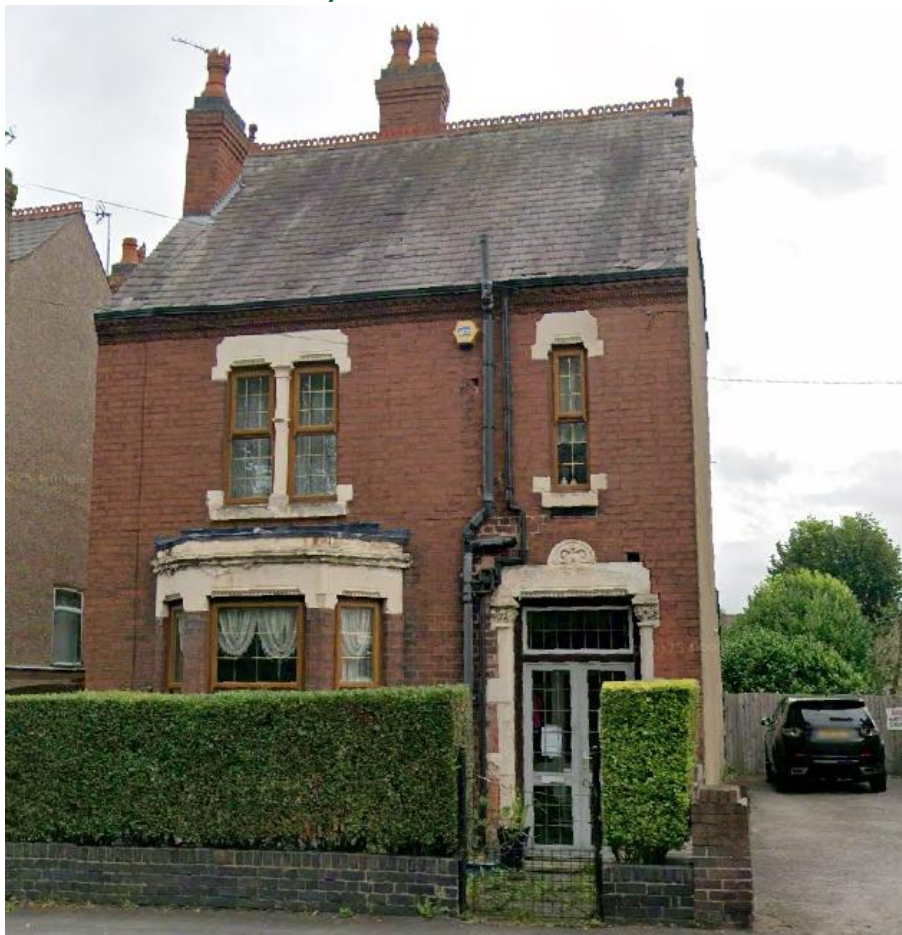
47 Leicester Road, Bedworth

Criteria	Description
Asset type	Building
Age	Built between 1886 and 1902
Rarity	Relatively rare in comparison to local characteristics.
Architectural and artistic interest	<ul style="list-style-type: none">• Decorative crown chimney pots• Decorative chimneys• Decorative roof tiles on the ridges in trefoil shape• Decorative cornice• Colonette between first floor windows

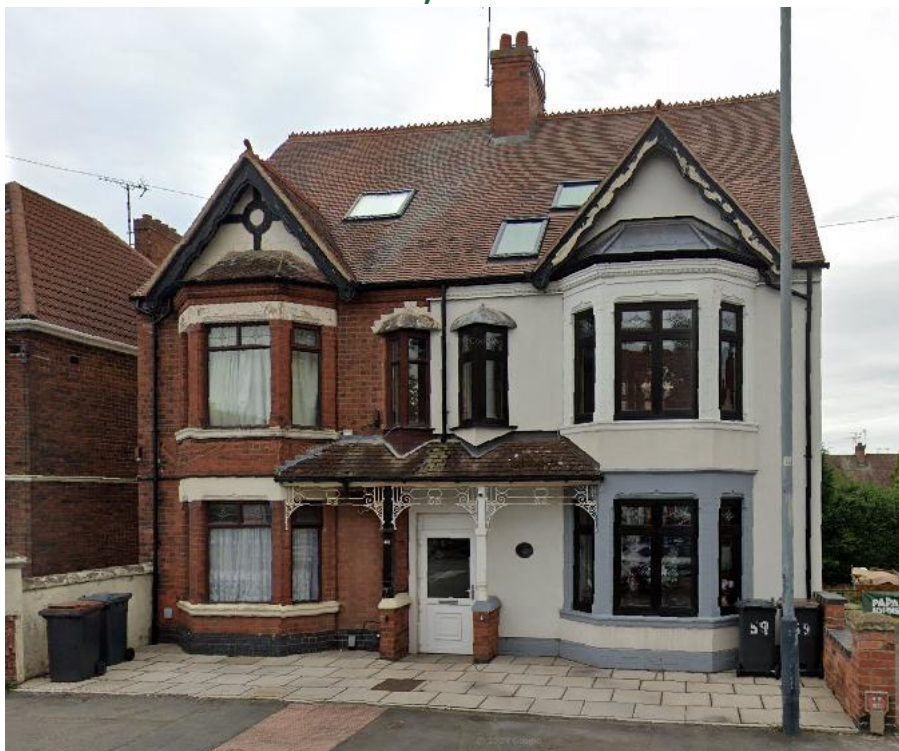
59 & 61 Leicester Road, Bedworth

Criteria	Description
Asset type	Buildings
Age	Built before 1923
Rarity	Rare in comparison to local characteristics.
Architectural and artistic interest	<ul style="list-style-type: none"> • Decorative roof tiles on the ridges • Decorative gables with swan neck terracotta finials above both barge boards • Decorative cornice • String course above ground floor • Decorative metalwork supporting canopy above main entrance • Exposed brick to left hand side and rendered to right

Group value	These buildings have a clear visual design and historic relationship.
Archaeological interest	Subject to future assessment
Historic interest	Unknown
Landmark status	None
References	None

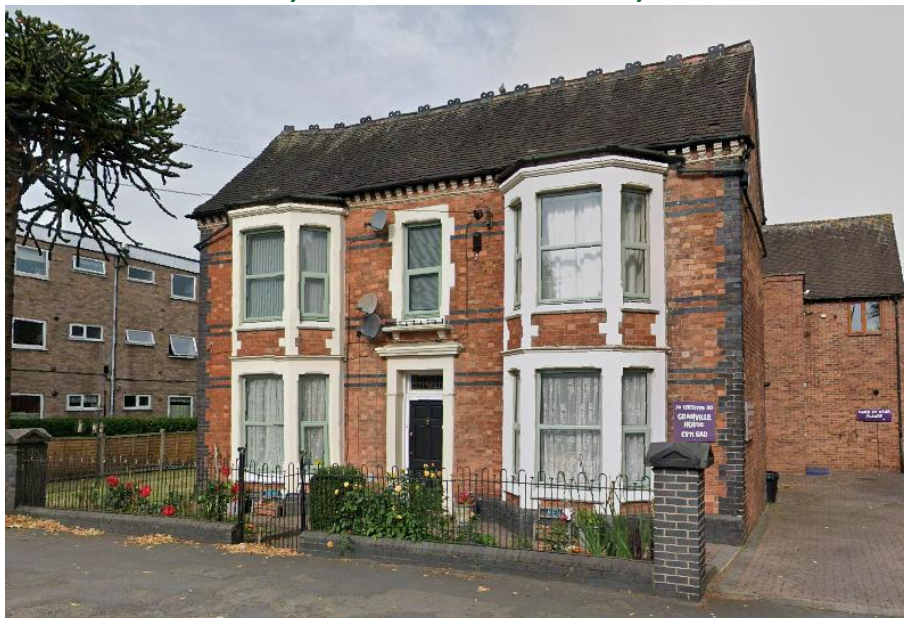
Granville House, 30 Leicester Road, Nuneaton

Criteria	Description
Asset type	Building
Age	Built before 1886
Rarity	Rare in comparison to local characteristics.
Architectural and artistic interest	<ul style="list-style-type: none"> • Decorative roof tiles on the ridges • Dentilled cornice • Bay windows with stonework surrounds • String courses at multiple levels • Pilasters either side of main entrance • Fanlight above main entrance • Dark brick quoins
Group value	n/a
Archaeological interest	Subject to future assessment
Historic interest	Unknown
Landmark status	None
References	None

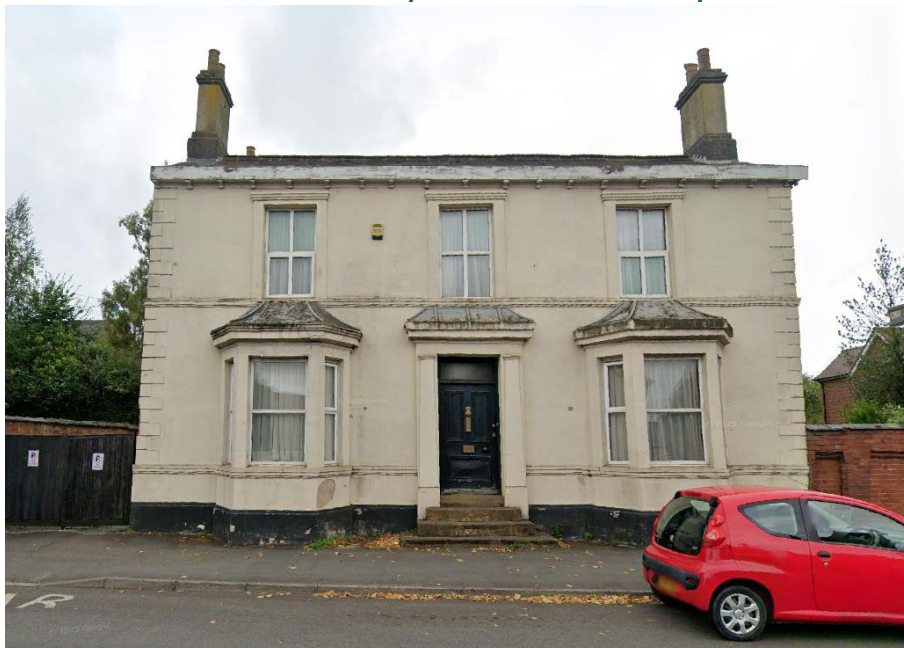
Mount Pleasant House, Leicester Road, Bedworth

Criteria	Description
Asset type	Building
Age	Built before 1877
Rarity	Rare in comparison to local characteristics.
Architectural and artistic interest	<ul style="list-style-type: none"> • Corbel table • Quoins • Hood mouldings above first floor windows • String courses above ground floor and below ground floor windows • Fanlight above main entrance • Pilasters either side of main entrance
Group value	n/a
Archaeological interest	Subject to future assessment
Historic interest	An 1877 newspaper indicates that Mount Pleasant House was occupied by the John Walter Byrne Land & Mining Surveyor Company.

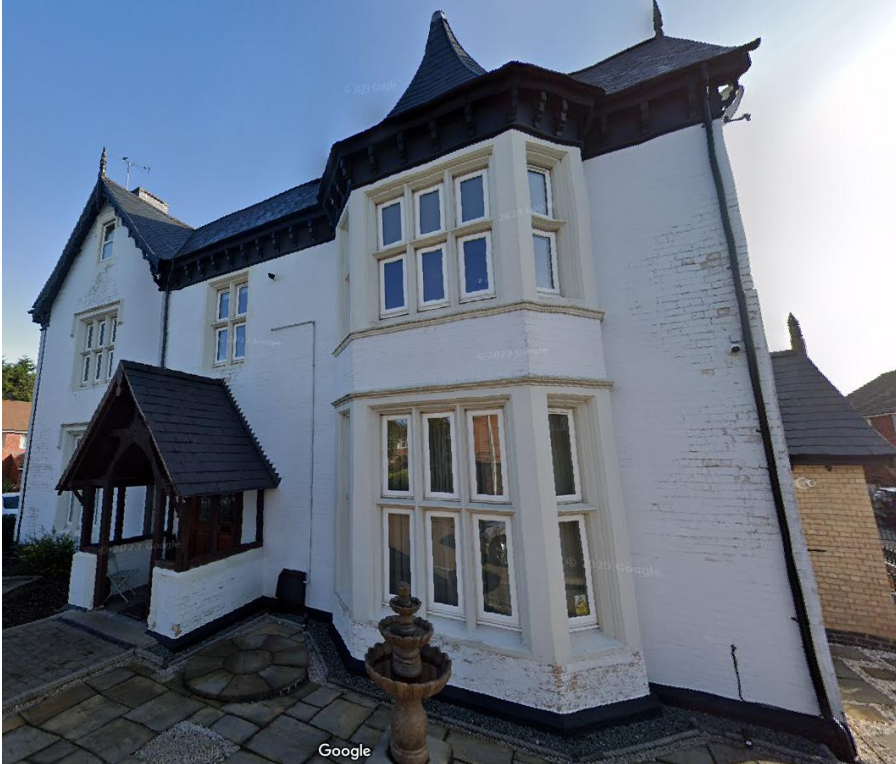
1-6 Grove Lodge, Lionel Close, Nuneaton (Formerly The Grove)

Criteria	Description
Asset type	Building
Age	Circa 1818 (Weddington Castle, 2021)
Rarity	Rare in comparison to local characteristics.
Architectural and artistic interest	<ul style="list-style-type: none"> • Decorative fascias • Corbel table • Hood mouldings above some windows • Mullion and transom windows • Finials to roof pitches
Group value	n/a
Archaeological interest	Subject to future assessment
Historic interest	Records state that the house was built in c. 1818. Mapping from 1814 shows a building on the same site.

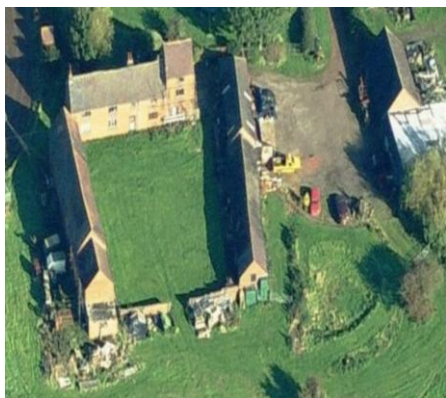
Bramcote Fields Farm, Lutterworth Road, Nuneaton

Criteria	Description
Asset type	Buildings
Age	Built before 1813
Rarity	Rare in comparison to local characteristics.
Architectural and artistic interest	<ul style="list-style-type: none"> Historic farmstead arranged in a loose courtyard plan, with three sides. The historic farmstead has interest as it evidences the local farming region, as well as advanced agricultural regimes. Additionally, the farmstead was an essential component of the former more rural landscape (Historic England, 2017).
Group value	These buildings have a clear visual design and historic relationship.
Archaeological interest	Subject to future assessment
Historic interest	In 1939, the Air Ministry informed Mr Bryan Elson of Bramcote Fields Farm that their land would be required along with the other locally owned farmlands. This was to support the new RAF aerodrome at Bulkington.

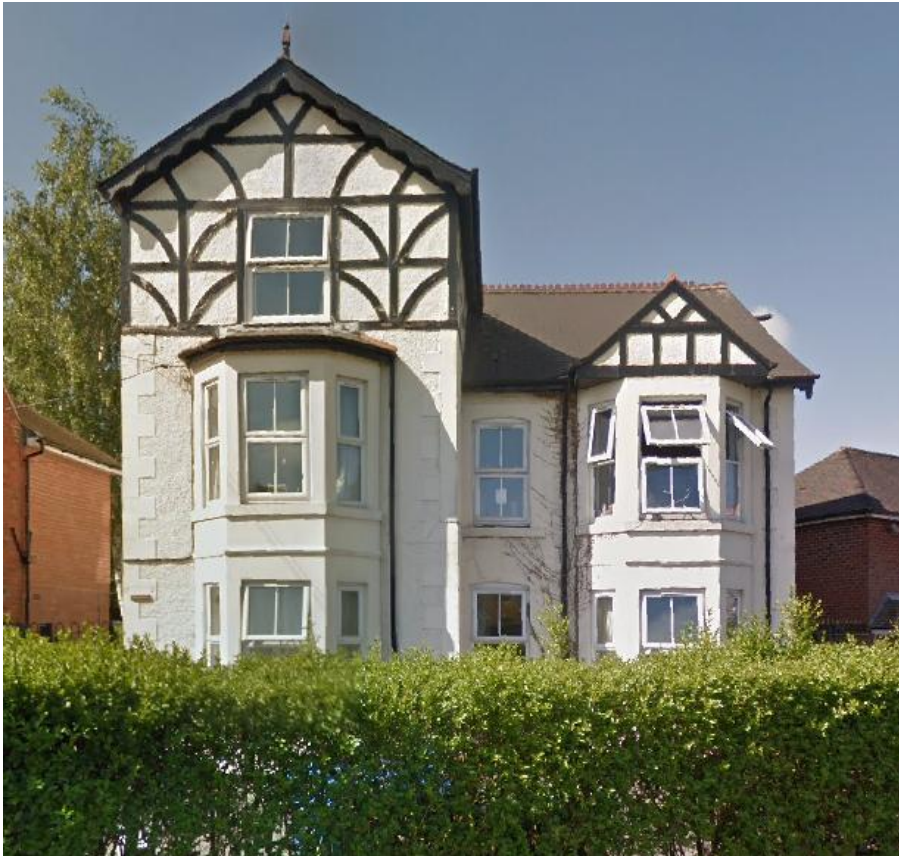
The Gables, 31 Lutterworth Road, Nuneaton

Criteria	Description
Asset type	Building
Age	Built before 1886
Rarity	Rare in comparison to local characteristics.
Architectural and artistic interest	<ul style="list-style-type: none">• Decorative roof tiles on the ridges, as well as finials• Decorative timber framing on the second floor and gables• Quoins on the first and ground floors• Round arched windows in the centre of the front of the building• Decorative bargeboard on north-western elevation• The 1920s photograph below shows the front elevation of the property, including the original

roughcast wall colour which has since been painted white to match the quoins.

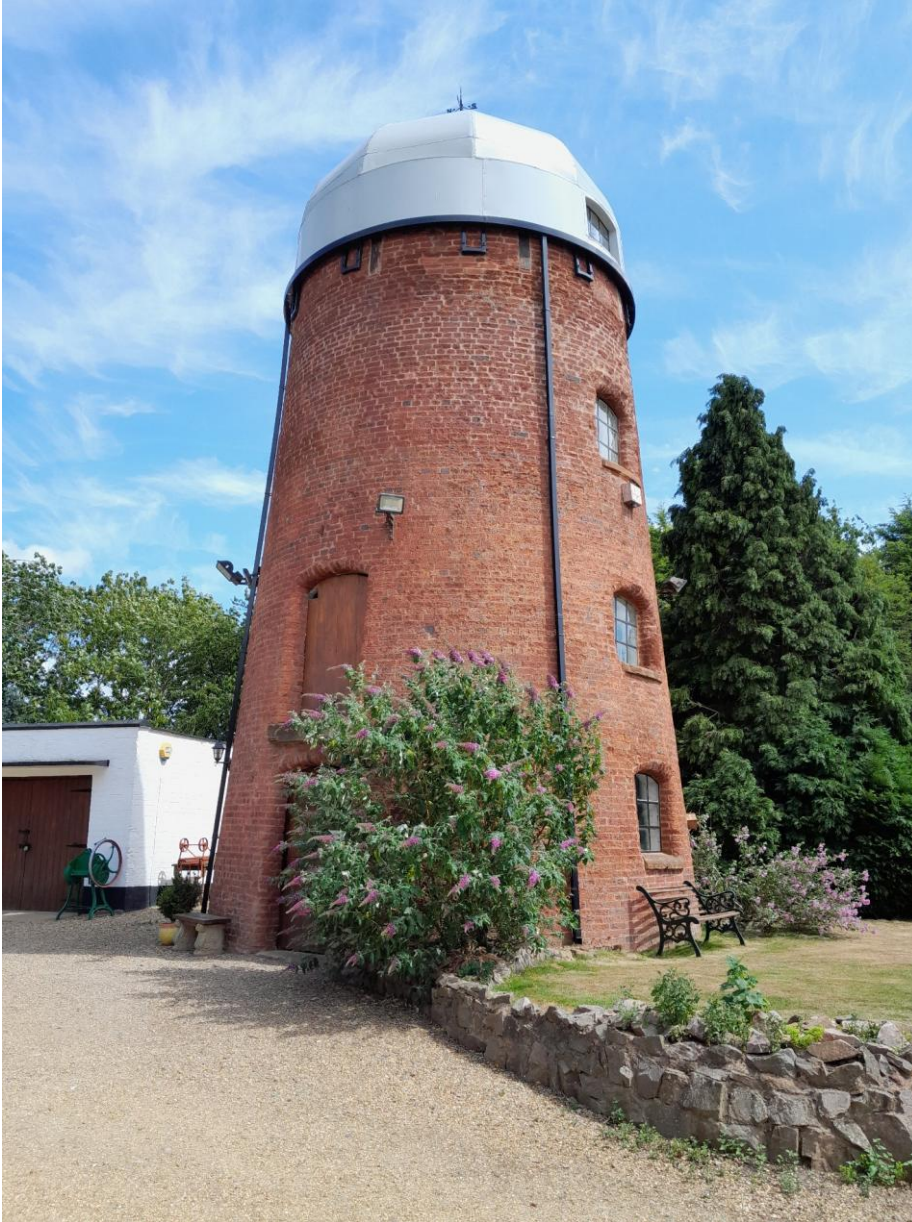
**Tuttle Hill Mill, Mancetter Road, Nuneaton
(Formerly Caldecote Mill)**

Criteria	Description
Asset type	Building
Age	1821 (Heritage Gateway, 2021)
Rarity	Rare in comparison to local characteristics.
Architectural and artistic interest	<ul style="list-style-type: none"> • Domed roof • Original arched windows to ground, first and second floors • Arched doorways to ground and first floor • Red brick (restored following period when rendered)
Group value	n/a
Archaeological interest	Subject to future assessment
Historic interest	<p>The mill was purposefully built on top of a windy hill, 450 feet above sea level in 1821. The mill and associated farm were part of the Caldecote estate. The estate once rented out the mill, along with a watermill and a steam mill. Before 1821, a previous mill stood on the site and was originally erected one hundred years prior.</p> <p>In 1905, one of the sails was damaged by severe wind, but it was soon rebuilt. The original sails were deemed to be too long and almost touched the floor, resulting in shorter sails being installed. This was also done to improve the safety of those entering the mill. In 1936, another gale damaged one of the five sails. It was the last working windmill in north Warwickshire.</p> <p>The mill continued to grind corn by electric motor until February 1976. Various maps indicate that the corn mill became disused between the 1930s and 1950s. In recent years, the windmill was topped by a grey metallic dome.</p>

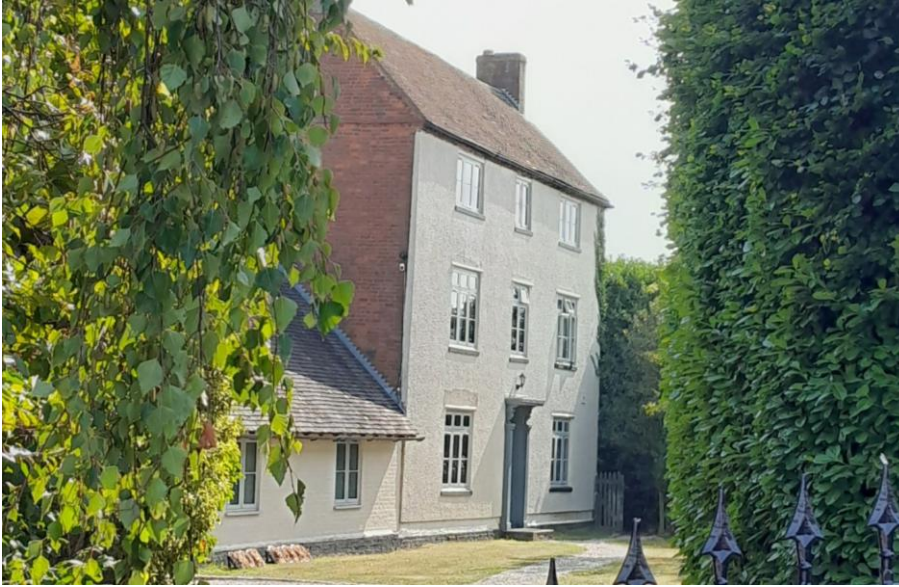
Hill Farm, Marlowe Close, Nuneaton

Criteria	Description
Asset type	Buildings
Age	Built before 1817
Rarity	Rare in comparison to local characteristics.
Architectural and artistic interest	<p>All buildings</p> <ul style="list-style-type: none"> Historic farmstead arranged in a full regular courtyard plan, however one side of the courtyard has been demolished. The historic farmstead has interest as it evidences the local farming region, as well as advanced agricultural regimes. Additionally, the farmstead was an essential component of the former more rural landscape. (Historic England, 2017) <p>Main house</p> <ul style="list-style-type: none"> Dentilled cornice

<ul style="list-style-type: none"> • Decorative porch supported by consoles • Pilasters either side of front door, supported by bases and topped with capitals • Stucco front elevation with exposed red brick to side elevations and gables
Group value	These buildings have a clear visual design and historic relationship.
Archaeological interest	Subject to future assessment
Historic interest	<p>The property served as the farmhouse for the surrounding lands, which has since been built on by residential units between the 1960s and 1990s.</p> <p>In 1907, Hill Farm held the Atherstone Hunt Steeplechases.</p>
Landmark status	None
References	Historic England (2017). <i>Agricultural Buildings: Listing Selection Guide</i> .

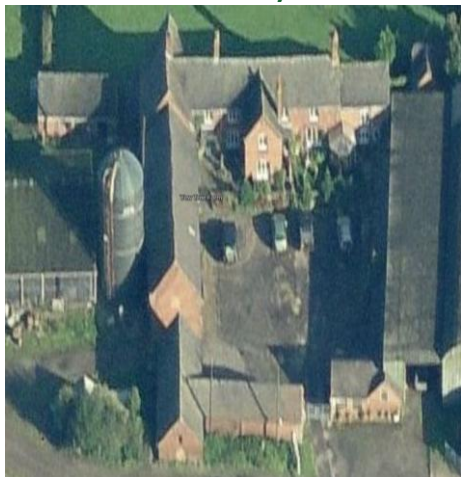
Yew Tree Farm, Marston Lane, Bedworth

Criteria	Description
Asset type	Buildings
Age	Built before 1813
Rarity	Rare in comparison to local characteristics.
Architectural and artistic interest	<ul style="list-style-type: none"> • Historic farmstead arranged in a full regular courtyard plan, which has interest as it evidences the local farming region, as well as advanced agricultural regimes. Additionally, the farmstead was an essential component of the former more rural landscape. (Historic England, 2017) • Red brick courtyard farmstead with grey slate roofing • The west wing of the courtyard has particular architectural interest, with a full-length barn door and distinct iron brackets on the wall. The full courtyard has a striking aesthetic with its red brick façade.

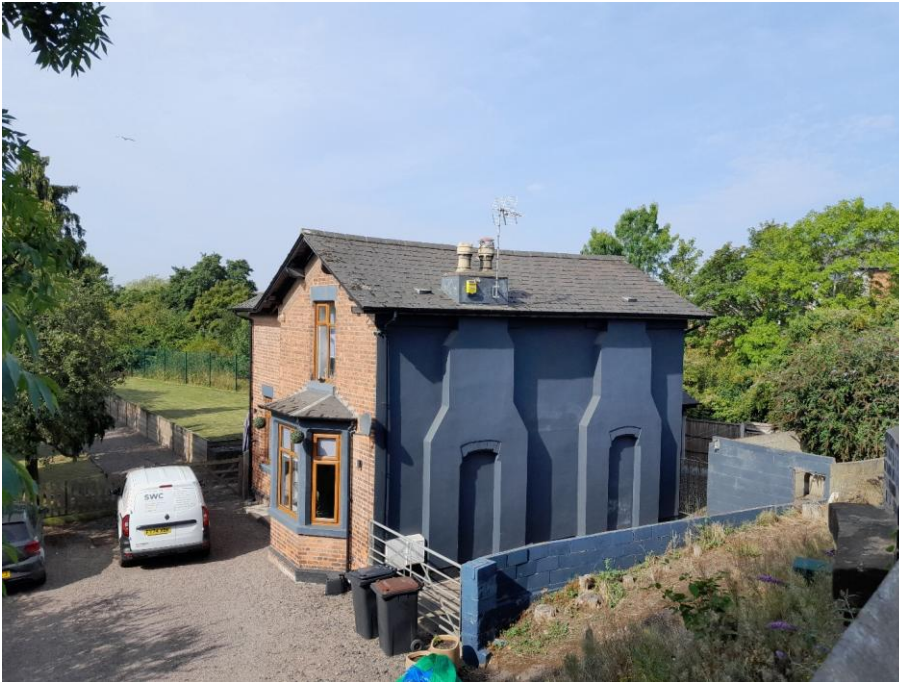
Abbey Station House and Waiting Room, Midland Road, Nuneaton (Former Stationmaster's House and Waiting Room)

Criteria	Description
Asset type	Buildings
Age	Built before 1873 (according to railway diagrams and OS Maps)
Rarity	Rare in comparison to local characteristics.
Architectural and artistic interest	<p>Abbey Station House</p> <ul style="list-style-type: none"> • Decorative cornice • Stonework lintels and cills • Stonework surround bay window on ground floor • Northern elevation is characterised by four chimney flues, two of which have been blocked off at roof level <p>Waiting Room</p> <ul style="list-style-type: none"> • Stonework surround doorway

<ul style="list-style-type: none"> • Keystone above doorway
Group value	These buildings have a clear visual design and historic relationship.
Archaeological interest	Subject to future assessment
Historic interest	<p>These buildings have a historical association of local note, as they are examples of early railway development, which opened up new markets for coal, clay and its derivative manufacturers in Nuneaton, leading to the late-Victorian and Edwardian town boom of the 1890s and 1900s. (Warwickshire County Council, 2015)</p> <p>Originally the station master's house.</p> <p>Former waiting room of Abbey Station, Nuneaton - now in private garden (2018)</p>
