Heritage Supplementary Planning Document (2026)

Heritage Supplementary Planning Document

2026

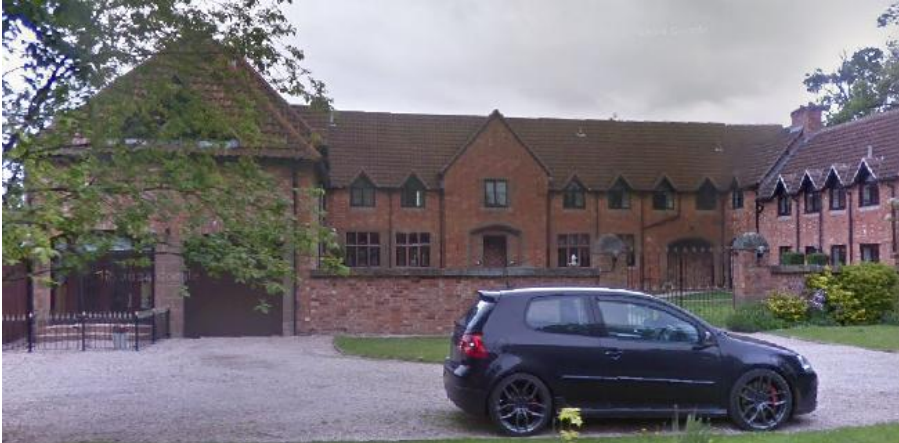
1-11 (odds) Weston Hall Stables, Mill Lane, Bulkington

Criteria	Description
Asset type	Building
Age	1893 (Weston Hall Hotel, 2021)
Rarity	Rare in comparison to local characteristics.
Architectural and artistic interest	<ul style="list-style-type: none"> Decorative gables and dormer windows Closers surrounding first floor windows on decorative gables Multiple round arched doorways Mullion and transom masonry on ground floor windows String course below first floor windows on eastern range Main red brick building arranged in a three-sided courtyard formation
Group value	n/a
Archaeological interest	Subject to future assessment
Historic interest	The stables were built c. 1893 to accompany the adjacent Grade II listed Weston Hall, built in the late sixteenth and early seventeenth century. The stables have since been converted into housing.
Landmark status	None

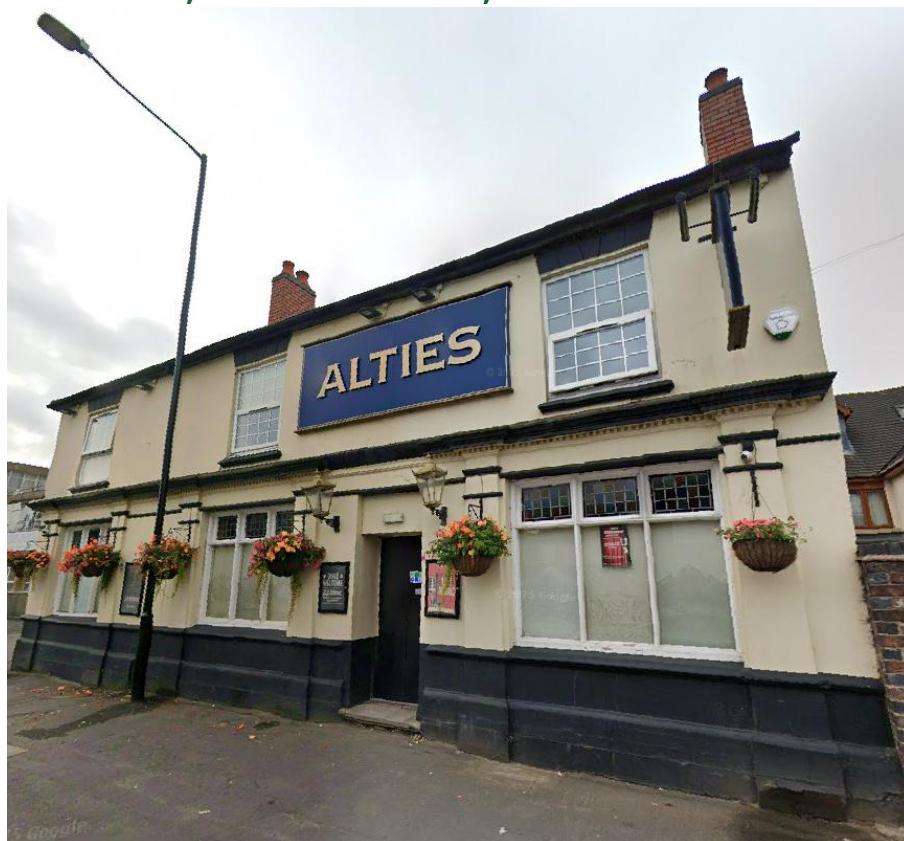
The Alties, Newtown Road, Bedworth

Criteria	Description
Asset type	Building
Age	Built before 1890
Rarity	Rare in comparison to local characteristics. This is one of only two surviving remnants of the industrial suburb of New Town. (Warwickshire County Council, 2015)
Architectural and artistic interest	<ul style="list-style-type: none"> • String course between first and ground floor • Dentil cornice beneath first floor string course • Pilasters either side of ground floor windows

<ul style="list-style-type: none"> • First floor windows topped by carved painted brick lintels • Stained glass windows on the ground floor • Predominantly rendered with exposed red brick to western elevation
Group value	n/a
Archaeological interest	Subject to future assessment
Historic interest	Previously known as the Queen's Head. The pub was renamed to the Alties in memory of Altie Twigger, who ran the pub from 1931 to 1966.
Landmark status	None
References	Warwickshire County Council (2015). <i>Bedworth Historic Character Assessment</i> .

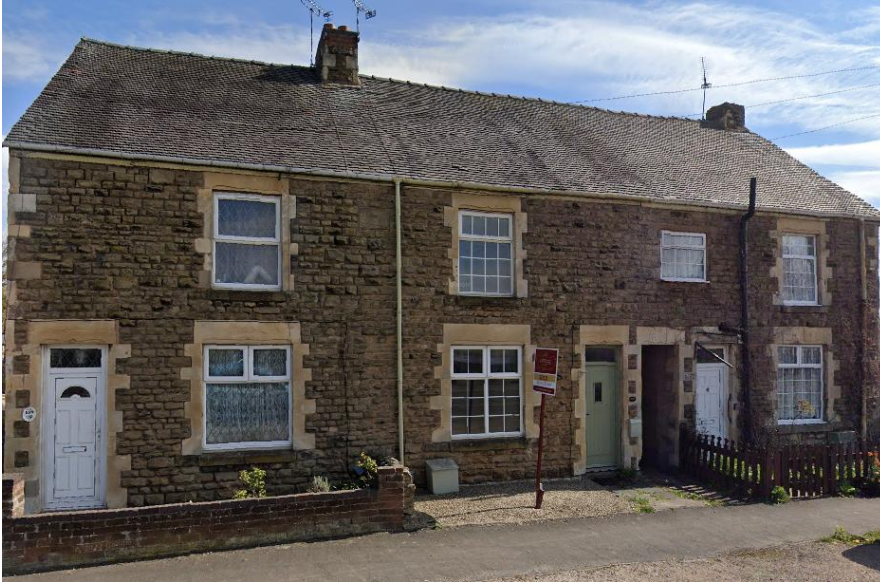
467-471 (odds) Nuneaton Road, Bulkington

Criteria	Description
Asset type	Buildings
Age	Built before 1843 (according to OS Maps)
Rarity	Rare in comparison to local characteristics.
Architectural and artistic interest	<ul style="list-style-type: none"> • Textured sandstone construction • Smooth stone closers around first and ground floor windows • Masonry surrounding doorways • Slate roof
Group value	These buildings have a clear visual design and historic relationship.
Archaeological interest	Subject to future assessment
Historic interest	Unknown
Landmark status	None
References	None

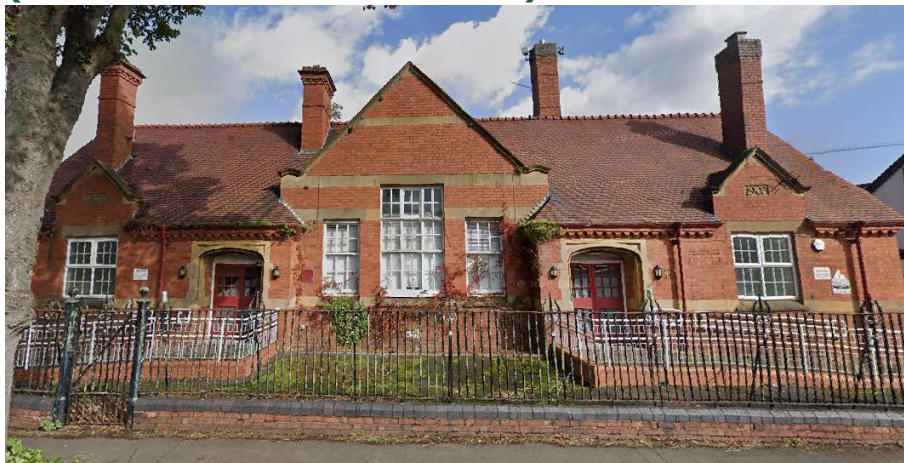
Aim 4, Freeway Building, Park Avenue, Nuneaton (Former Park Avenue School)

Criteria	Description
Asset type	Building
Age	1907
Rarity	Rare in comparison to local characteristics.
Architectural and artistic interest	<ul style="list-style-type: none"> • Decorative chimneys • Decorative roof tiles on ridges • Dentilled cornice beneath roof line on gable ends • Decorative gables to the front of the building • Multiple stone string courses • Dentilled cornice beneath ground floor eaves • Sash windows to central gable • Four-centred stonework arched doorways • Fanlights above front entrances • Stone plaque with 1907 inscribed on two small gables • Red brick chimneys extending above roof level with dentilled cornice
Group value	n/a
Archaeological interest	Subject to future assessment

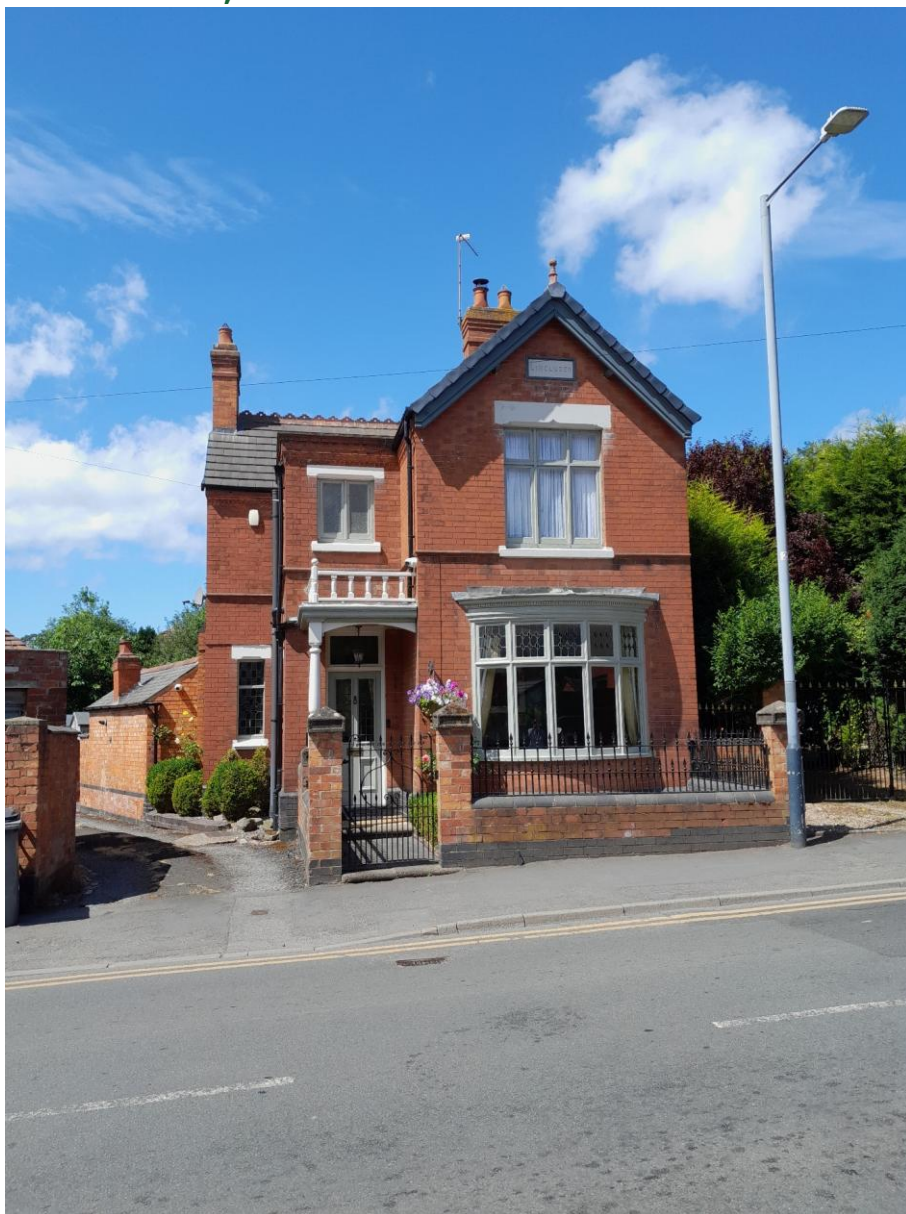
4 Park Road, Bedworth

Criteria	Description
Asset type	Building

Age	Built between 1902 and 1913
Rarity	Rare in comparison to local characteristics.
Architectural and artistic interest	<ul style="list-style-type: none"> • Decorative chimneys • Decorative terracotta roof tiles on the ridges • Mullion and transom windows on the first floor • String courses • Timber balustraded porch over main entrance • Fanlight above main entrance • Stained glass windows on the ground floor • Stone plaque in gable stating "Lincluden" • Rendered window lintels and cills • Wooden bargeboard
Group value	n/a
Archaeological interest	Subject to future assessment
Historic interest	<p>Park Road, Bedworth (1910s)</p>

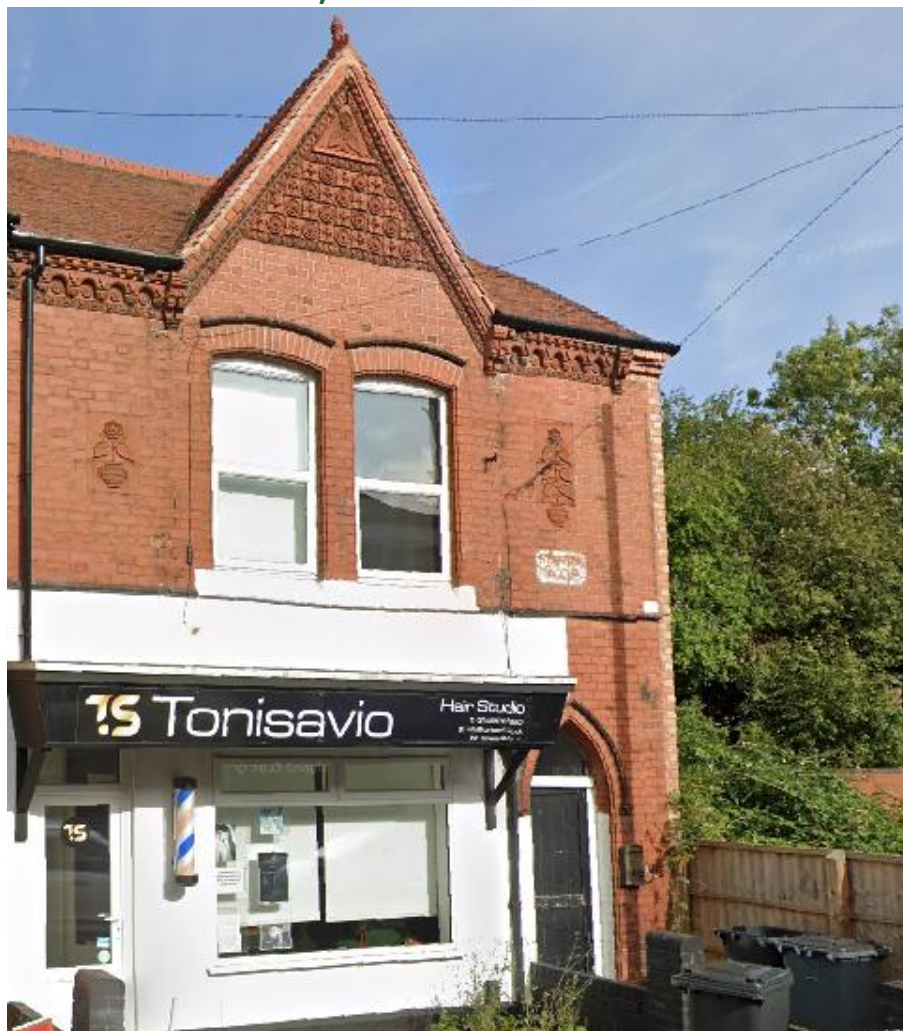
31 Princes Street, Nuneaton

Criteria	Description
Asset type	Building
Age	Built between 1886 and 1903
Rarity	Rare in comparison to local characteristics.
Architectural and artistic interest	<ul style="list-style-type: none">Decorative chimneyDecorative ridge tiles

<ul style="list-style-type: none"> • Decorative gable with ridge tiles and a finial, including intricate tile designs such as terracotta rosettes • Intricate cornices including dentilled pattern • Round arched windows on the first floor, including hood mouldings • Floral tiles on the first floor elevation • Pointed arch doorway, including hood moulding
Group value	This building has a clear visual design and historic relationship with 33 Princes Street.
Archaeological interest	Subject to future assessment
Historic interest	The building was constructed with the wider late 19 th century / early 20 th century residential development of the area, including the construction of this terrace, as shown in the early 20 th century photograph of the building below. This historic photograph also shows the decorative iron railings which were removed later in the 20 th century.

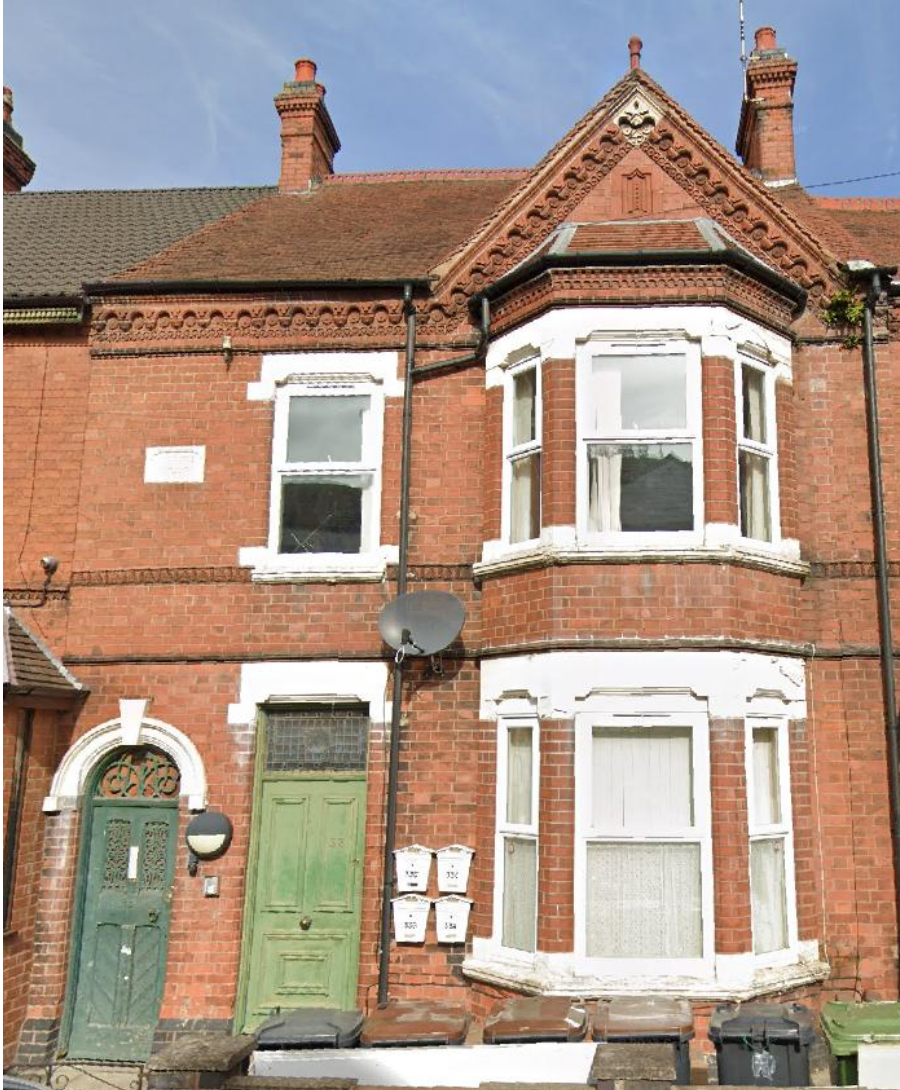
33 Princes Street, Nuneaton (Formerly Ivanhoe Villa)

Criteria	Description
Asset type	Building
Age	Built between 1886 and 1902
Rarity	Rare in comparison to local characteristics.

Architectural and artistic interest	<ul style="list-style-type: none"> • Decorative chimney • Decorative ridge tiles • Decorative gable with central decorative terracotta detail, intricate terracotta cornice, extending below all of the roof line • Modillion cornice above first floor bay window • String course below first floor window with intricate detailing, and another simpler string course above the ground floor windows • Two-storey bay window with hipped roof • Keystone over round arched doorway leading to an alleyway • Ornate metalwork above alleyway entrance • Ornatly detailed door leading to the alleyway • Fanlight with stained glass above main entrance • Original front door
Group value	This building has a clear visual design and historic relationship with 31 Princes Street.
Archaeological interest	Subject to future assessment
Historic interest	<p>The building was constructed with the wider late 19th century / early 20th century residential development of the area, including the construction of this terrace, as shown in the early 20th century photograph of the building below. This historic photograph also shows the decorative iron railings which were removed later in the 20th century.</p>

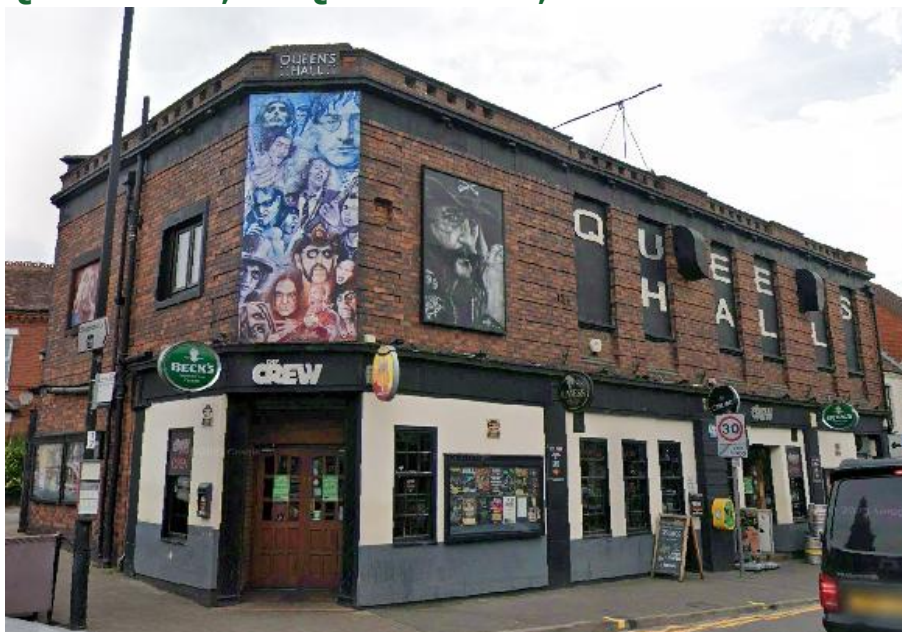
Queens Hall, 75 Queens Road, Nuneaton

Criteria	Description
Asset type	Building
Age	Built in 1925
Rarity	Rare in comparison to local characteristics.
Architectural and artistic interest	<ul style="list-style-type: none"> • Two cupolas • Hipped roof with brick parapet including openings and brick piers, with a corbel table below • Sash windows on the ground floor • Indented brick detailing across the building
Group value	None
Archaeological interest	Subject to future assessment
Historic interest	The building was first constructed in 1925, as shown in the article below (Lee, P., 2017). This includes a drawing of the original design of the building.

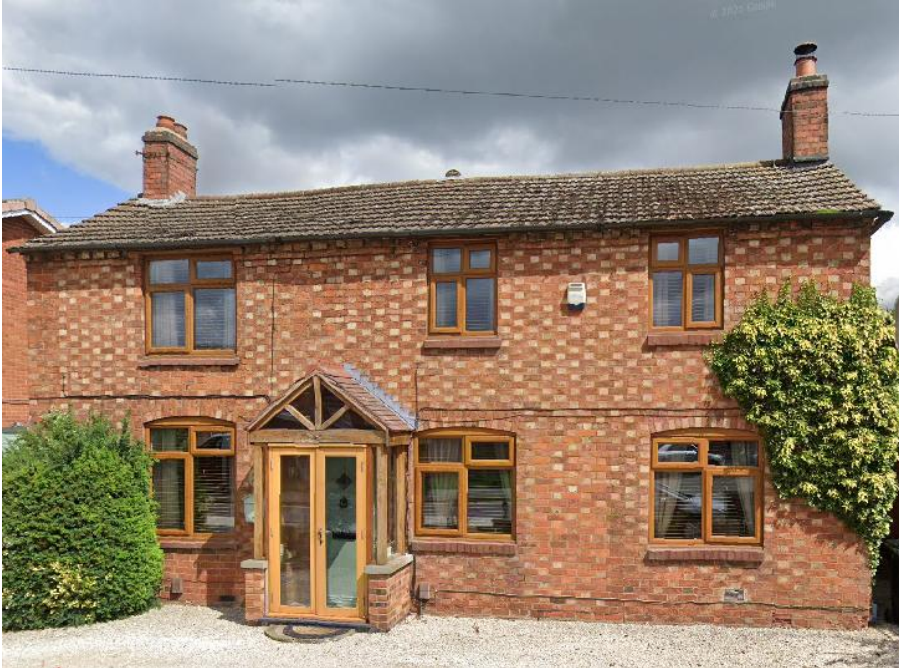
51 Rugby Road, Bulkington

Criteria	Description
Asset type	Building
Age	Built before 1886
Rarity	Relatively rare in comparison to local characteristics.
Architectural and artistic interest	<ul style="list-style-type: none"> • Dentilled brick cornice • Chequer-board pattern brickwork • Round arched windows on the ground floor with brickwork pattern • Historic T-shaped plot conserved, partially altered with the additional rear pitched extension and single storey extension
Group value	51 Rugby Road and 1 Withybrook Road form a group of pre-1886 chequer-board brickwork houses.
Archaeological interest	The building has a connection to the post-medieval settlement remains relating to the village of Ryton.
Historic interest	This building and No. 1 Withybrook Road are the last two conserved houses from the historic terrace along Withybrook (built before 1886) forming the south end of the historic village of Ryton. This historic connection is shown through their shared architectural character.

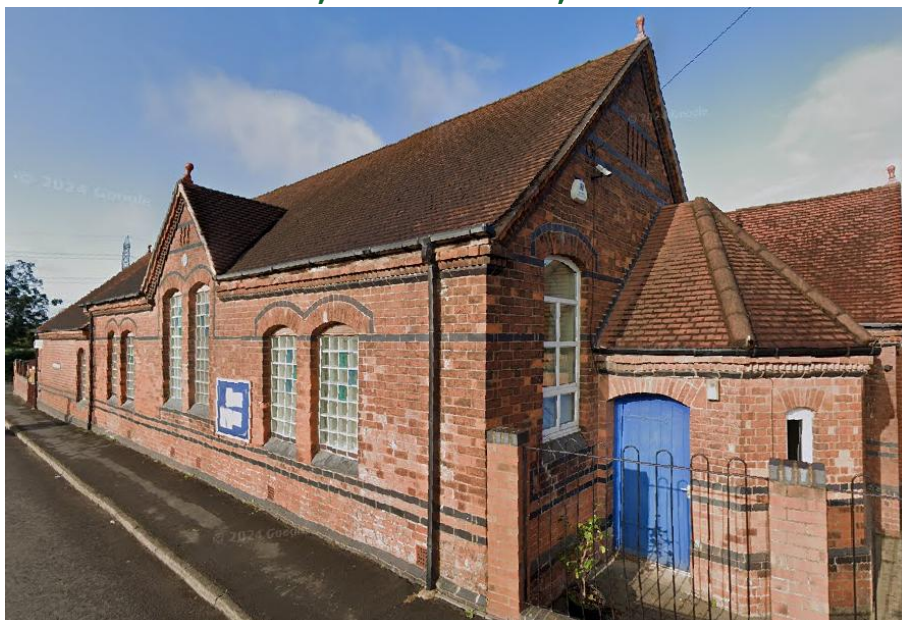
Exhall Old School, School Lane, Bedworth

Criteria	Description
Asset type	Building
Age	Built before 1886
Rarity	Rare in comparison to local characteristics.
Architectural and artistic interest	<ul style="list-style-type: none"> • Decorative chimneys • Finial detailing to the gables • Decorative brick cornice • Blue brick string courses at various levels • Round arched windows with blue brick detailing over arches • Round arched doorway to north side of the building • Decorative gable to Exhall Green elevation • Large two storey arched windows on the gable of the School Lane elevation • Main building extended but historic core still conserved

Group value	This building has a clear historic relationship with The School House.
Archaeological interest	Subject to future assessment
Historic interest	The building was built as a school for the local Exhall Green area. The current building is now a community centre. The building has maintained an important role within the local community which provides additional interest.
Landmark status	None
References	None

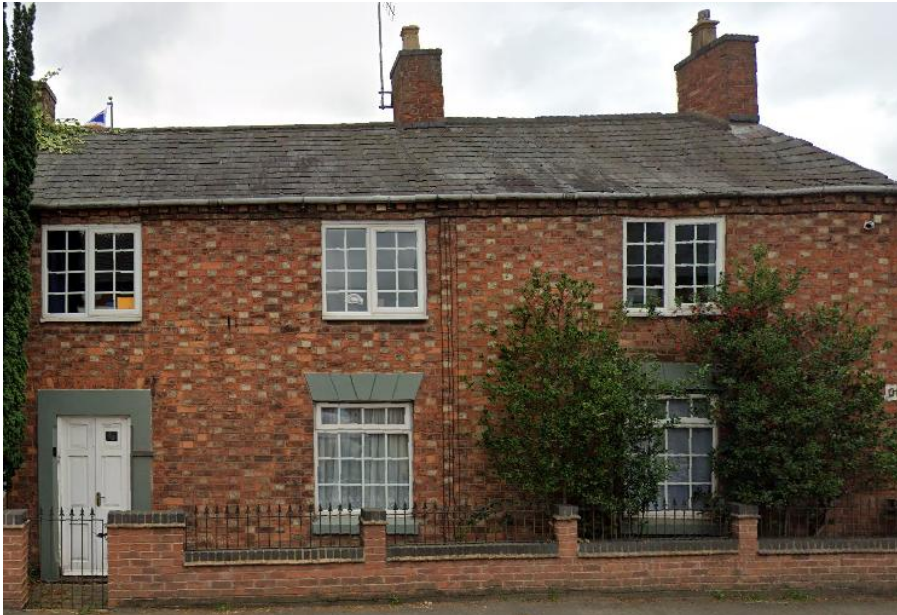
30 School Road, Bulkington

Criteria	Description
Asset type	Building
Age	Built before 1890
Rarity	Rare in comparison to local characteristics.
Architectural and artistic interest	<ul style="list-style-type: none"> • Brickwork dentilled cornice • Chequer-board pattern brickwork • Masonry front door surround and angled lintels • Historic tiled roof
Group value	n/a
Archaeological interest	Subject to future assessment
Historic interest	This building was constructed before the 1886 OS map, and demonstrates the historic character of the early residential buildings along School Road.
Landmark status	None
References	None

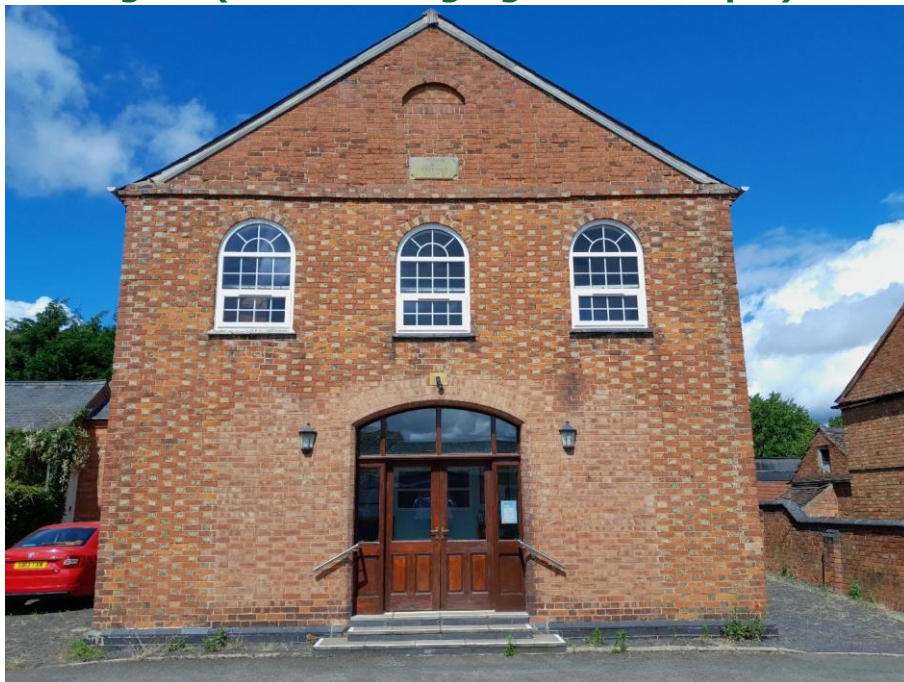
Bulkington Congregational Church, School Road, Bulkington (Former Congregational Chapel)

Criteria	Description
Asset type	Building
Age	1811 (Restored 1883)
Rarity	Rare in comparison to local characteristics.
Architectural and artistic interest	<ul style="list-style-type: none"> • Brick dentilled cornice to north and south sides • String course between second floor to the front of the building and the above gable end • Chequer-board pattern brickwork on ground and first floors • Round arched windows at first floor level to the front of the building, and on the sides at ground and first floor level, although frames are detracting modern uPVC.

<ul style="list-style-type: none"> • Large arched main doorway
Group value	The Manse, an adjacent house used in connection with the church, also reflects the same chequer-board brick pattern.
Archaeological interest	Subject to future assessment
Historic interest	The Bulkington Congregational Church was constructed in 1811 and restored in 1883. The building has conserved its use as a congregational church. This demonstrates the long-term communal interest in the building as a religious centre in the village. The building has largely conserved its historic plot form, with an additional extension constructed between 1886 and 1902.
Landmark status	None
References	<ul style="list-style-type: none"> • Timetrail (2021). <i>MWA2436: Congregational Chapel, School Road, Bulkington</i>. Available from https://timetrail.warwickshire.gov.uk/detail.aspx?monuid=WA2436 • Arnold, W. (n.d.). Congregational chapel, Bulkington. <i>Our Warwickshire</i>. Available from https://www.ourwarwickshire.org.uk/content/catalogue_her/congregational-chapel-school-road-bulkington

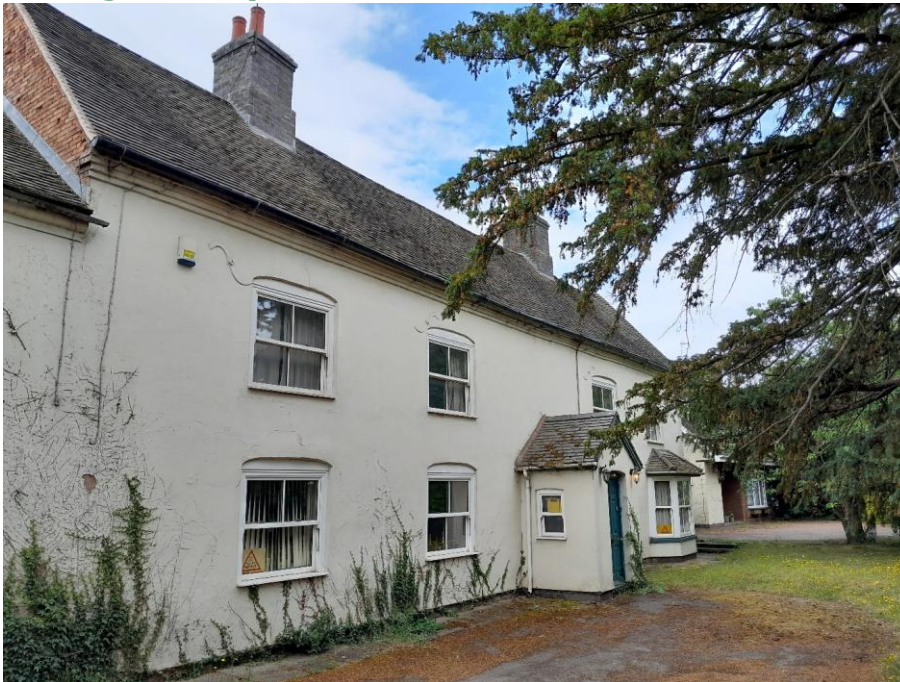
45 The Long Shoot, Nuneaton (Formerly Rose Cottage Farm)

Criteria	Description
Asset type	Buildings
Age	Built before 1886
Rarity	Rare in comparison to local characteristics.
Architectural and artistic interest	<ul style="list-style-type: none"> Historic farmstead arranged in a regular courtyard E-plan, however two sides have been demolished. The historic farmstead has interest as it evidences the local farming region, as well as advanced agricultural regimes. Additionally, the farmstead was an essential component of the former more rural landscape. (Historic England, 2017) Arched four by four windows to the front elevation, with a

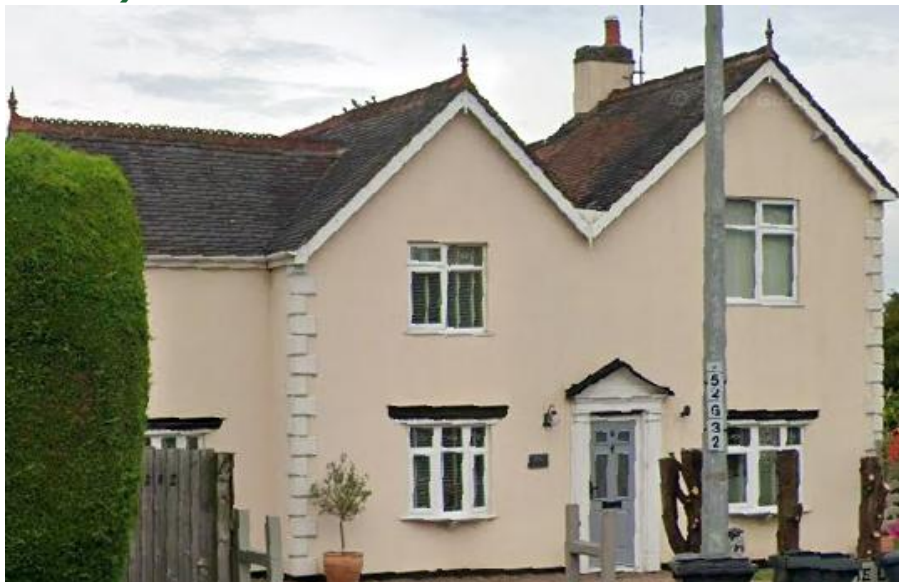
284 The Long Shoot, Nuneaton (Formerly Tollgate House)

Criteria	Description
Asset type	Building
Age	Built before 1886
Rarity	Rare in comparison to local characteristics.
Architectural and artistic interest	<ul style="list-style-type: none"> Decorative ridge tiles with finials Quoins Balustraded parapet balcony to the west of the building Pedimented porch over front entrance with pilasters Bargeboards to asymmetrical front gables
Group value	n/a
Archaeological interest	Subject to future assessment
Historic interest	There may be a significant historical association of local note, as Watling Street used to be a toll road, which travellers would have to pay to use during the Imperial period between 1751 and 1913

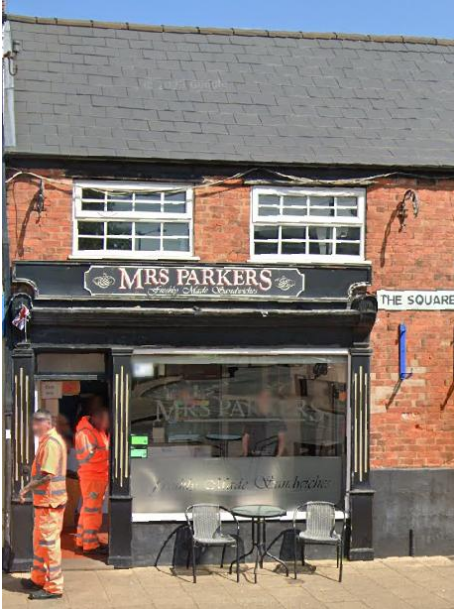
2 The Square, Nuneaton

Criteria	Description
Asset type	Building
Age	Built between 1842 and 1886
Rarity	Rare in comparison to local characteristics.
Architectural and artistic interest	<p>The historic shopfront is of particular interest to this building, including the following.</p> <ul style="list-style-type: none"> • Original fascia • Consoles • Cornice • Fluted pilasters • Stallriser • Fanlight <p>Various extensions to the rear throughout the plot's history, but some historic fabric could be conserved in the historic core.</p>
Group value	n/a
Archaeological interest	Subject to future assessment

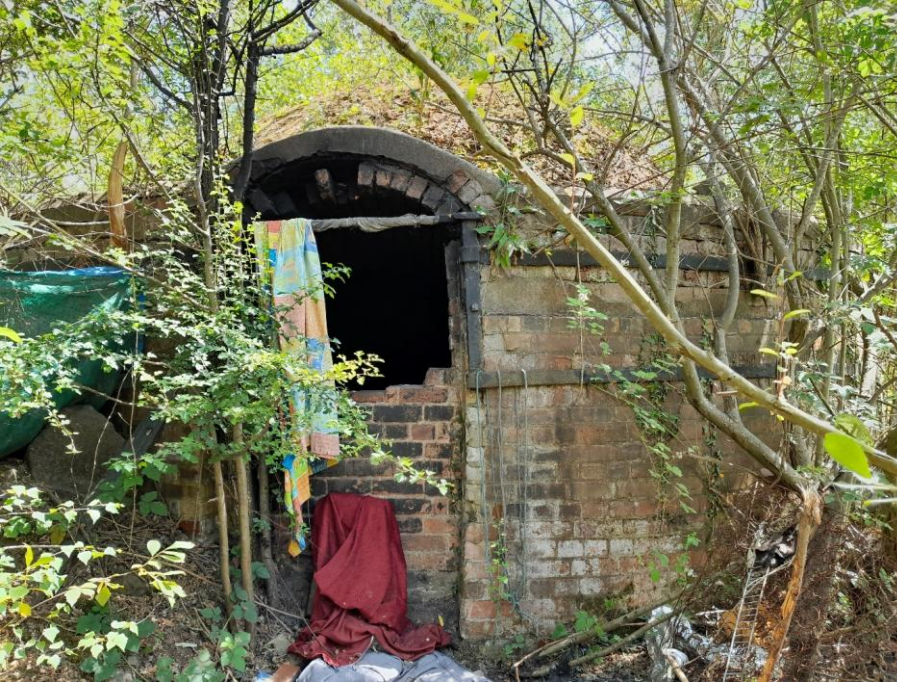
Beehive Kiln, Tuttle Hill, Nuneaton

Criteria	Description
Asset type	Structure
Age	Built before 1890
Rarity	Rare in comparison to local characteristics.
Architectural and artistic interest	<ul style="list-style-type: none"> Round domed brick kiln with structural metal braces
Group value	n/a
Archaeological interest	Subject to future assessment
Historic interest	This structure has a significant historical association of local note, as it was a brick kiln associated with the brickworks in this location, which was operating at least by 1890. The manufacturing of bricks led to the late-Victorian and Edwardian town boom in the 1890s and 1900s. (Warwickshire County Council, 2015)
Landmark status	None

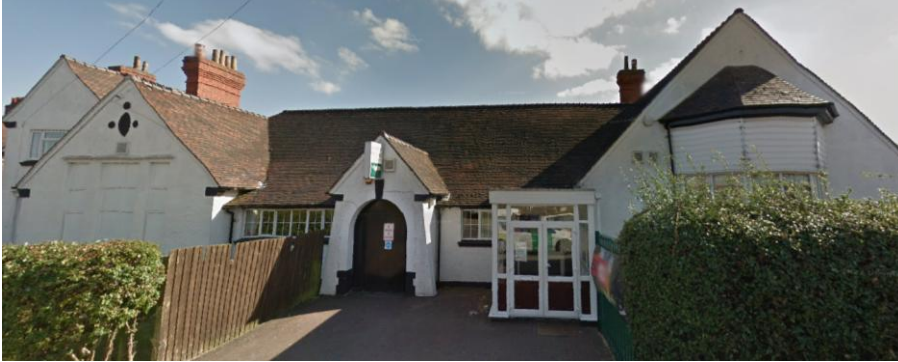
Haunchwood Sports and Social Club, Valley Road, Nuneaton (Formerly Haunchwood Institute)

Criteria	Description
Asset type	Building
Age	Built between 1913 and 1923
Rarity	Rare in comparison to local characteristics.
Architectural and artistic interest	<ul style="list-style-type: none"> • Decorative chimneys • Decorative ridge tiles • Four projecting gables to the front of the building, one with a decorative pattern in black, and another with a timber boarded and hipped roof addition above the ground floor bay window • Arched entrance topped with keystone • The historic core is still conserved, although with a single storey flat roofed extension to the rear
Group value	n/a
Archaeological interest	Subject to future assessment
Historic interest	The building was constructed between 1913 and 1923, and is labelled on maps as "The Institute", with a bowling green to the rear. The existing building has retained this sports and community hall use.

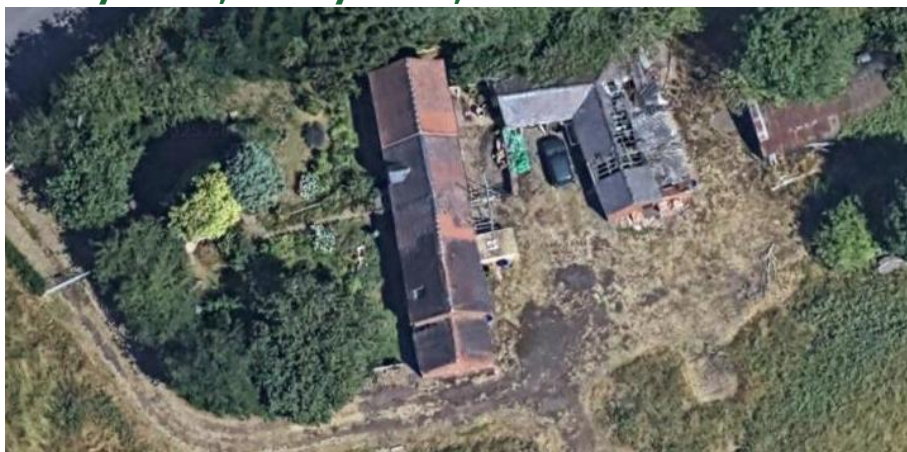
Valley Farm, Valley Road, Nuneaton

Criteria	Description
Asset type	Buildings
Age	Built in the early 18 th century with additions in the early 19 th century
Rarity	Rare in comparison to local characteristics.
Architectural and artistic interest	<ul style="list-style-type: none"> • Decorative chimneys • Keystone above main entrance • Round arched doorway • Original 18th century structure with part square timber frame and replacement brick infill • Rendered two storey bay to the north dates to the early 19th century • A single storey gabled brick extension with decorative gable, dentilled verges in brick, some retained timber framing and double barn doors • Regular rectangular plan form in line with historic agricultural use • Historic clay roof tiles of interest

<ul style="list-style-type: none"> • Timber framing internally and externally is of interest • Irregular fenestration throughout • L-shaped outbuilding also historic (shown in 1842 Tithe map) but of less interest
Group value	These buildings have a clear historic relationship.
Archaeological interest	Subject to future assessment
Historic interest	<p>The early 18th century date of the main farm building is of interest. There is documentary evidence (in the 1690 land survey) that the farmhouse could predate this, as the land was already enclosed and divided by 1690, although there is no specific mention of the building in the survey (Timetrail, 2025).</p> <p>The farm buildings are evident on the 1842 tithe map, including the L-shaped outbuilding, as shown below. The main building (plot 240) and surrounding farmland (plots 232, 239, 243, 244, 245 and 259) were occupied at this date by the farmer Thomas Parker, with the southern addition to the farmhouse (plot 241) occupied by Ann Cooper.</p> <p>1842 Tithe Map</p>

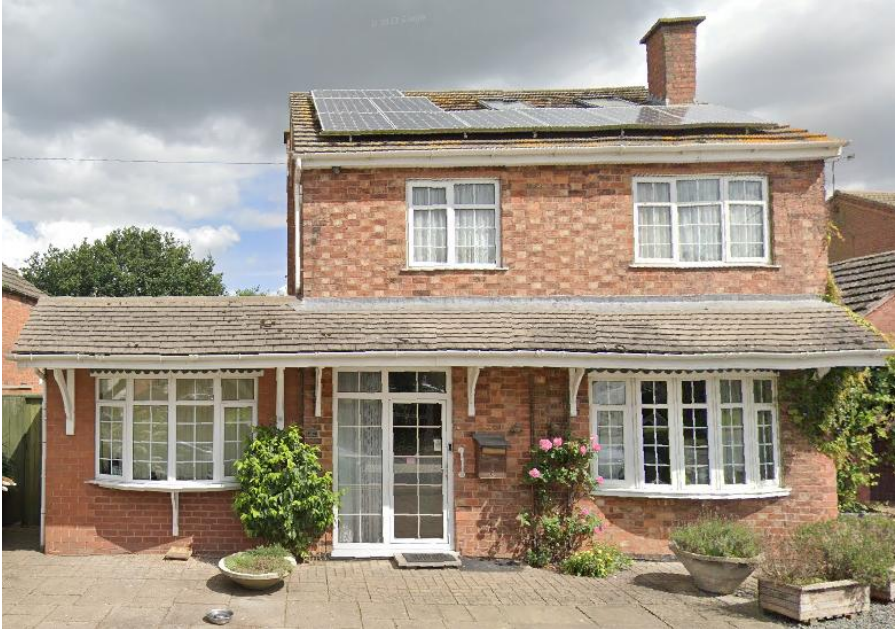
1 Withybrook Road, Bulkington

Criteria	Description
Asset type	Building
Age	Built before 1886
Rarity	Rare in comparison to local characteristics.
Architectural and artistic interest	<ul style="list-style-type: none"> Chequer-board pattern brickwork, most evident at first floor Bargeboard to front elevation and gables
Group value	51 Rugby Road and 1 Withybrook Road form a group of pre-1886 chequer-board brickwork houses.
Archaeological interest	Connection to the post-medieval settlement remains relating to the village of Ryton.
Historic interest	This building and No. 51 Rugby Road are the last two conserved houses from the historic terrace along Withybrook (built before 1886), forming the south end of the historic village of Ryton. This
